Campaign Update CA#10000

Subject: The Victron Battery Protect BP100
Affects certain 2022 Unity U24RL, U24MB, U24TB, U24CB,
U24FX and 2022 Wonder W24RL motorhomes

Reset Victron BP100 Low Voltage

Disconnect for 2022MY AGM Batteries

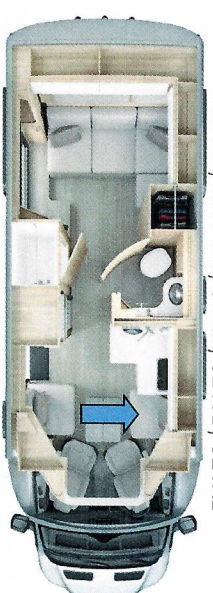
2

BP-100 low voltage disconnect is located under the driver side dinette lid (removal of screws is necessary).

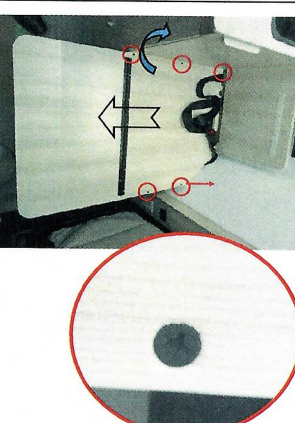
3

Remove the Phillips (star) screws in the dinette lid.

Slide the dinette towards yourself and then lift it away.

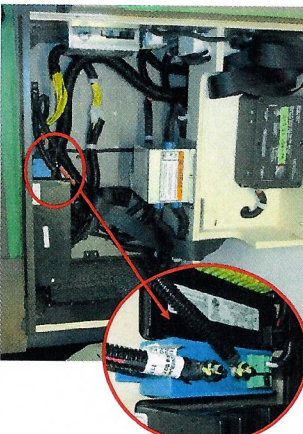
4

Locate the blue box mounted to the backside of the dinette face.

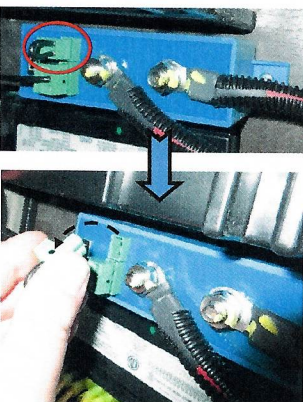
5

With the battery disconnect ON.

Remove the external on/off signal bypass (2-pin connector) and set aside.

When you remove the external on/off plug the lights will go out. This is normal.

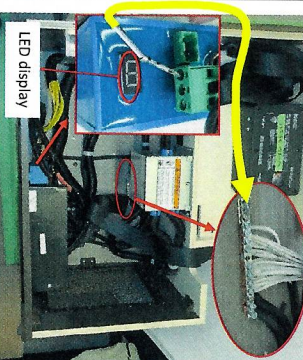
6

Touch and hold one end of the supplied wire to the ground bar and the other to the inner set screw on the 3-pin plug.

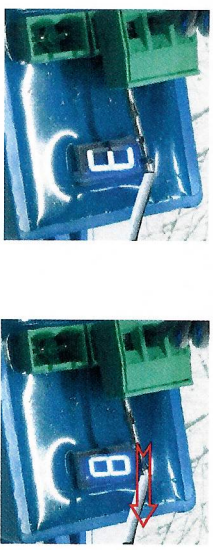
7

The LED display will cycle from 3 upwards.

Remove the jumper wire when 8 is reached.

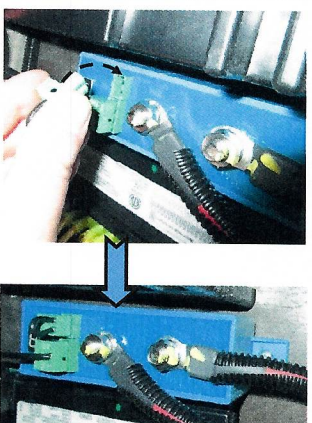
9

Reinsert the external on/off 2-pin plug into the BP-100 to complete the reprogramming and reinstall the dinette lid.

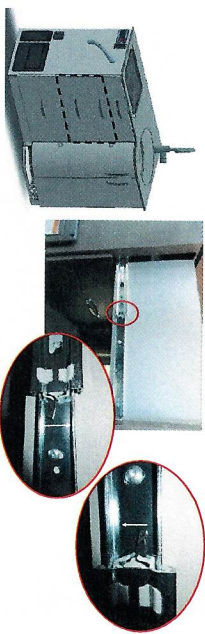
3

Remove the top two drawers of the galley. Pulling the drawer out all the way. There is a lever on each track, one moves up the other moves down to release the drawer to be pulled out of the galley.

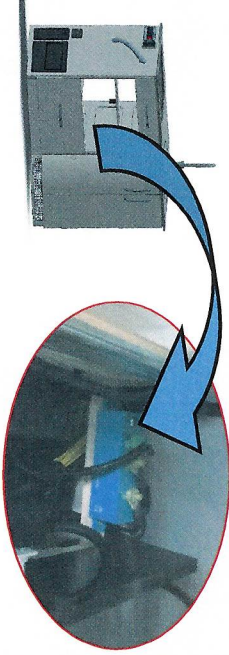
4

Locate the blue box mounted behind the galley drawers.

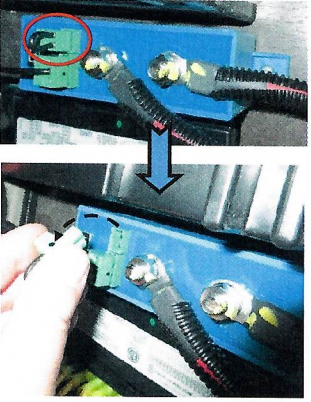
5

With the battery disconnect ON. Remove the external on/off signal bypass (2-pin connector) and set aside. When you remove the external on/off plug the lights will go out. This is normal.

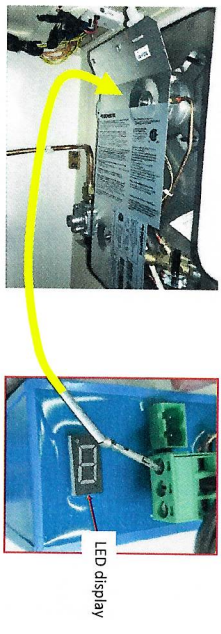
6

Touch and hold one end of the supplied wire to the metal box of the cooktop and the other to the inner set screw on the 3-pin plug.

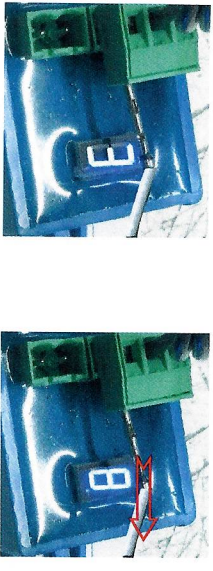
7

The LED display will cycle from 3 upwards. Remove the jumper wire when 8 is reached.

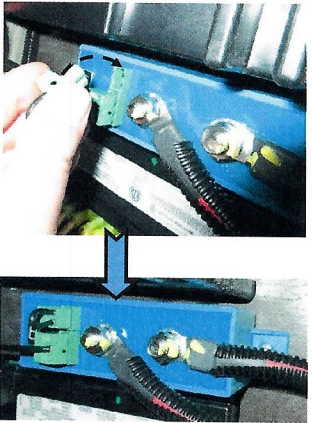
9

Reinsert the external on/off 2-pin plug into the BP-100 and to complete the reprogramming and reinstall the drawers.
