AMB9 – Reworking Brake Booster (Recall Campaign)

Vehicle Type: **Taycan (Y1A)/Taycan 4S (Y1A)/Taycan Turbo (Y1A)/Taycan Turbo S (Y1A)
Taycan 4S Cross Turismo (Y1B)**

Concerns: **Brake booster**

Information: **On the affected vehicles, the screw of the brake booster's pressure input rod may not have been connected according to specifications.**

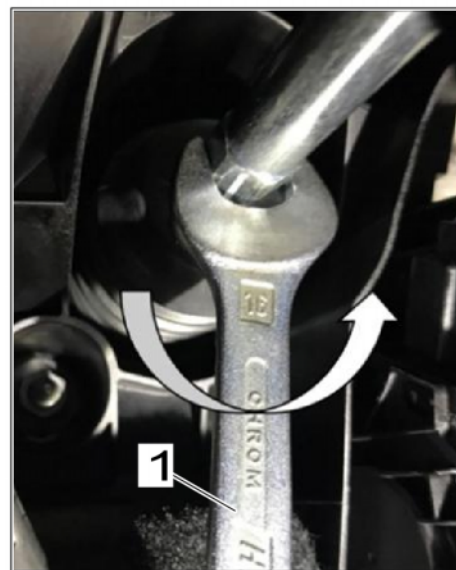
Pressure input rod

- 4 Turn the pressure input rod using an open-ended wrench (a/f 16) ⇒ *Pressure input rod -1-* 45 degrees (counterclockwise) ⇒ *Pressure input rod -in direction of arrow-*.
