991 – Clicking Noises from Centerlock Wheels

Vehicles Affected

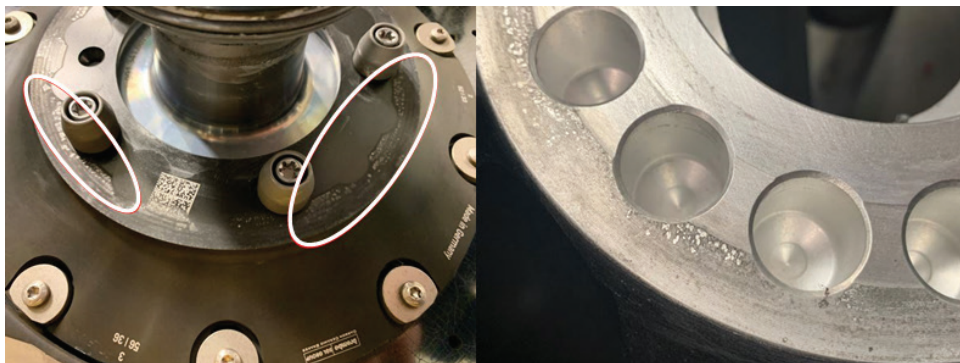
3. Inspect the outer surface of the brake disc bell and the inner surface of the wheel that contacts the brake disc bell. If any material transfer or corrosion is present on either surface (Figure 2), gently and thoroughly clean the surface of both parts. Document any material transfer and corrosion with pictures.

Figure 2
Material Transfer to Brake Disc Bell (Left) from Wheel (Right)

- a. To clean the surfaces, please use special tool **VAS 294009 – Wheel Hub Cleaner**.
 - i. **Only if special tool VAS 294009 is unavailable**, 3M Scotch-Brite Hand Pads 7445 (white) and 7448 (light gray) may also be used.

1. Begin by gently cleaning with pad 7445. If pad 7445 does not completely remove all corrosion and material transfer from the surfaces, gently clean the surfaces with pad 7448.

2. **Note: Do not use a more abrasive Scotch-Brite pad than pad 7448. Doing so may remove any protective coating from the surfaces of the wheel and brake disc bell.**

- b. If a surface cannot successfully be cleaned, replace **only** the component that cannot be cleaned.
 - i. If no parts are replaced, or if only the wheel is replaced, or if only the brake disc is replaced, continue to Step 4.
 - ii. If both the wheel and brake disc are replaced, skip to Step 6
- 4. Inspect for material transfer on the contact surfaces between the drive pegs and brake disc (Figure 3). Replace the drive pegs **and all drive peg screws** if material transfer is present. Document any material transfer with pictures.

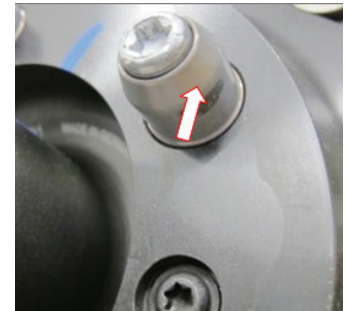
Figure 3
Material Transfer on Drive Peg

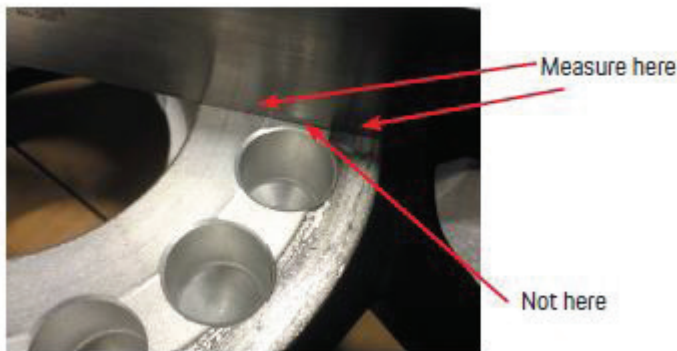
- 5. Check the flatness of the wheel mating surfaces with a straight edge (12" Starrett 380). Imperfections in the surface may have an influence on the rotor and cause noise. It is necessary to check for flatness in 6 different positions around the mating surface, roughly every 60 degrees. Using a feeler gauge, determine the minimum gap between the straight edge and the mating surface on both the inner and outer rings of the mating surface. Be sure to thoroughly document all measurements.

Figure 4
Flatness measuring positions

The inner (smaller) ring of the mating surface has a conical taper and may not be completely flat. However, the minimum distance between the mating surface and the straight edge should be relatively uniform across all measuring positions.

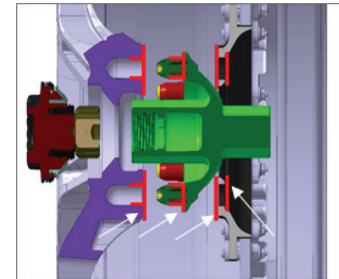
Figure 5
Mating Surfaces to Check for
Anti-Corrosion Oil

6. If any anti-corrosion oil is present from manufacturing on any mating surfaces (marked in red with white arrows in Figure 5), on new or old parts, clean the parts with a microfiber cloth and brake parts cleaner. Document presence of anti-corrosion oil with pictures.

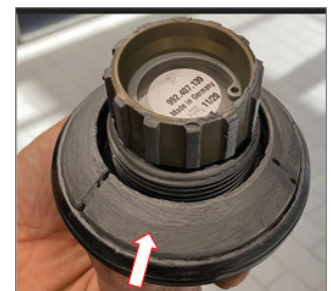
Figure 6
Application of Grease to
Centerlock Cone

7. Thoroughly clean the centerlock nut and apply a complete layer of Optimoly grease to the centerlock cone. Ensure that the center lock nut is properly lubricated in accordance with WM 440519 / WM 440737, and that all mating surfaces are clean and free of debris.

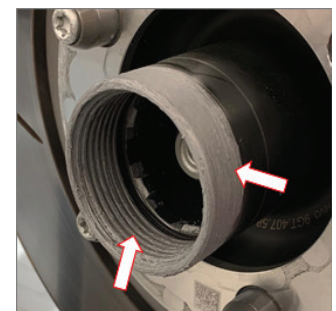
Figure 7
Application of Grease
to Wheel Hub

8. Thoroughly clean the wheel hub threads and apply a complete layer of Optimoly grease to both the inside threads and the outside diameter. Ensure all contact surfaces of the wheel hub are clean and free of debris.

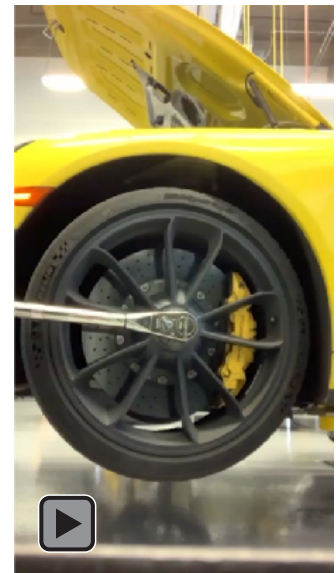
Figure 8
Proper Centerlock Tightening Motion (Video File)

11. Reinstall both wheels as instructed in *WM 440519 – Removing and installing wheel with central bolt, section on Installing wheel with central bolt*.
 - a. Please use recommended special tool **QD4RN800A – Torque Wrench** from Snap-on for the centerlock wheels.
 Note: When tightening the centerlock nuts, **ensure that the nuts are tightened in one continuous motion, while the vehicle is completely lifted from the ground**. This guarantees that the prescribed tightening torque is achieved. Please see sections 6.1-6.3, within section on *Installing wheel with central bolt*, for proper tightening procedure and tightening torque values.
