Multistrada V4S Model Year 2021-2022 Service Repair Bulletin SRV-SRB-21-059

This document introduces the installation process for the new lowering spring kit for the front fork and rear shock absorber for the Multistrada V4S.

This kit is designed to lower the motorcycle by 20 mm, bringing the seat height to 840 mm, without sacrificing the agility and riding pleasure.

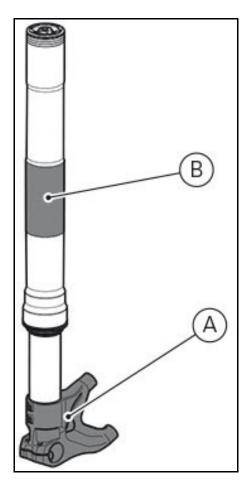
The figure shows areas (A) and (B) recommended to fasten the fork to the vice.

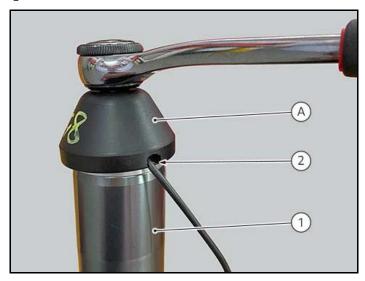
- 2. Use tool part no. 88713.4302 to secure upper fork leg (1) vertically in the vice.
- 3. Loosen plug (2) from sleeve (1) using tool (A) part no. 88713.0029.
- 4. Slide the upper leg (1) down on the fork

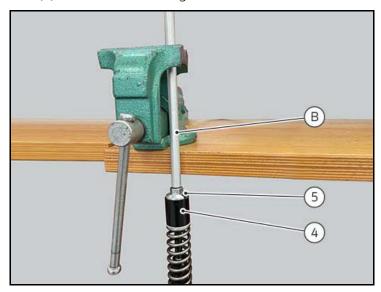
- 6. Fit tool (B) part no. 88713.3203 on the thread of the damper rod
- 7. Lock tool (B) in a vice with soft jaw covers to facilitate the removal of the retaining bushing (5)
- 8. Lower the **preload tube (4)** and remove the **retaining bushing (5)** by lifting it from the seat of the **preload tube (4)**, as shown in the figure

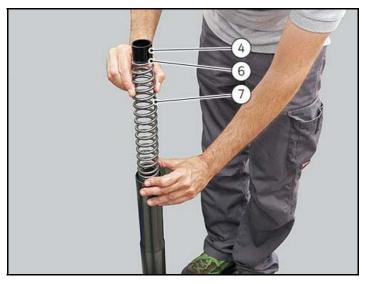
10. Remove the preload tube (4), the centering bush (6) and the spring (7)

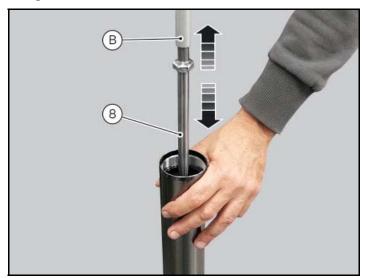
- 1. Lower the fork outer sleeve
- 2. Refit tool (B) part no. 88713.3203 on the thread of the damper rod
- **3.** Slowly operate the **damper rod (8)** repeatedly to allow the fluid to fill the entire internal volume of the cartridge

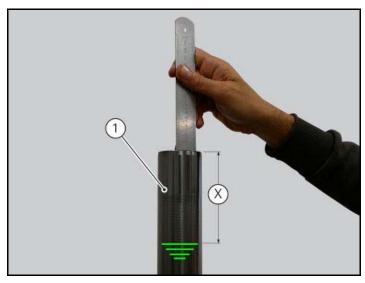
9. Move damper rod (8) down to the end of its stroke; check that the level of fluid contained inside the fork with respect to the edge of sleeve (1) is (X) = 120 mm (4,72 in)

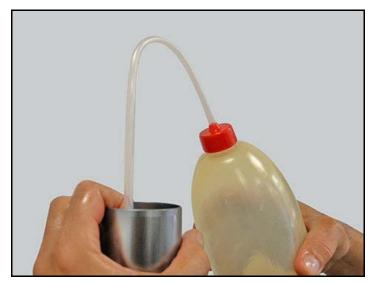
10. Should it be necessary to remove any excess fluid, proceed as shown in the figure below. Check again that you have reached the correct amount of fluid that must be present inside the leg.

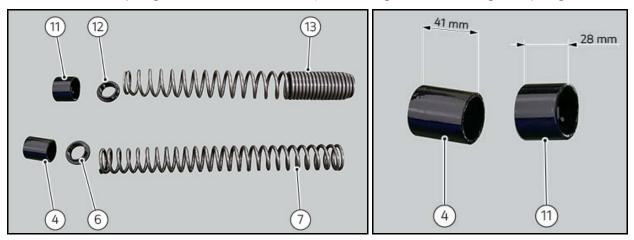
The figure shows the differences between the original components in the fork and the components of the "Lowered spring kit".

- Preload tube (11): is L=28 mm (1.10 in) long, compared to the original preload tube (4) which is L=41 mm (1.16 in) long
- Centering bushing (12): has the same shape of the original centering bushing (6)
- The lowered spring (13) has a different shape and length than the original spring (7)

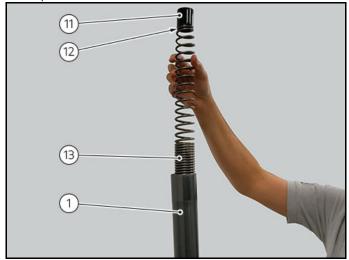
Insert the lowered spring assembly, consisting of **preload tube (11)**, **centering bushing (12)** and **lowered spring (13)**, inside sleeve (1). Aim spring as shown in the figure, with the closest coils facing fork bottom ends.

The spring must be positioned as indicated.

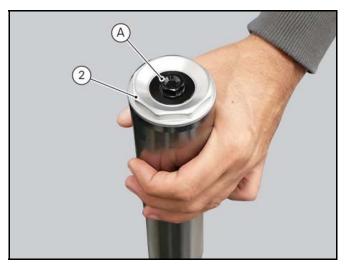
1. Protect the flat of the adjuster (A) on the plug (2) with adhesive tape. Reduce the spring preload, by loosening adjuster (A) by 5 turns anticlockwise, until fully home. Remove the adhesive tape from the flat of the adjuster (12). Restore the 5 preload turns during refitting.

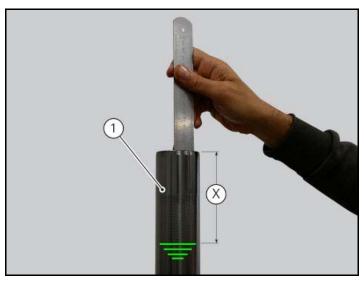
6. Move damper rod (8) down to the end of its stroke; check that the level of fluid contained inside the fork with respect to the edge of sleeve (1) is (X) = 130 mm (5,12 in)

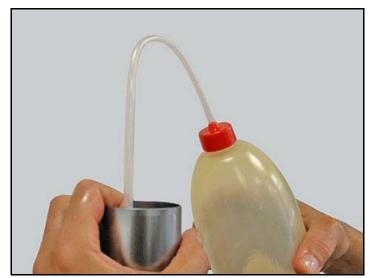
7. Should it be necessary to remove any excess fluid, proceed as shown in the figure. Check again that you have reached the correct amount of fluid that must be present inside leg.

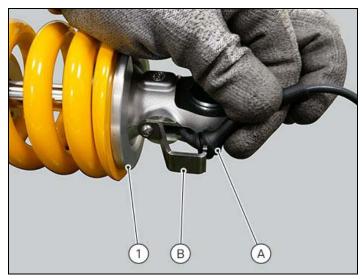
- 1. Remove the rear shock absorber (See Sec. 7: "Chassis Rear shock absorber assembly" of the Workshop Manual)
- 2. Release cap (A) from plate (B) of the rear shock absorber (1)
- 3. Slide cap (A) on wiring and away from the rear shock absorber, taking care not to pull too much on the harness, which could be damaged

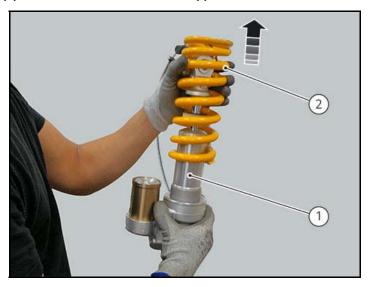
- 8. Decompress the rear shock absorber (1) and remove it from the spring removal tool
- 9. Remove spring (2) from rear shock absorber (1)

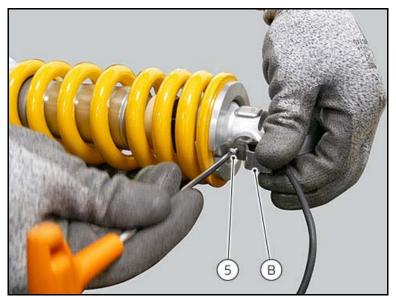
Make sure that plate recess is positioned on spring flat surface, taking care not to make it match with the spring cut.

6. Refit plate (B) by tightening screw (5) to 3 Nm ± 10%

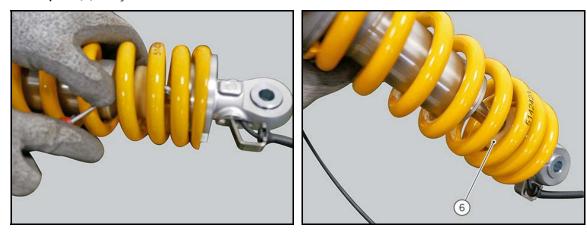
8. Drive pad (6) fully home
