Technical Service Bulletin

SUBJECT:		No: TSB-21-54-004	
UPDATES TO CHASSIS ELECTRICAL - SERVICE MANUAL REVISION		DATE: October 2021	
		MODEL: See Below	
CIRCULATE TO:	<input type="checkbox"/> GENERAL MANAGER	<input checked="" type="checkbox"/> PARTS MANAGER	<input checked="" type="checkbox"/> TECHNICIAN
<input checked="" type="checkbox"/> SERVICE ADVISOR	<input checked="" type="checkbox"/> SERVICE MANAGER	<input checked="" type="checkbox"/> WARRANTY PROCESSOR	<input type="checkbox"/> SALES MANAGER

This TSB provides updated content for the Chassis Electrical section of the affected Service Manuals, Horn.

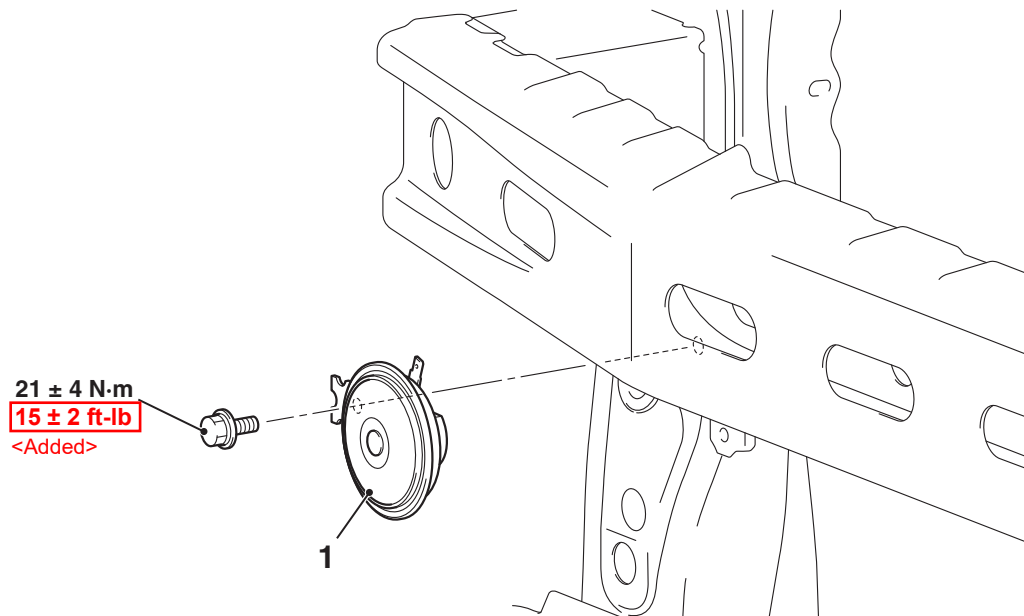
ACB03498AB

Removal

- Front bumper and radiator grille assembly (Refer to GROUP 51 – Front Bumper Assembly and Radiator Grille P.51-3).

>>A<< 1. Horn (LOW)

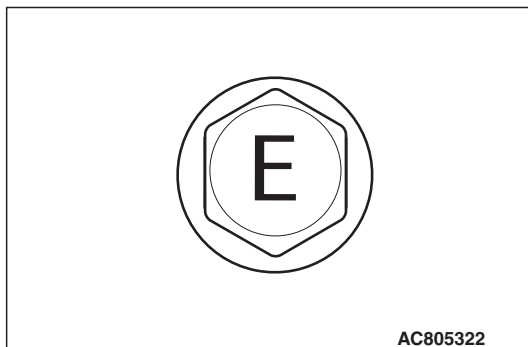
>>A<< HORN (LOW) INSTALLATION

Use the ground bolts as the mounting bolts for horn (LOW).
The ground bolts have "E" mark on the bolt heads.

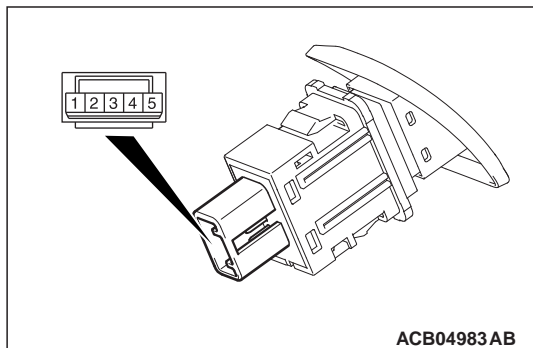
CONTINUITY CHECK FOR HAZARD WARNING
LIGHT SWITCH

Switch position	Measured terminals	Normal condition
OFF	2 – 5	Open loop
ON		Less than 2 ohm

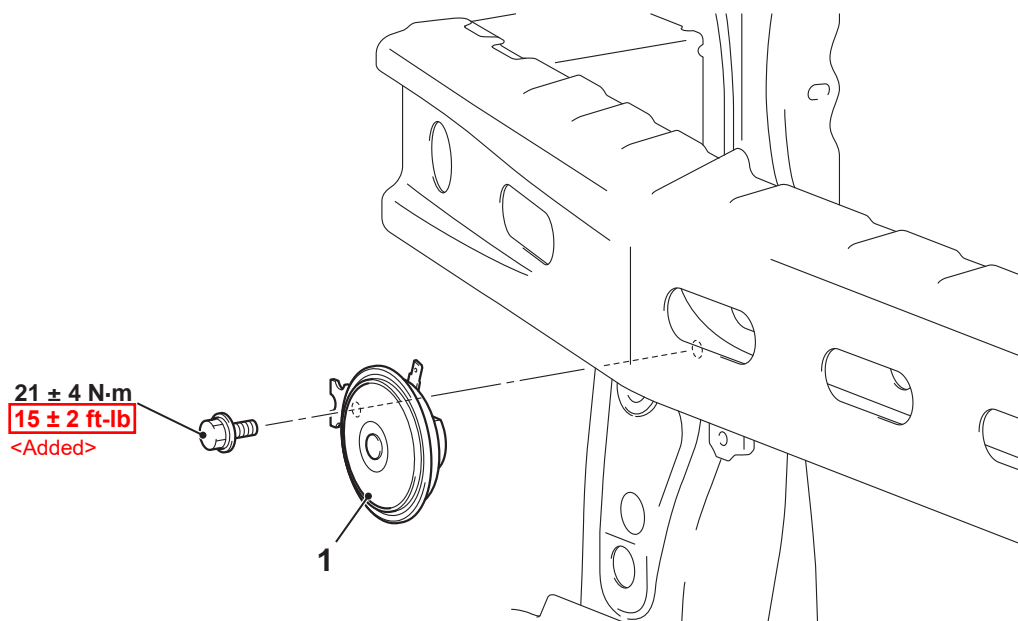
ACB03498AB

Removal

- Front bumper and radiator grille assembly (Refer to GROUP 51 – Front Bumper Assembly and Radiator Grille [P.51-3](#)).

>>A<< 1. Horn (LOW)
