**** TECHNICAL INFORMATION NOTICE ****

DATE: October 25, 2021
TO: Mitsubishi Motors US & Puerto Rico Dealer Service and Parts Managers
RE: Loose Leather Trim on Center Console sides
TIN NO. TIN-21-52A-002

AFFECTED VEHICLES: 2022 Outlander

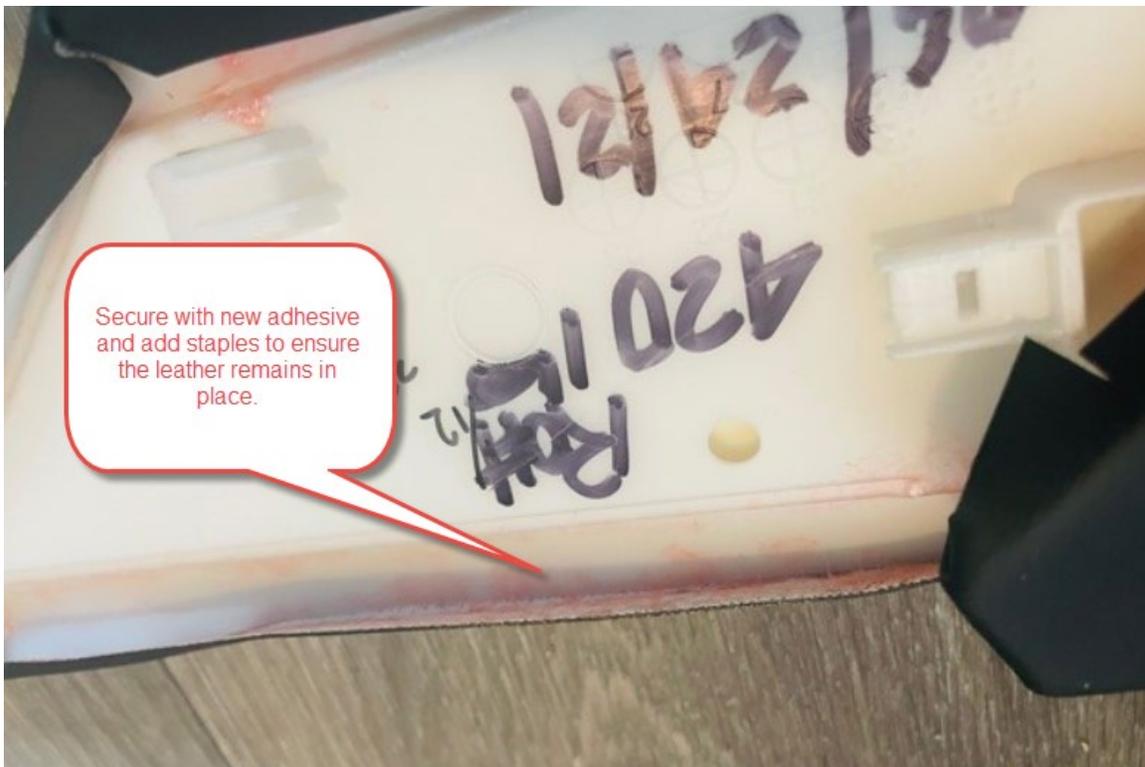
If you have a 2022 Outlander with the complaint of leather trim coming loose on the sides of the center console, please replace the affected finisher with a new part. In the event of a backorder supply concern you can instead have part number 8011C440XA or 8011C440XB repaired. The leather can be bonded back to the trim panel with the addition of staples in several areas by an upholsterer.
