HYUNDAI Technical Service Bulletin

21-BD-002H-1

Palisade (LX2)

SUBJECT: HEADREST ODOR SERVICE PROCEDURE

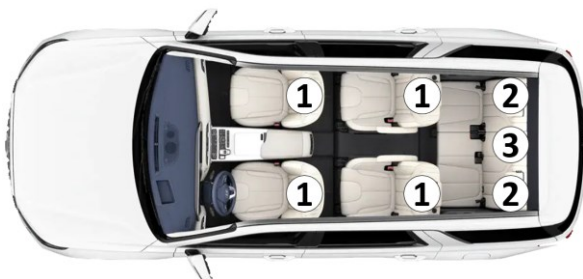
Note: Refer to the image below for the applicable headrest number.

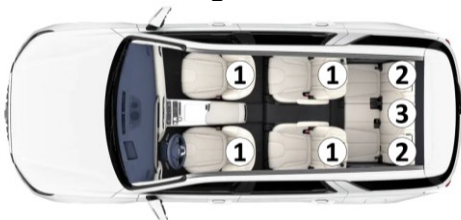
Note 4: Refer to the image below for the applicable headrest number:

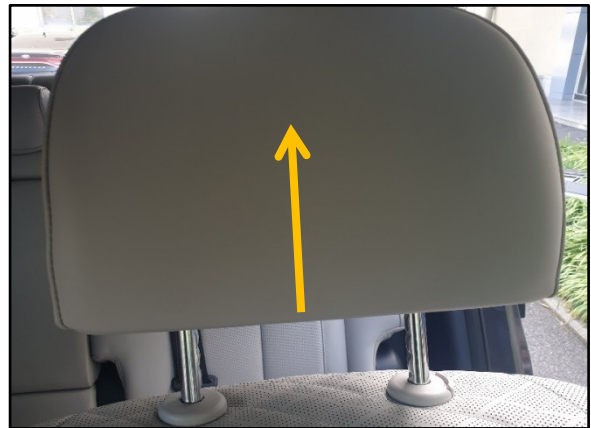
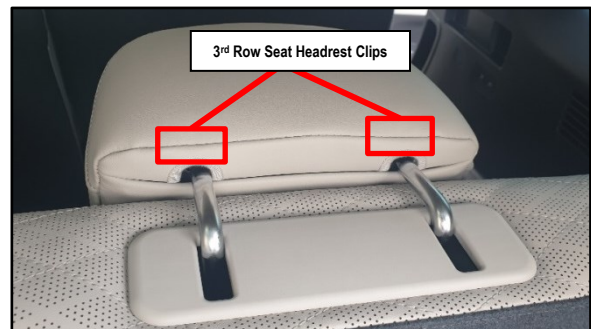
1. Remove all affected headrests.

The headrests located on the third row of the vehicle are secured by clips. Press down on the indicated clip locations to remove the headrests.

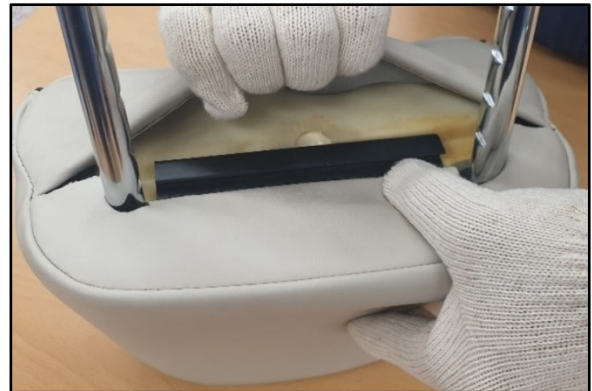
2. Open each headrest leather cover to expose the foam pad.

Do not fully remove the leather cover from the foam pad. Removal can damage the leather cover stitching.

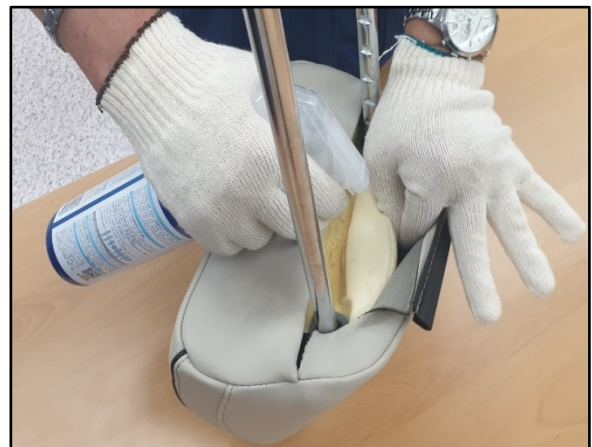
3. Spray the foam pad with the odor eliminator product and squeeze the foam pad to absorb the liquid.

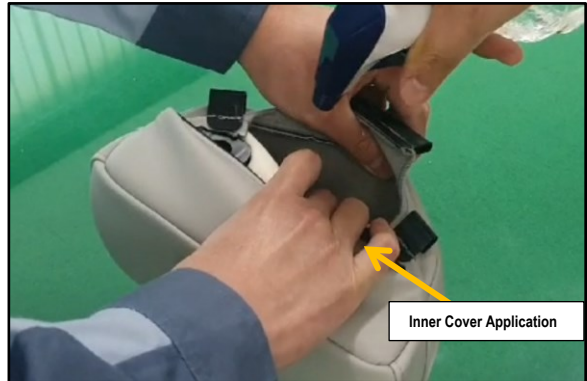
4. Apply the odor eliminator product to all inside fabric surfaces of the leather cover(s).

Do not spray onto the outside of the leather cover(s).

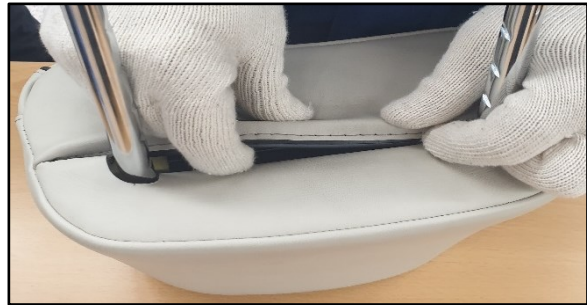
5. Close the headrest cover(s).

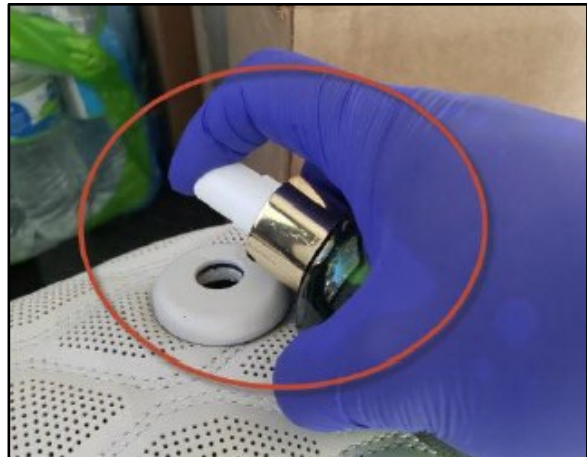
6. Apply the odor eliminator product to the headrest mounting holes on the top of each seat.

7. Reinstall the parts in the reverse order of removal.
8. Park the vehicle in direct sunlight for 2-3 hours to let the odor eliminator product dry.
9. Reinspect each headrest for the odor.

If the odor is still present for a certain headrest, replace only the affected headrest(s).
