Tesla, Inc. Service Bulletin		<i>Inspect Center Console Decor Lid Latch Pin</i>	
SB-21-15-006 September 11, 2021			
Classification		Section/Group	Mobile Service
Repair Bulletin		15 - Interior Trim	Can Perform (where permitted)
Model Year	Model	Country/Region	Version
2021	Model S Palladium	United States	All
<small>The model(s) and model year(s) listed are a general approximation of the affected VIN list. Refer to the VIN/Bulletin Tracker or Customer/Vehicle profile to determine applicability of this bulletin for a particular vehicle.</small>

Some Model S Palladium vehicles were manufactured with center console decor lid latch pins too short to reliably secure the decor lid open.

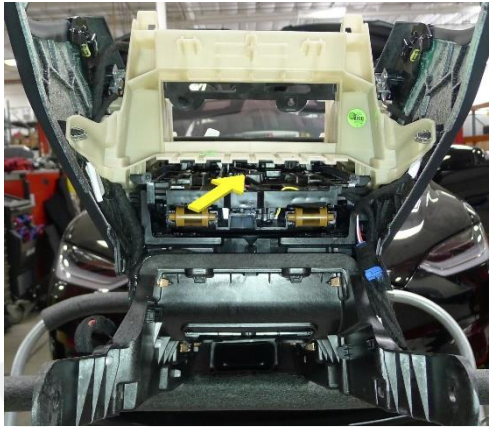
Figure 4

- From the front of the center console (Figure 4), use needle nose pliers to swivel the latch pin to the left, out from under the tang (Figure 5).

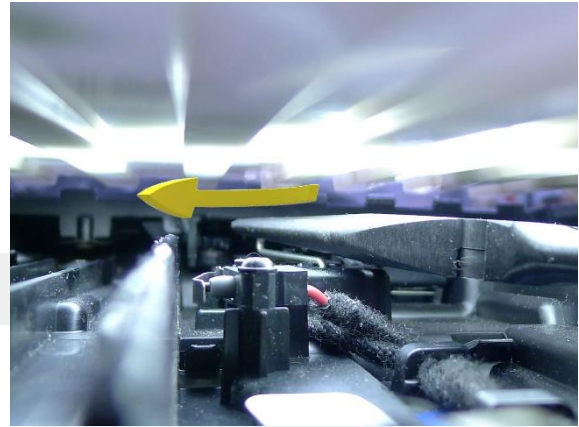
Figure 5 – Swivel fully to the left

⚠ CAUTION: Swivel the latch pin as far to the left is possible. If not, the tang might break in the next step. If the tang breaks, replace the center console decor as described in step 2 and repeat this step.

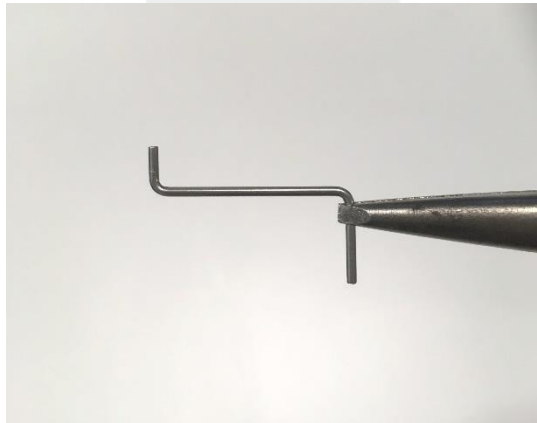
Figure 6

- Lift up on the latch pin and separate it from the latch pin boss.
- Remove the latch pin from the center console.
- Set the replacement latch pin in the needle nose pliers so that the pliers grip the long shank of the latch pin, with the shank pointing down (Figure 6).

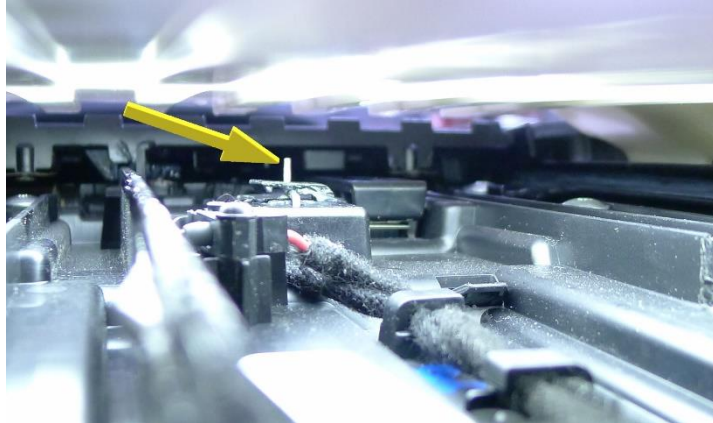
Figure 8

10. Use the needle nose pliers to gently move the latch pin to the left, then back to the right, under the tang (Figure 8).
