Spartan Fire, LLC

Technical Service Bulletin
TSB21-170-002

APPLIES TO: This service bulletin applies to Model Year 2017 through 2022 Gladiator and Metro Star emergency response chassis cabs built between March 30, 2016 and February 25, 2021.

CONDITION: DEF head sensor failure can occur resulting in engine fault codes.

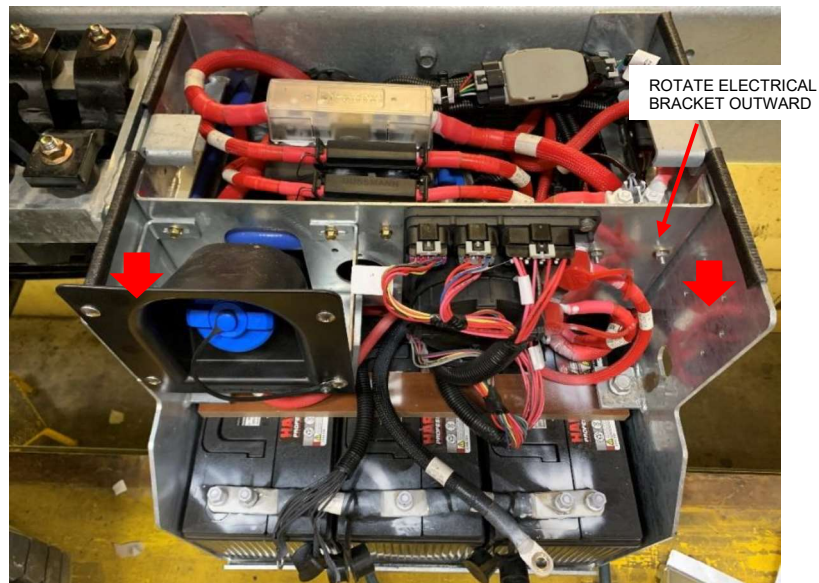
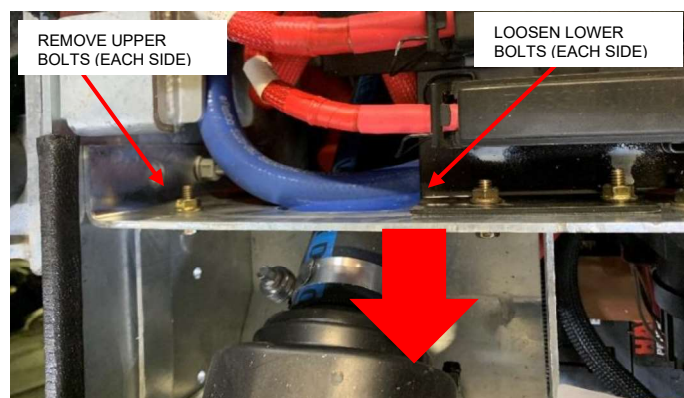
1. Remove driver side battery box cover to access DEF tank.
2. Move harnesses as needed to access the top of the Multifunction Head Unit (MFHU) on top of the DEF tank. Remove two bolts at top of electrical bracket and loosen lower 2 bolts. This will allow the bracket to be rotated outward to allow room to remove and replace the (MFHU).
Refer to Figure 2.1 and 2.2

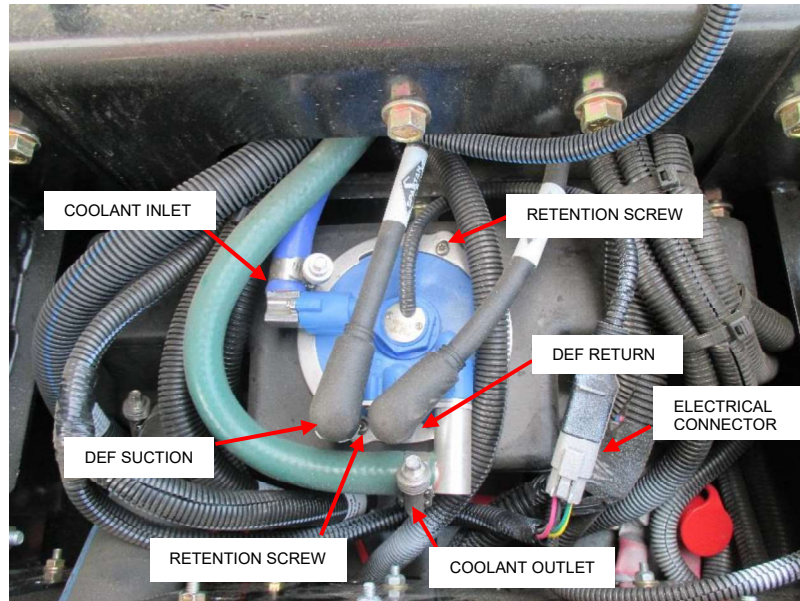
Figure 2.1

3. Cover battery area with an absorbent mat to prevent any DEF fluid that might spill from removal of the DEF head from contacting components in the area.
4. Disconnect coolant hoses, DEF hoses and electrical connector from MFHU on top of surge tank. *Reference Figure 3.1*

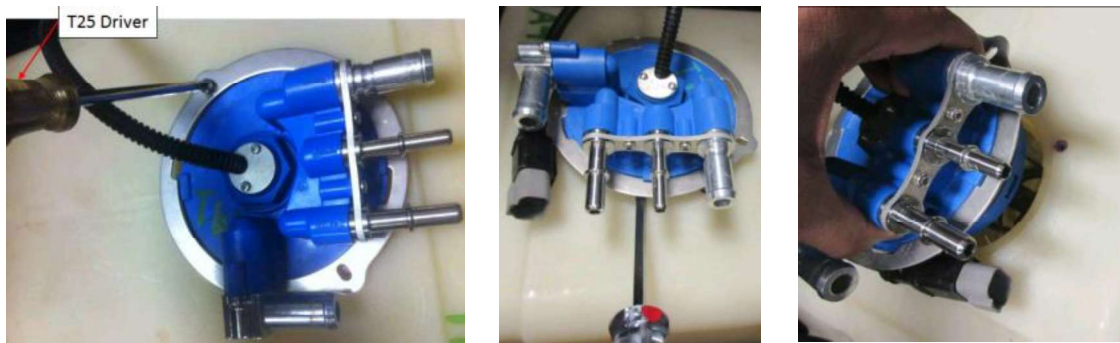
Figure 3.2

5. Use a T25 Torx driver, remove (2) screws around perimeter of the MFHU. Using a flathead screwdriver, gently pry around the head unit while simultaneously pull up on top of the unit. Continue until the MFHU mounting base is free from the tank and remove MFHU. Do not pull on any wires or fittings. *Reference Figure 3.2*

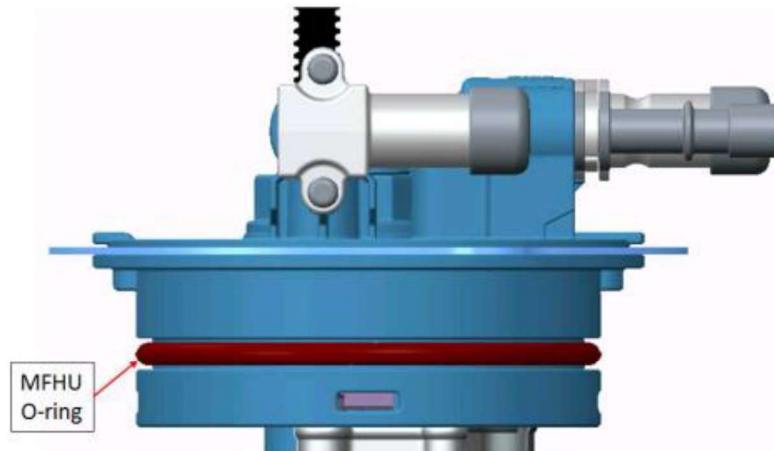
Figure 4.1

6. Apply a thin layer of DOW UCON LB-625 or equivalent O-ring lubricant to the bore seal O-ring on replacement MFHU. *Reference Figure 4.1*

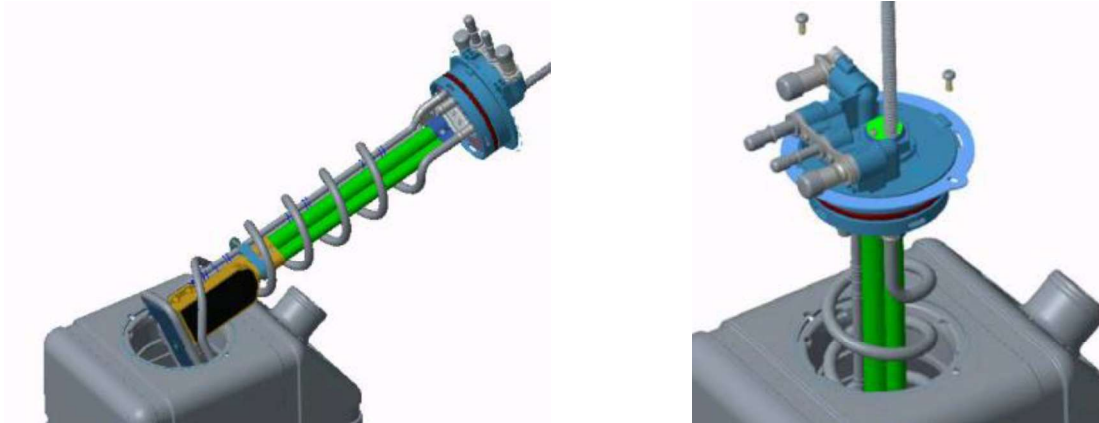
Figure 5.1

7. Tilt the header to an approximate 45° angle, with respect to the top of the tank. With the heel of the MFHU Sensor foot angled upward, place the toe of the coolant heater coil into the tank bore. Gradually work the bottom portion of the DEF head into the bore opening until completely inserted in the tank. *Reference Figure 5.1*

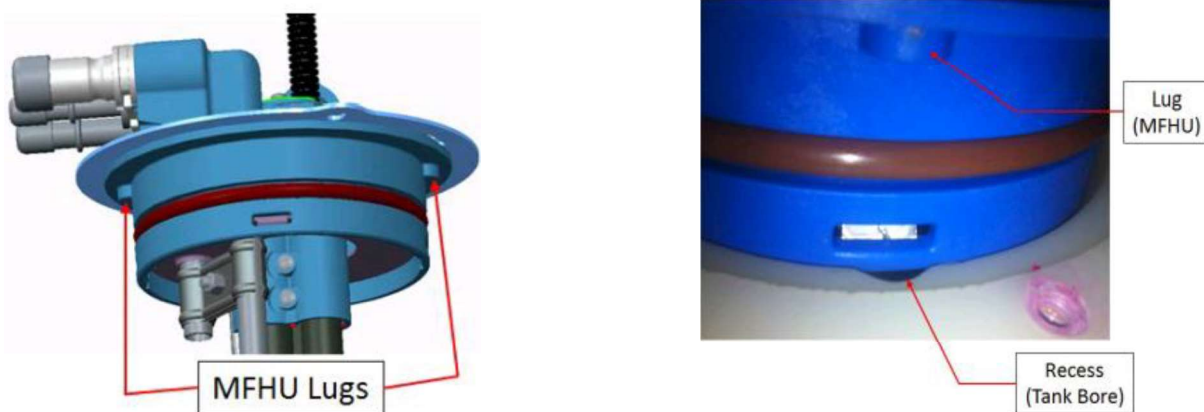
8. Position the DEF head unit in the desired orientation (lugs on the MFHU should align with the cut out/recess on the tank bore) and orient the Coolant and DEF Fittings. *Reference Figure 5.2 and 6.1.* Press on the top of the MFHU mounting base until it is completely seated in the tank bore.

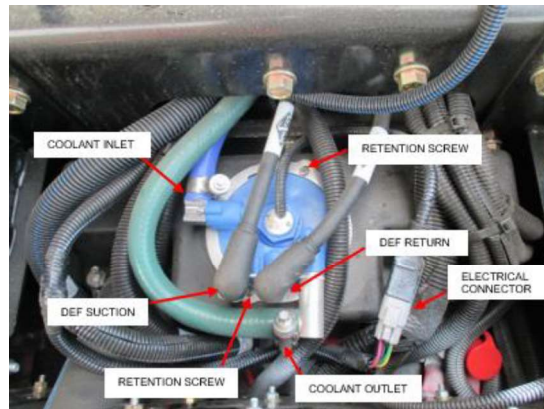
Figure 6.1

9. Position the retaining ring on MFHU to align with the tank mounting holes and install the retention screws using the T25 Torx driver. Tighten screws to 20-30 in-lbs (2.26–3.38 Nm).
10. Reinstall coolant hoses, DEF hoses, and electrical connector as shown in Figure 6.1. Tighten coolant hose clamps to 50-60 in-lbs (5.65 to 6.78 Nm).
11. Start engine and verify no leaks are present.
