QUARANTINE NOTICE

Reference number:	QN-31-1547V2	Issued: 15 September, 2021
Subject:	Install Spacers to the Roof Blind Assembly	
Model(s):	DBX	
VIN range:	Refer to the separately published list of affected Vehicle Identification Numbers (VINs)	
Applicable to:	All Dealers	
Distribute to:	Head of Business After Sales Manager Service Manager Sales Manager	Warranty Staff Technician(s) Parts Staff

Reason for this Quarantine Notice

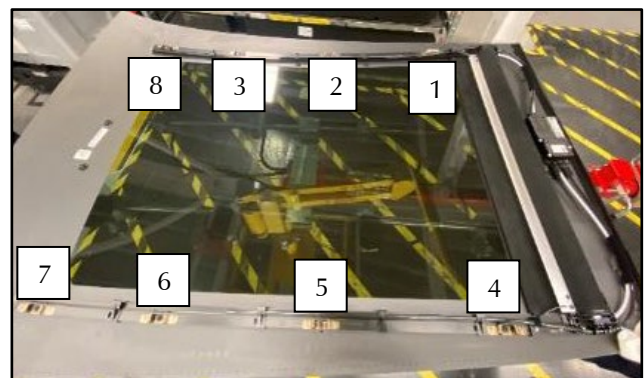
Figure 1

1. Remove the front overhead console assembly refer to (refer to Workshop Manual procedure 30.04.AD).
2. Remove the headlining (refer to Workshop Manual procedure 30.04.CA).
3. Complete steps 4 and 5 for the nuts in the sequence shown (refer to Figure 1).

Note: Start from the rear of the vehicle.

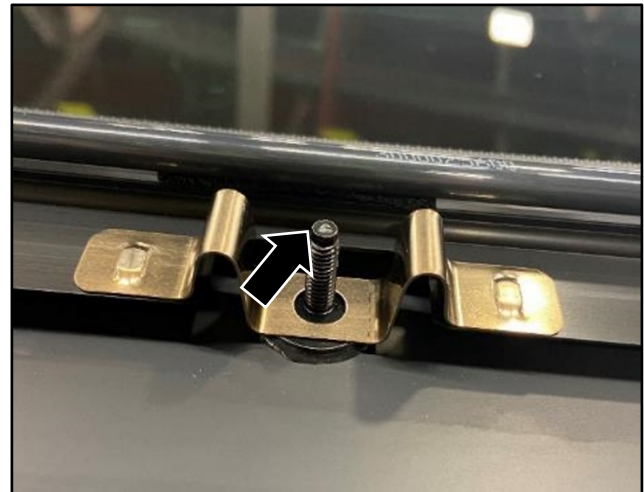
Figure 2

- Remove the nut that attaches the blind assembly to the roof (refer to Figure 2).

You must only remove **one** nut at a time to prevent any movement in the blind assembly.

CAUTION: CARE MUST BE TAKEN WHEN YOU REMOVE THE NUT TO AVOID ANY UNWANTED FORCE ON THE FIXING AND PREVENT DAMAGE TO THE GLASS.

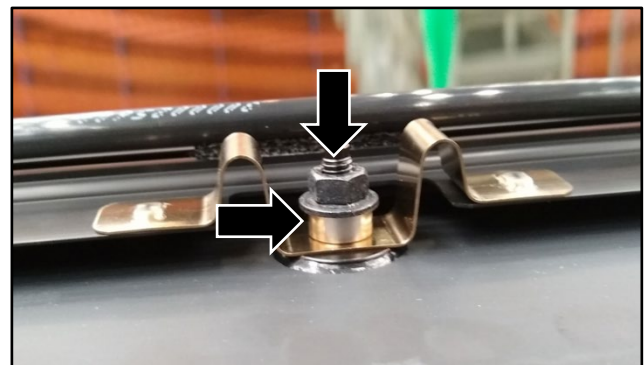
Figure 3

- Install the spacer to the stud, then hand start the nut onto the thread.

Use a manual torque wrench to torque the nut to 2.6Nm (refer to Figure 3).

CAUTION: DO NOT USE POWER TOOLS TO TORQUE THE NUTS. THIS CAN CAUSE DAMAGE TO THE GLASS.
