# AfterSales Diagnostic Sheet

**MAS002343**  
(BOL 21-27)

## Diagnosis of the fuel transfer system inside the fuel tank

**Models:** Maserati M156, M157 and M161 V6 with gasoline engines

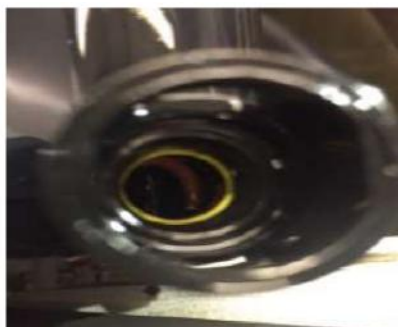
Figure 2: Sealing o-ring

- If no fuel can be found, perform a fuel filling of at least 13 liters and start the engine.
- If the engine starts, inspect the fuel transfer pipe from the right side to the left side of the fuel tank (refer to Figure 1) and in particular:
  - a) Check that the quick connector of junction A (figure 1) is correctly inserted and that the sealing o-ring is present (figure 2). If the pipe is not correctly inserted proceed to restore the connection. If the o-ring is not present, the low pressure fuel pump must be replaced.
