# HUSQVARNA TECHNICAL BULLETIN HTB2106

JUNE 25, 2021

## CHECKING THE MOUNTING POSITION OF THE LICENSE PLATE HOLDER

**2018, 2019, 2020 – VITPILEN 701**

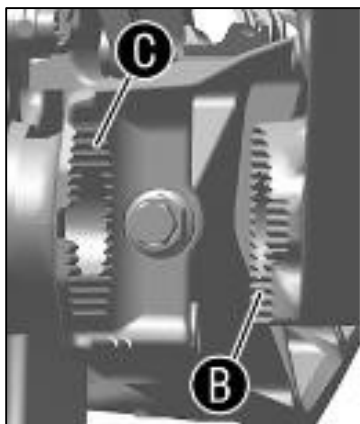
Fig. 1

1. Visually check the alignment of the gear teeth on the license plate carrier (B) and swingarm (C). (Fig. 1-3) to verify that they are aligned with each other.
2. If the alignment of the gear teeth on the license plate carrier (B) and swingarm (C) **is correct** as shown in Fig. 2 then retighten rear wheel axle collar nut to 90 Nm to complete the inspection.
3. If the alignment of the gear teeth on the license plate carrier (B) and swingarm (C) **is incorrect** as shown in Fig. 3 then loosen the components and align the gear teeth on the license plate carrier (B) and swingarm (C) correctly.
4. Retighten the rear wheel axle collar nut to 90 Nm to complete the repair.

Component	Screw	Torque	Remark
Collar nut wheel spindle rear	M25x1,5	90 Nm

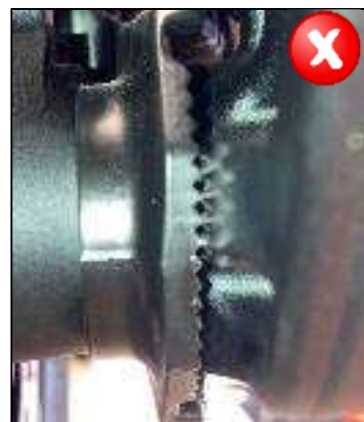
Fig. 3

Incorrect alignment of the gear teeth on the license plate holder and swingarm could result in the possibility of the rear wheel axle nut becoming loose which may cause the license plate bracket to fall down and contact the rear wheel. This could cause injury to the rider or others and/or damage to property.
