# Special Bulletin

# SP21-83A

## DOOR INNER PANEL INSPECTION - CRACKING ISSUE

B13R (9700 us/can)

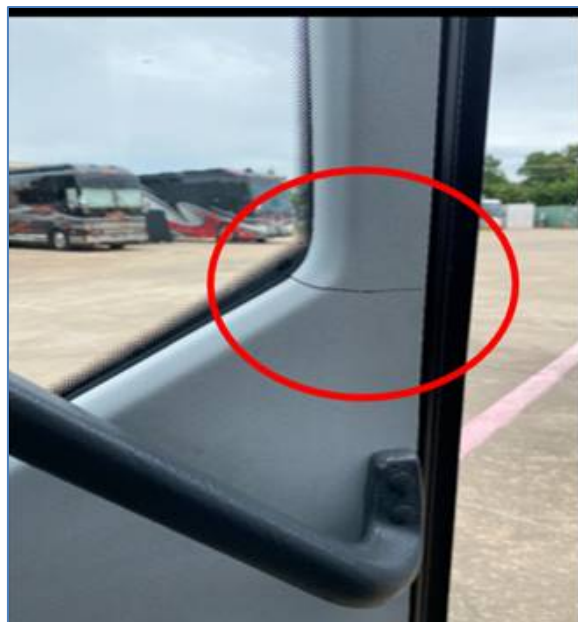
1. Inspect the door inner panel for cracking issues particularly were shown in the picture below. If no presence of cracking is found, close the operation and claim the inspection (15 minutes).

In case of cracking issues, perform the replacement of the inner panel as described in PART 2.
