# S007: T440/T470, T800, and W900 Convex Mirror Shortage

Parts Shortage - S

Kenworth shipped chassis without driver and passenger side convex mirrors due to parts shortages.

98 (71 U.S. and 27 Canada) T440/T470, T800, and W900 chassis built from 04/06/2021 through 04/23/2021 ordered with heated driver side and passenger side convex mirrors. See the attached chassis list for specific chassis.

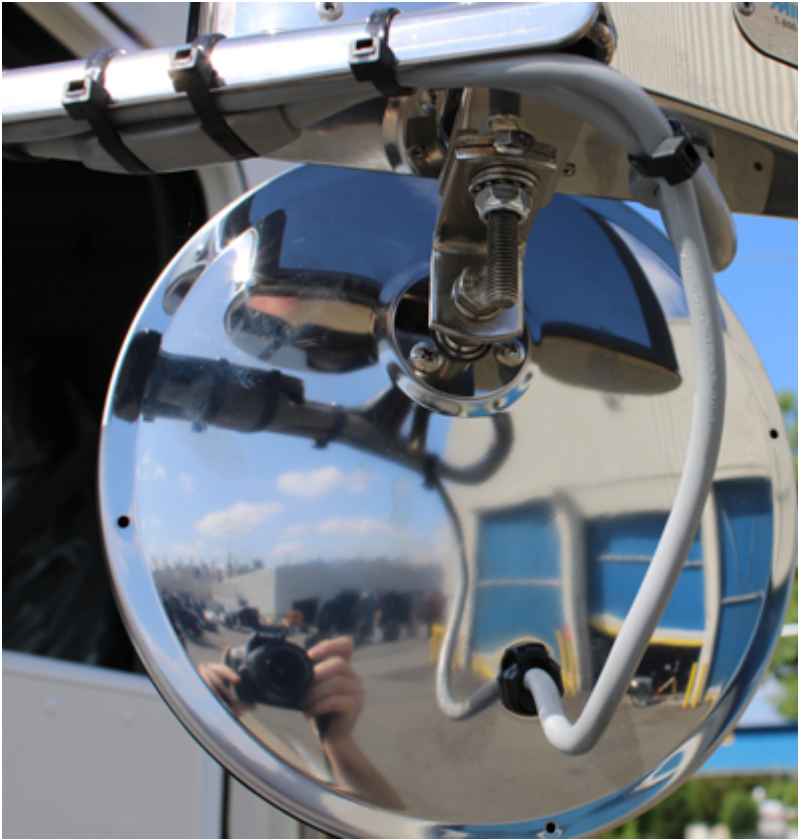
1. Install the convex mirror to the bracket using a bolt and lock washer.

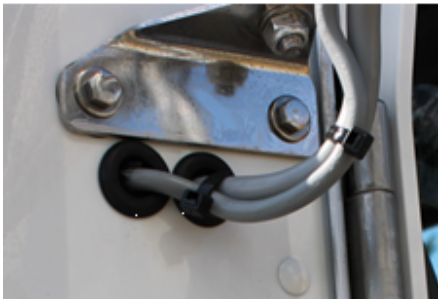
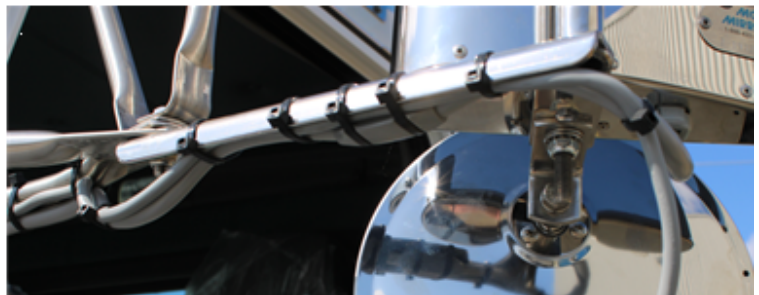
2. Route the harness through the grommet found below the mirror arm bracket and then cable-tie the harness along the mirror arm.

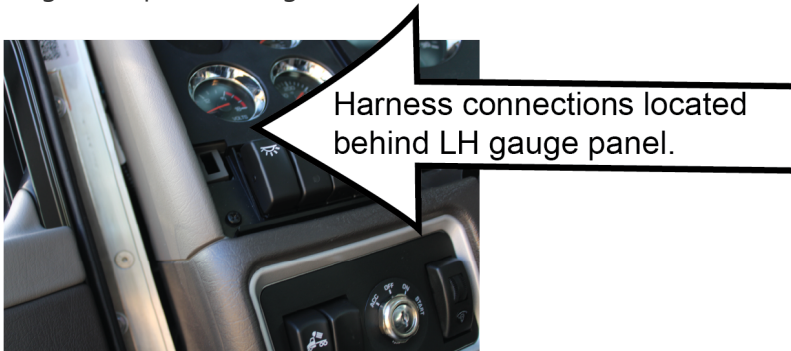
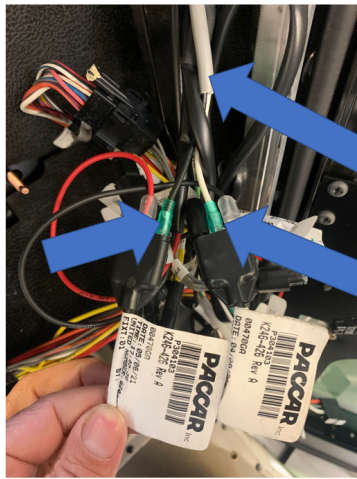
3. Driver's side: Remove the dash bezel and open the dash panel.  
Passenger's side: Remove the glove box.
4. Plug in the power and ground wires to the harness connections in the dash.

Light grey protective sheathing from mirror.

Breaks out to black and white individual wires.

Connect to separate K246-426 jumpers inside the dash.
