INTRODUCTION:

This bulletin provides an inspection procedure to follow when addressing customer concerns of a rattling, knocking or klunk type sound when going over slight bumps and / or uneven road surfaces.

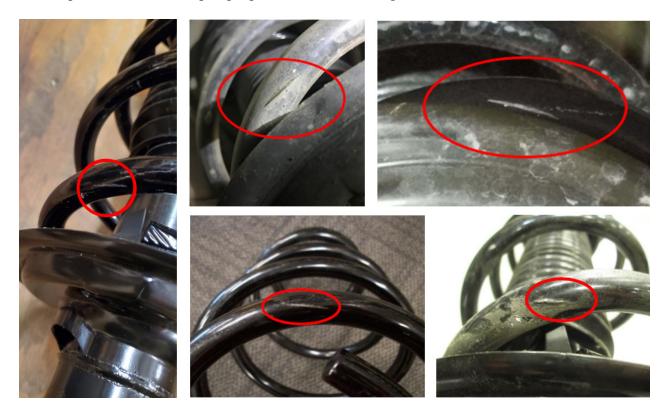
After verifying the customer concern, inspect the front coil springs **closely** for any contact (witness) marks as shown in the example photos supplied below. If any contact marks are confirmed, replace the affected coil spring closely following the procedure in the applicable Service Manual. The current procedures for coil spring replacement are unchanged.

The Service Manual procedures contain information critical to performing an effective repair the first time and every time. This includes but is not limited to: important SAFETY precautions, proper inspection criteria, necessary special tools, required processes and related **one-time use** parts needed for a complete and lasting repair.
