SERVICE BULLETIN

APPLICABILITY: 2019-21MY Forester

NUMBER: 10-103-21

SUBJECT: Evaporator Core Drain / Water Sloshing Sound When Turning

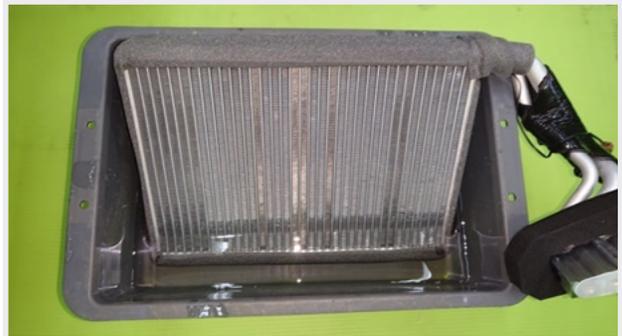
STEP 2) Submerge the insulated portions of the evaporator into a suitable container of water. A five gallon bucket or storage bin can be used. Make sure the evaporator insulation is fully submerged for 5 minutes. This will allow the adhesive to soften. **DO NOT** let any water enter the evaporator.

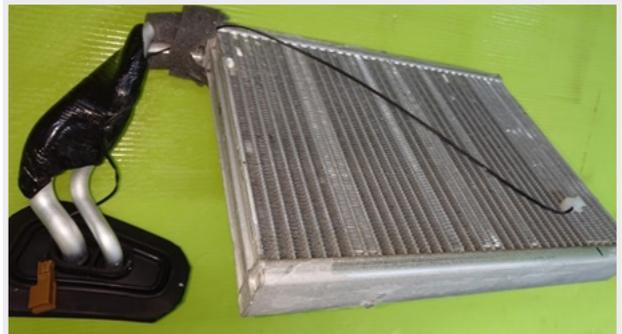
STEP 3) Remove the evaporator from the water after 5 minutes.

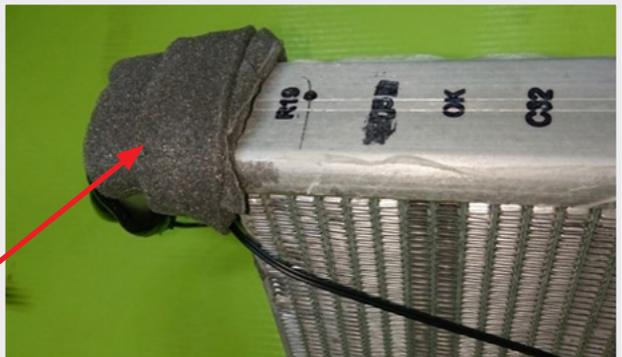
Connector Insulation

STEP 4) **CAREFULLY** remove the evaporator core insulation. Any remaining residue from the original adhesive is acceptable once it is completely dry.

IMPORTANT NOTE: The connector insulation is overlapped by the evaporator core insulation. Use **CAUTION** when working in this area so the connection insulation is not damaged.

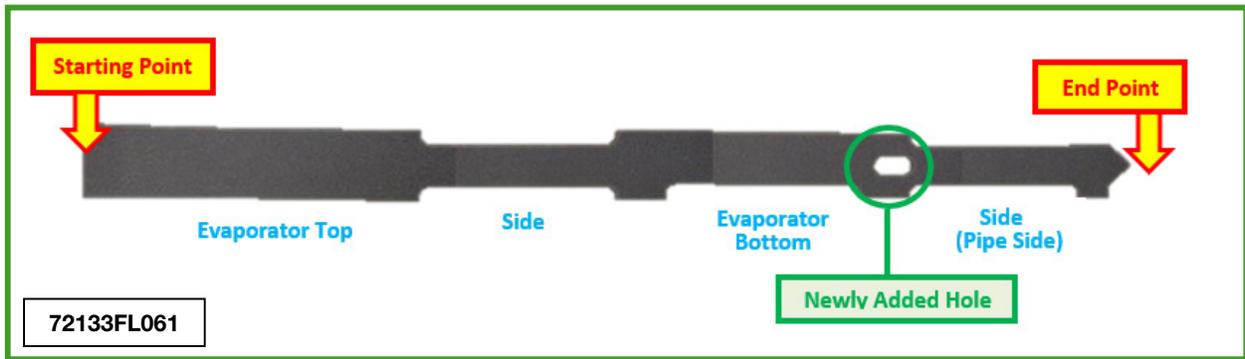
STEP 5) Install the new evaporator core insulation onto the evaporator.

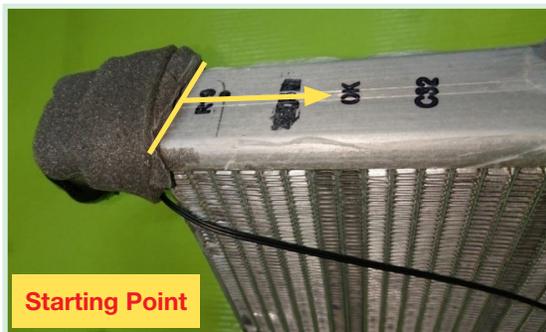
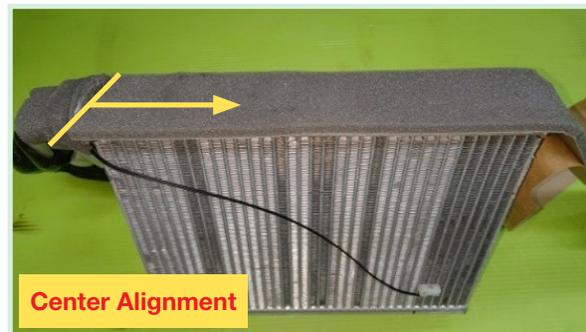
- Start from the connector insulation side of the evaporator top surface. Make sure the insulation is center aligned with the evaporator.

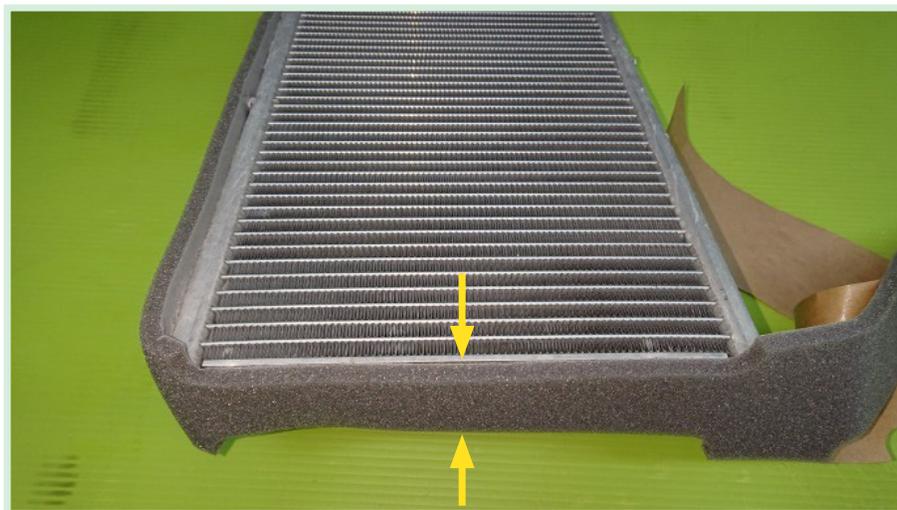
- Continue wrapping the insulation around the side surface of the evaporator while maintaining a center aligned installation.

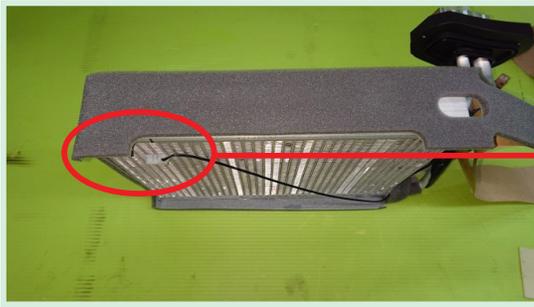
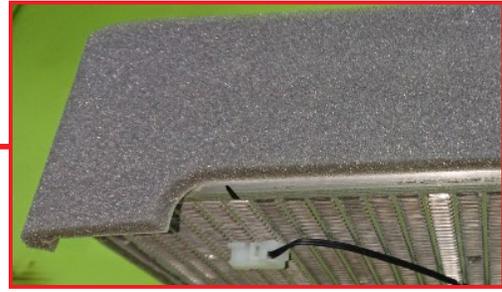
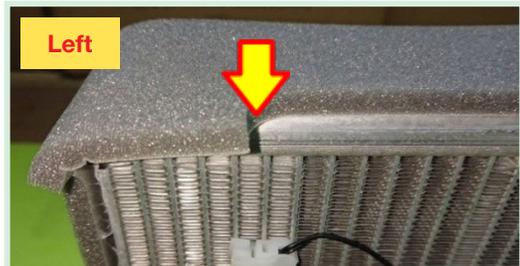
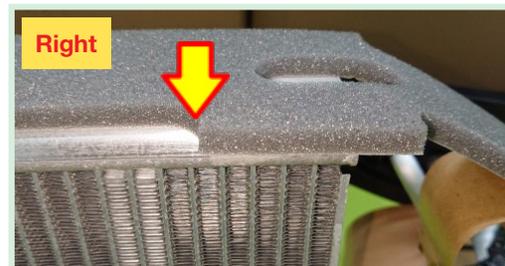
- Continue wrapping the insulation to the bottom surface of the evaporator. Align the surface edge of the evaporator with the edge of the insulation. The grooved edge portions of the insulation should line up with the 5th row of fins on the evaporator at both ends.

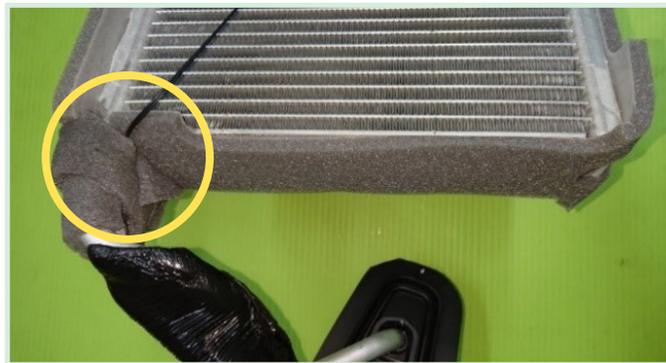
- Continue wrapping the insulation to the pipe side surface of the evaporator. Be sure to align the insulation centered onto the evaporator. Tuck the end portion of the insulation under the connector insulation as shown below.

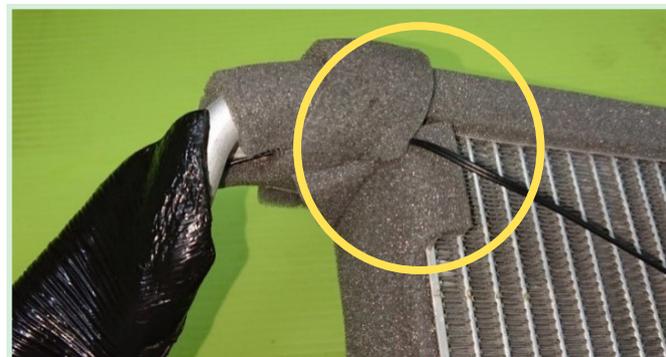
IMPORTANT NOTE: Make sure the lead wire is routed toward the end between the connector insulation and the evaporator insulation.
