## Volvo Chassis - I-Shift Transmission - AMT Gear Box Air Leaks

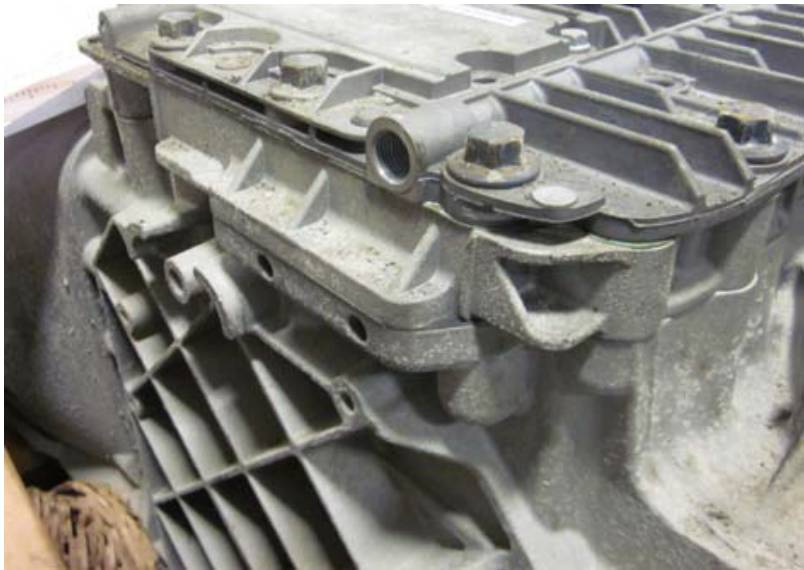
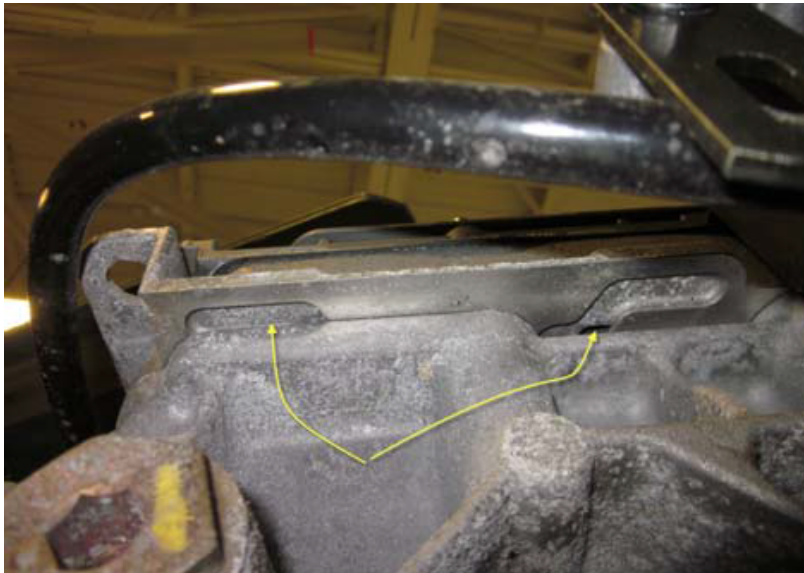
Air leak from the left or right side vent of the TECU all the time. AMT-D: See Figures 2 and 3.

AMT - C & D; One or more TECU shift valves have become stuck open allowing the air path to the open venting solenoid. This can be an intermittent issue. Testing and investigation has shown that exercising the valves with TT by forcing shifts can 'unstick' the valves and the leak might not return however there is a good chance that the valve will become stuck again. TECU to control housing seals can leak causing symptoms like described and should be checked prior to major component replacement. A leak between ports in the TECU due to a failed gasket like in picture below can cause erratic or undesired shifting due to air bleeding to the wrong ports during shifting. The seals should be pliable and have a peaked appearance. This seal is bad due to the flattened sealing surfaces.

Replace TECU to Control housing seals if faulty and retest

Replace TECU

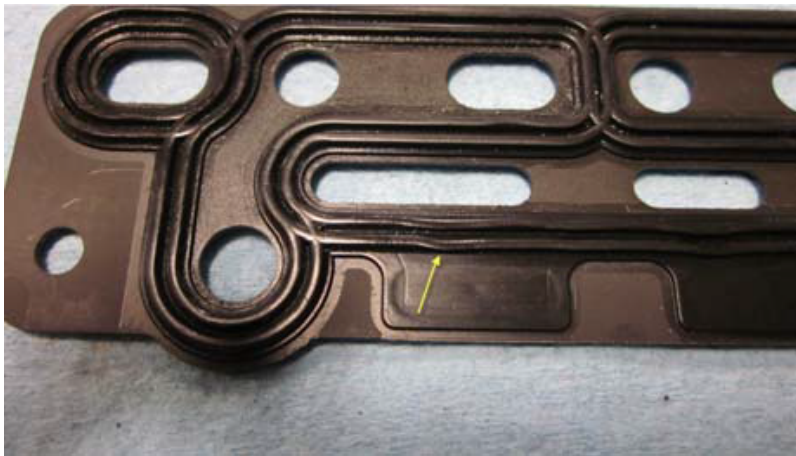
Air leak from gearbox case vent tube all the time AMT-C: see Figure 5

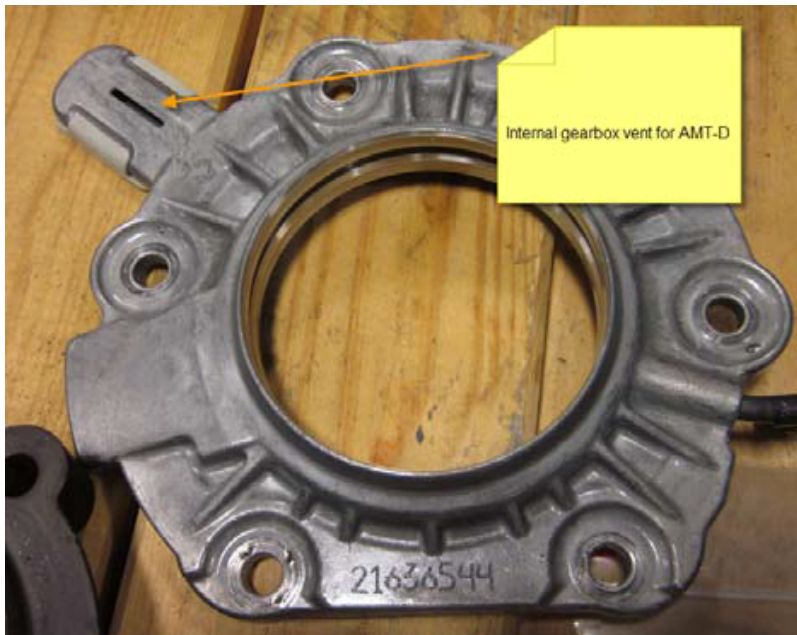
The internal venting of the AMT-D is provided in the bearing retainer plate for the rear main shaft bearing. This provides venting and oil separation for return back to the gearbox.

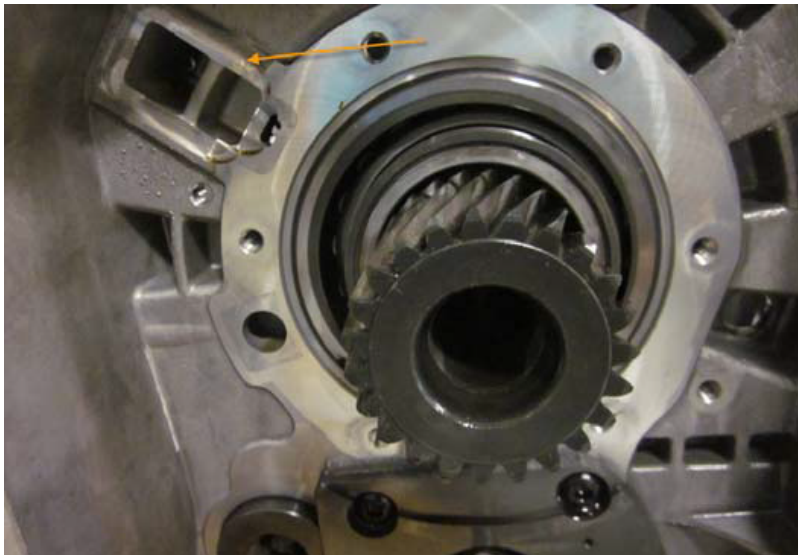
AMT-D gearbox venting with bearing retainer removed. All of this is contained behind the high range synchronizer cone in the rear of the gearbox.

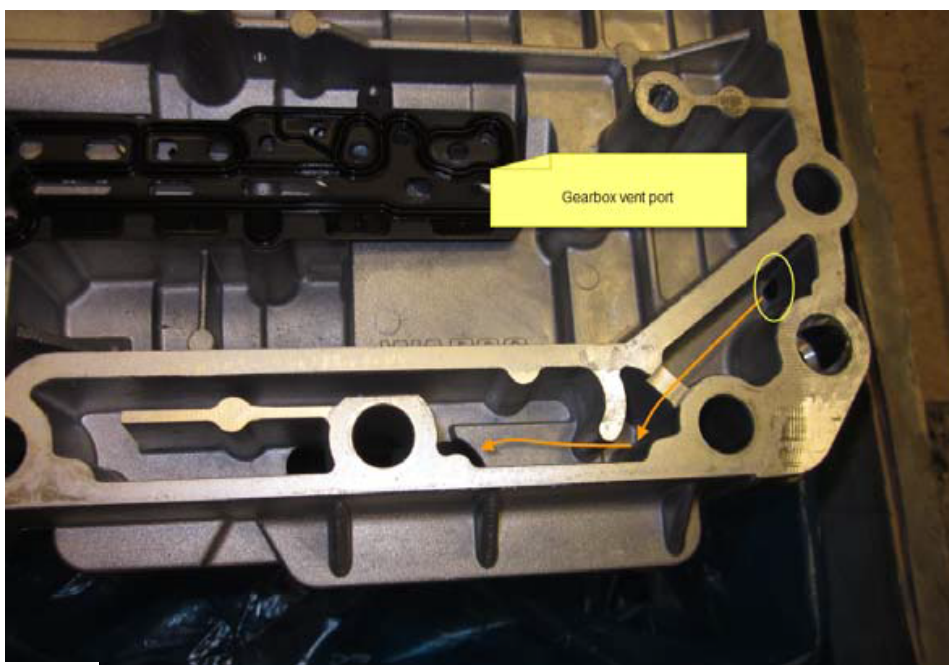
### Internal ports in the control housing and the air path for gearbox

case venting.
