## STAR ONLINE PUBLICATION

**Case Number:** S2123000075

**Symptom/Vehicle Issue:** Lift Gate Fitment Adjustments

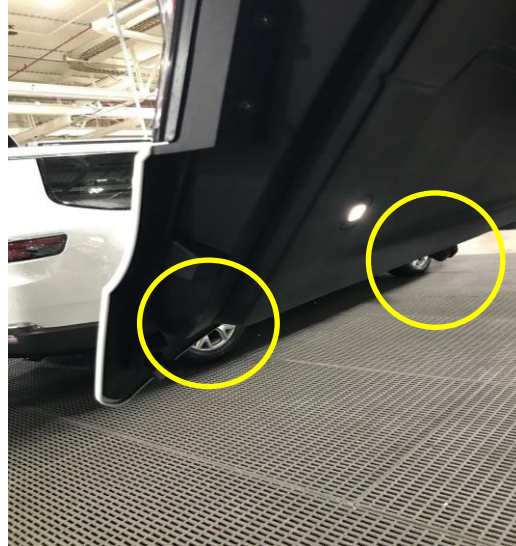
Fig 1 Gate Bumper Location

Turn in adjustment bumper to set underflush  
Turn out adjustment bumper bring liftgate overflush

Flush at the sides of the lift gate can be adjusted by turning the adjustment bumpers in the lower outboard corners of the lift gate panel (Fig 1). If the gate is over flush on one side screw in the adjusting bumper on that side and evaluate the flushness for any change. Striker adjustment may also be required to achieve fit. Verify auto closing function after adjustment

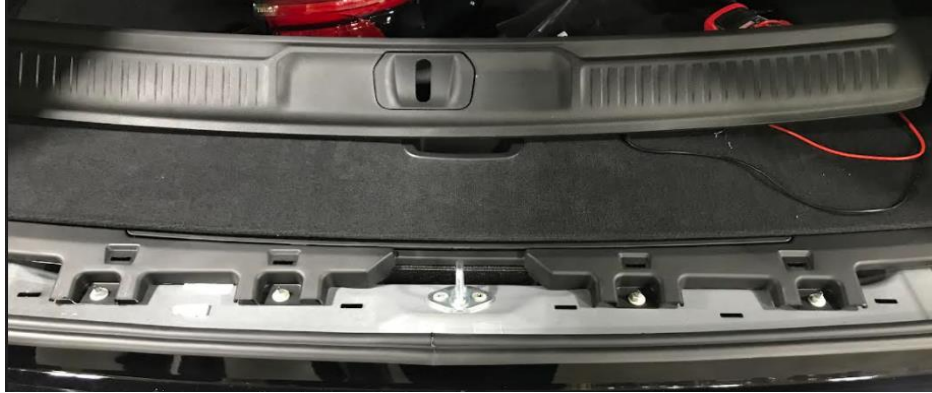
Fig 2 Striker Cover Removed.

To access the striker, simply remove the rear cover panel by pulling up  
Loosen both bolts on the striker and move as required - retightening when complete (Nominal 27.5 Nm) (Fig 2)

In some cases re-adjusting the striker is required when refitting the gate

OPTIONAL - Removing the striker altogether can aid in refitting, as it allows the gate to close with no stress. The striker can then be soft torqued, allowing the gate to align the striker. Then open the gate and retighten the striker.

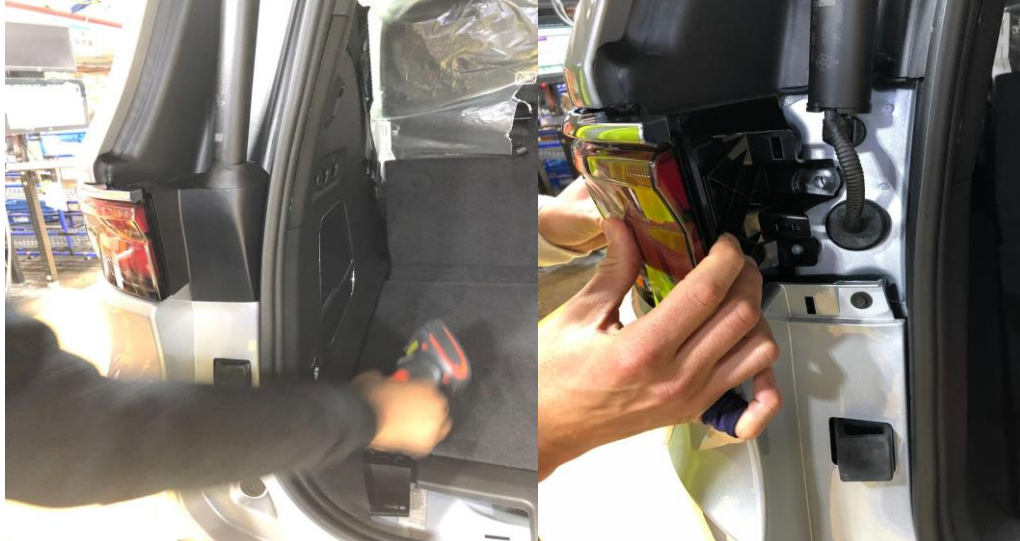
Fig 3 Tail Lamp Adjustment

Tail lights on body are adjustable up/down and left and right. Remove plastic cover to expose the 2 fasteners securing the tail light. Loosen the 2 fasteners to allow the tail light to move. Make sure the 3 front ball stud locators are engaged to the body. Move the tail light to the desired position to adjust then secure the 2 fasteners. Replace the plastic beauty cover.

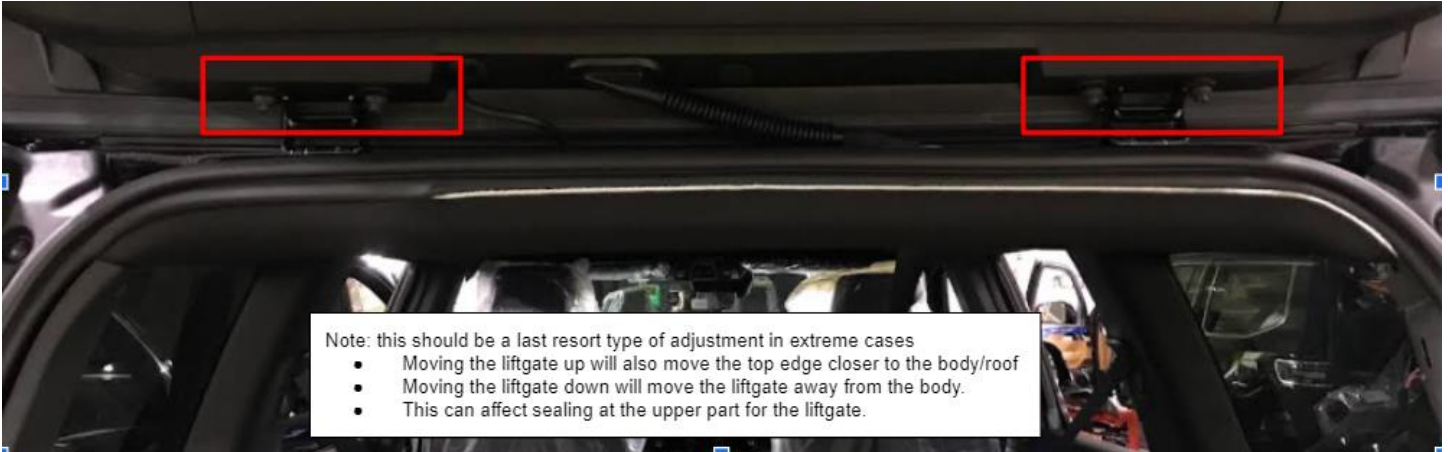
Fig 4 Gate Up/Down Fore/Aft Adjustment

Open the lift gate and loosen (but do not remove) the four bolts at the hinge to lift gate. The bolts only need to be loose enough to allow the gate to slide. Remove 1 bolt at a time and add medium strength thread locker (such as MOPAR 04318031AB) then re-install leaving the bolt slightly loose before moving to the next bolt. Leaving the gate open, bump the gate side to side to adjust left or right or bump by the hinge forward/rearward to adjust the lift gate up/down. Upon completion of adjustments, re-tighten each fastener (Nominal 30 Nm). Refer to image 4. Verify the seal still contacts to lift gate at the upper portion.
