**NUMBER:** 23-037-21

Rear Wiper Inoperative

This bulletin involves tightening the rear wiper arm nut to the proper torque.

2022 (WS) Grand Wagoneer/Wagoneer

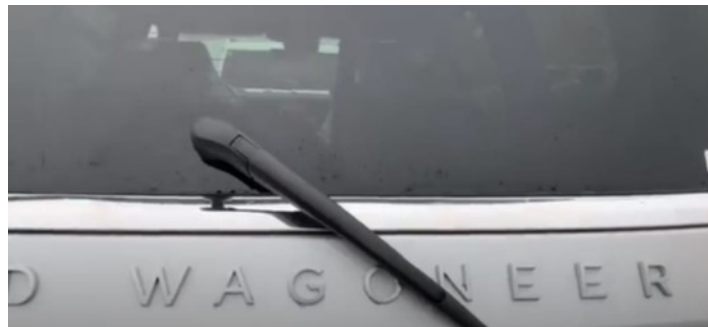
**Fig. 1**

- The rear wiper is inoperative, or will not move when turned on and is sagging downward (Fig. 1) .

**Rear Wiper Not In Parked Position**

1. Remove the rear wiper arm nut cover.
2. Remove the rear wiper arm nut.
3. Remove the rear wiper arm.
4. Using a wire brush or equivalent tool, clean wiper motor splines of any debris or shavings.
5. Install the rear wiper arm onto the motor splines and align wiper arm to the tick mark on the rear backglass (Fig. 2) .

6. Install the rear wiper arm nut. While holding the arm in place, tighten the wiper arm nut to 5 N·m (44 in. lbs.).
7. Install the rear wiper arm nut cover.

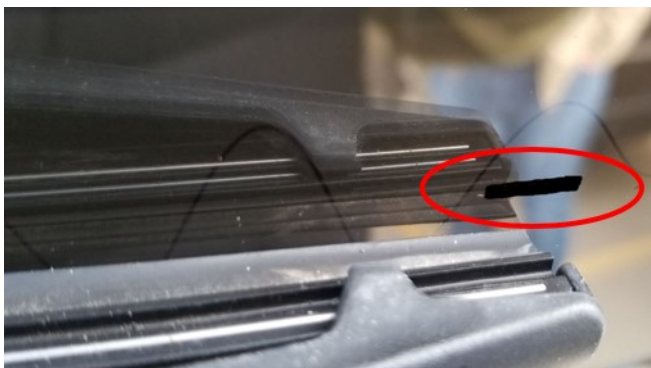
Fig. 2

**Alignment Tick Mark On Rear Backglass**
