# Technical Service Bulletin

| <b>Technical Service Bulletin:</b> TSB210216 | <b>Released Date:</b> 07-Oct-2021 |
| <b>High Voltage Junction Box Connections</b> | |

- BES CM0904 EV104B
- BES CM2450 EV105B

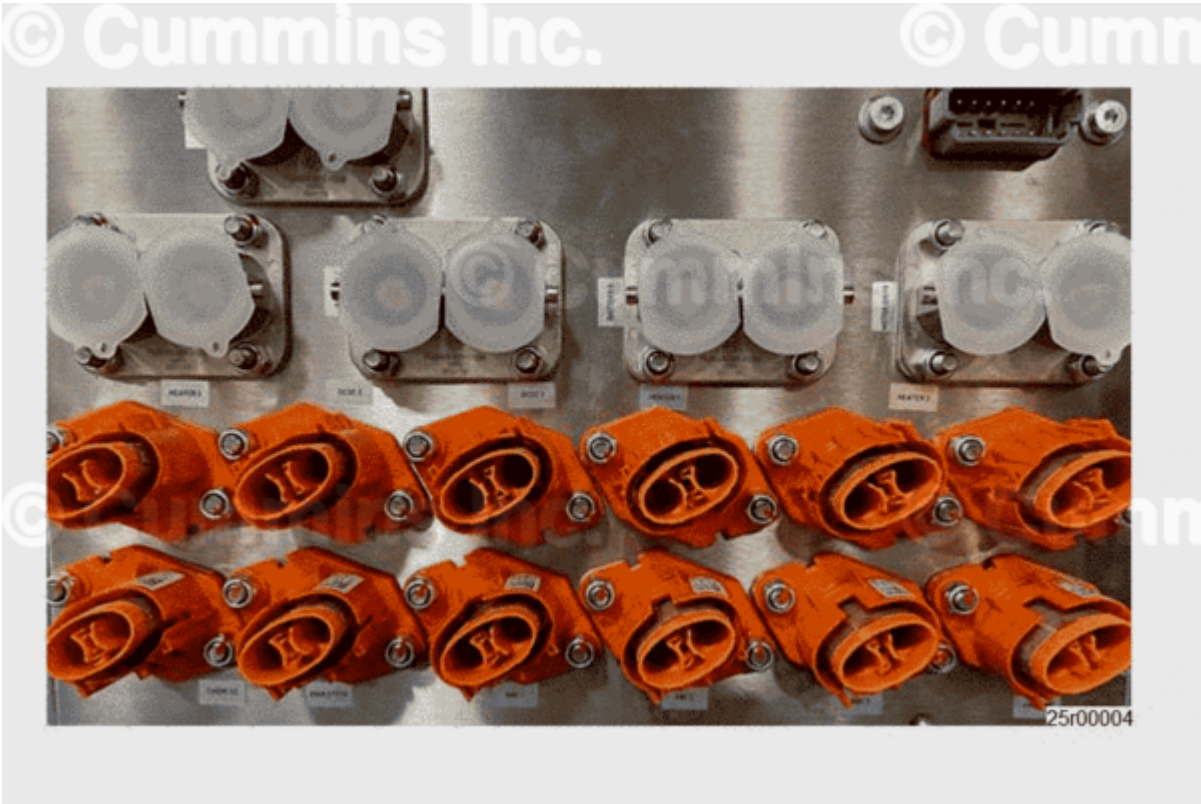
The high voltage junction box orange high voltage connections are keyed alike and can easily be mixed up. This complicates troubleshooting, because the vehicle may still function even though the high voltage plugs are in different locations. If the high voltage plugs are in different locations this changes the service procedures for troubleshooting the high voltage circuits. The high voltage cables may **not** be in the corresponding labeled ports. The buses can come from the factory with incorrect wiring.

Figure 1, Orange Colored Plugs Are the Connections That Can Be Mixed Up.

Verify where high voltage lines are plugged in before checking fuses in the high voltage junction box. All the fuses are the same value.
