SIB 01 10 21

## EXTERNAL ENGINE OIL LEAKS AND REPAIRS

This Service Information bulletin (Revision 01) replaces SI B01 10 21 **dated June 2021**

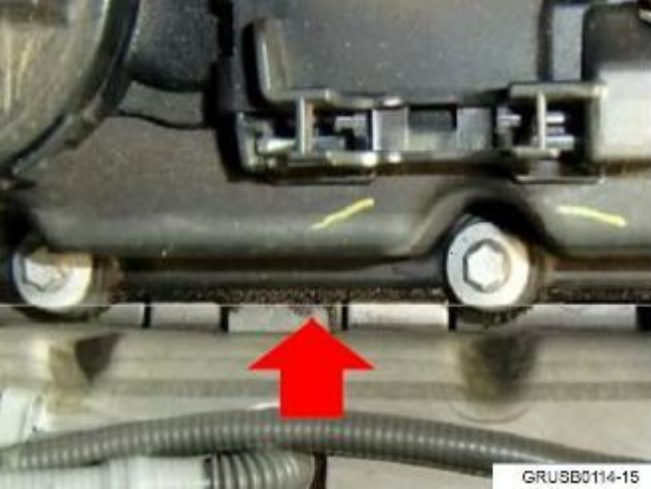
| <p>GRUSB0114-15</p> | <p><b>Example: A</b><br/>Cylinder Head Cover Gasket</p> <p><b>Light external engine oil accumulation</b></p> <ul style="list-style-type: none"> <li>• No repair is necessary.</li> </ul> |

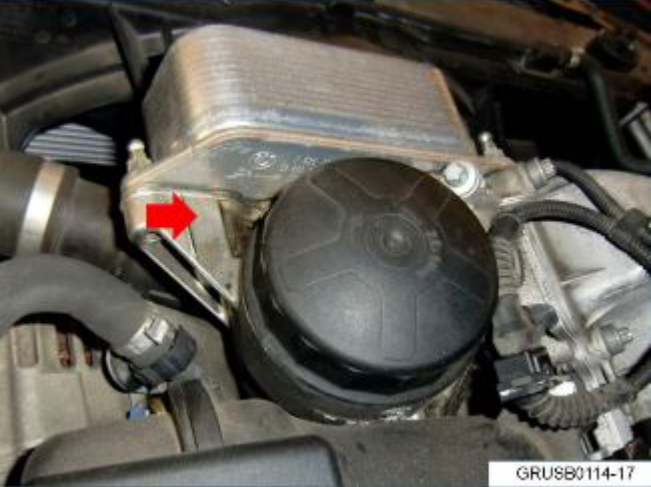
| <p>GRUSB0114-17</p> | <p><b>Example: A</b><br/>Oil Filter Housing and Heat Exchanger</p> <p><b>Light external engine oil accumulation</b></p> <ul style="list-style-type: none"> <li>• No repair is necessary.</li> </ul> |

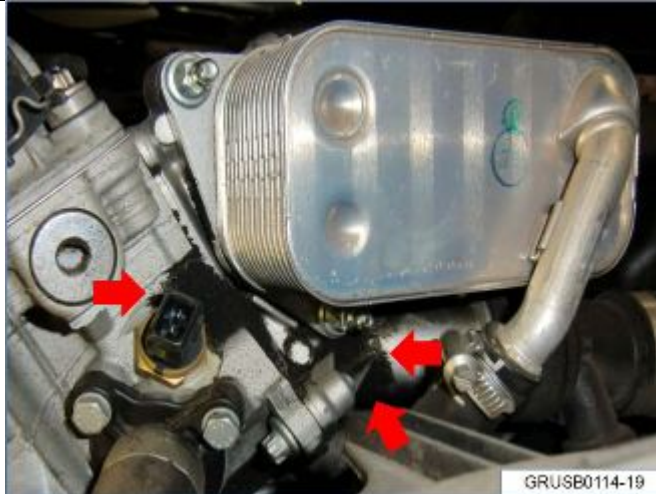
| <p>GRUSB0114-19</p> | <p><b>Example: A</b><br/>Heat Exchanger</p> <p><b>Light external engine oil accumulation</b></p> <ul style="list-style-type: none"><li>• No repair is necessary.</li></ul> |

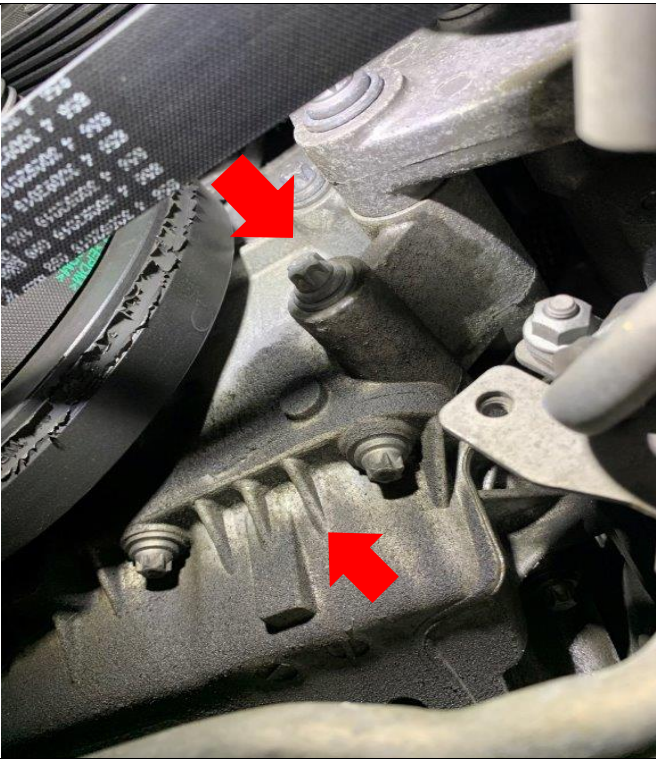
| <p>---</p> | <p><b>Example: A</b><br/>N63X/S63X Front Cover Gasket</p> <p><b>Light external engine oil accumulation</b></p> <ul style="list-style-type: none"><li>• No repair is necessary.</li></ul> |

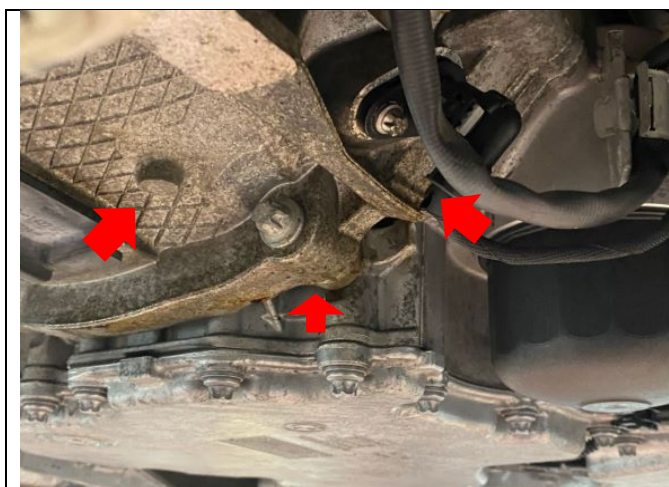
**Example: A**

N63X/S63X Bell Housing

**Light external engine oil accumulation**

- No repair is necessary.

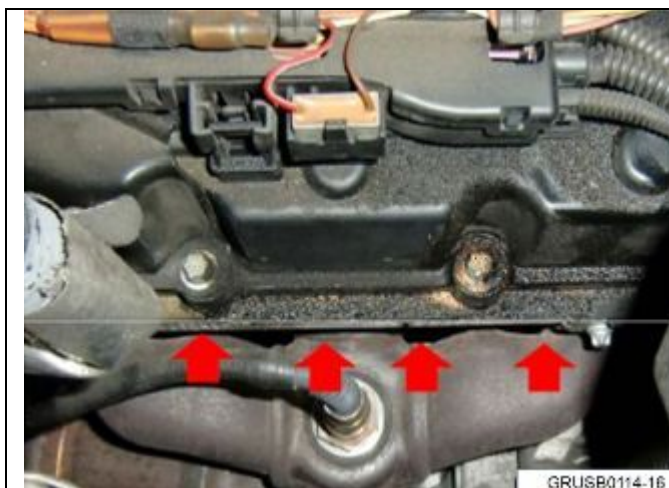
**Example: B**

Cylinder Head Cover Gasket

**Medium to large external engine oil accumulation**

- A repair is necessary.

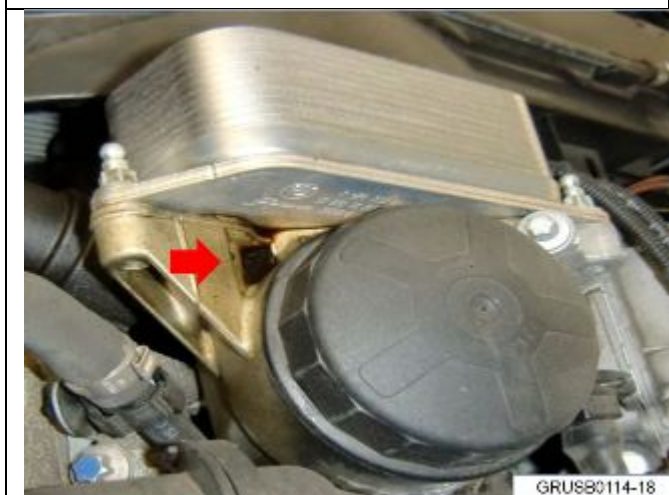
**Example: B**

Oil Filter Housing and Heat Exchanger

**Medium to large external engine oil accumulation**

- A repair is necessary.

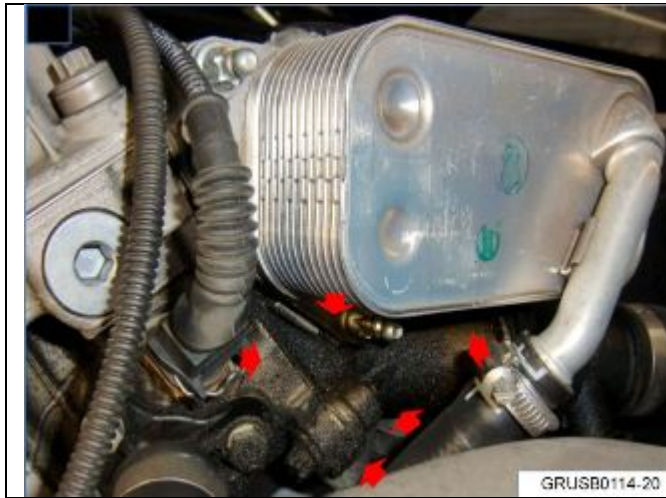
**Example: B**  
Heat Exchanger

**Medium to large external engine oil accumulation**

- A repair is necessary.

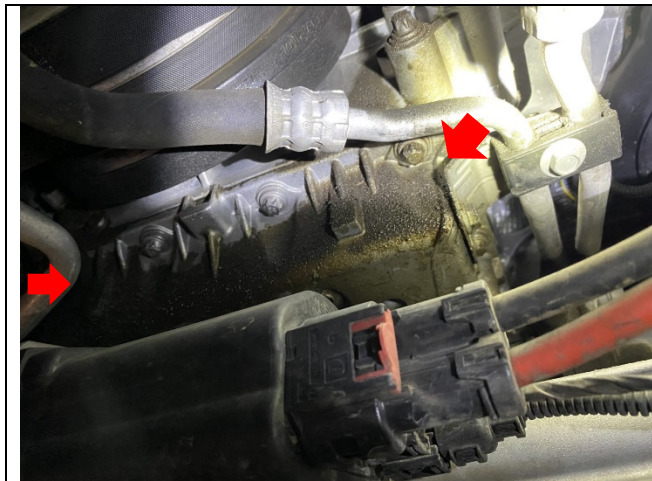
**Example: B**  
N63T Upper Oil Pan Gasket

**Medium to large external engine oil accumulation**

- A repair is necessary.

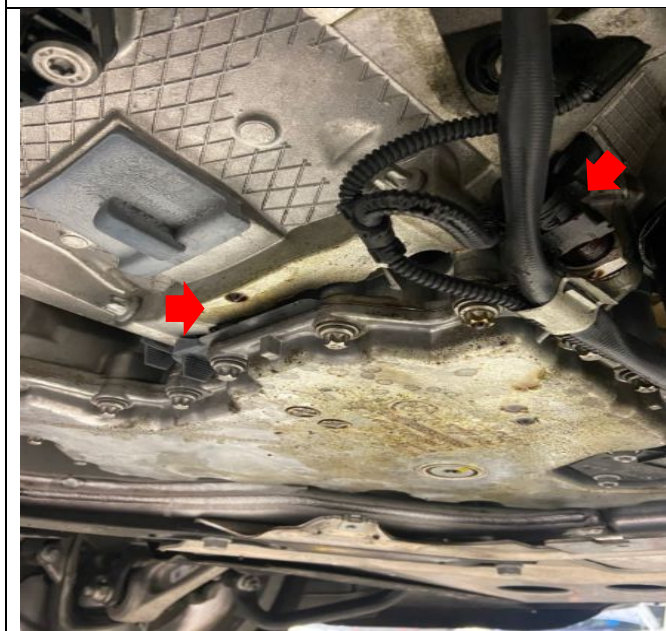
**Example: B**  
N63X/S63X Bell Housing

**Medium to large external engine oil accumulation**

- A repair is necessary.
