**SIB 33 03 21**

**EXTERNAL OIL LEAKS FROM THE REAR AXLE DIFFERENTIAL-DIAGNOSIS AND REPAIR**

## EXTERNAL OIL LEAKS FROM REAR DIFFERENTIALS AND REPAIRS

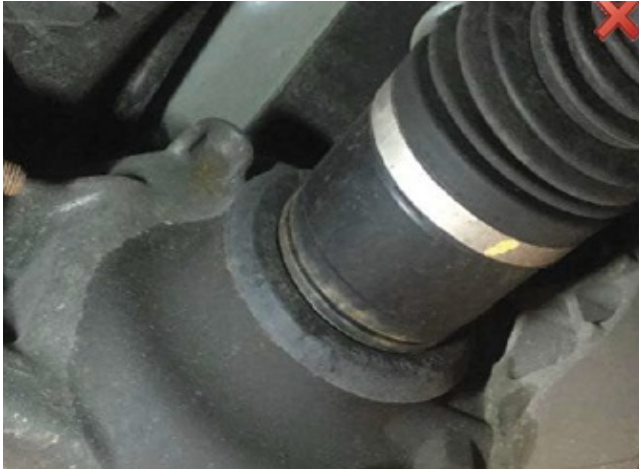
**Example A:**  
Output shaft sweating

Staining and dirt accumulation around the output shaft.

- No Repair is necessary

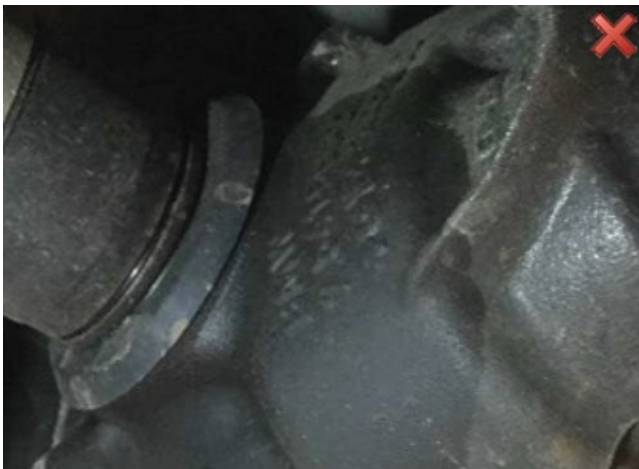
**Example A:**  
Output shaft sweating

Staining and dirt accumulation around the output shaft.

- No Repair is necessary

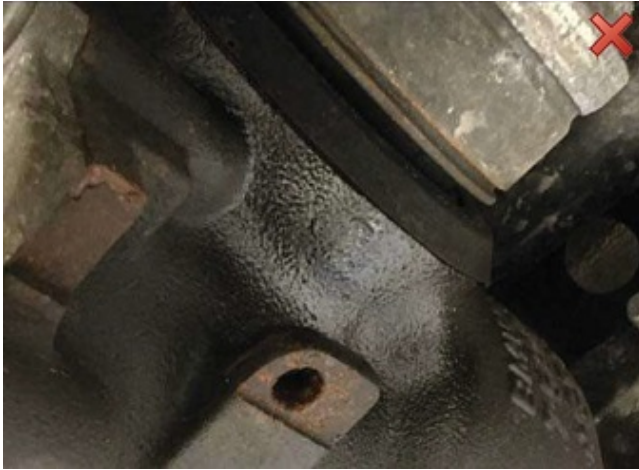
**Example A:**  
Output shaft sweating

Staining and dirt accumulation around the output shaft.

No Repair is necessary

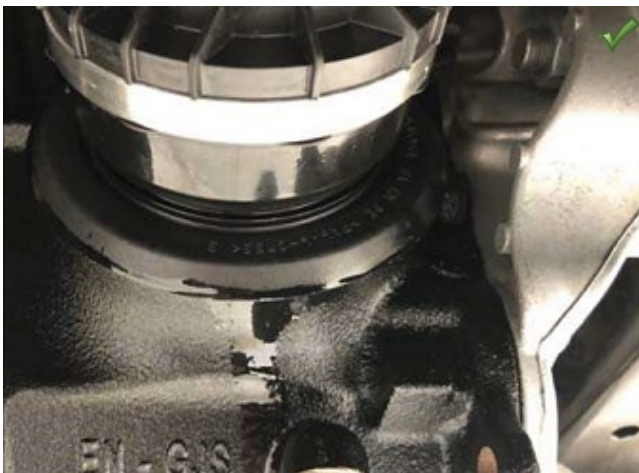
**Example B:**  
Oil is actively leaking out of the output shaft seal.

- **Replace the output shaft seal**

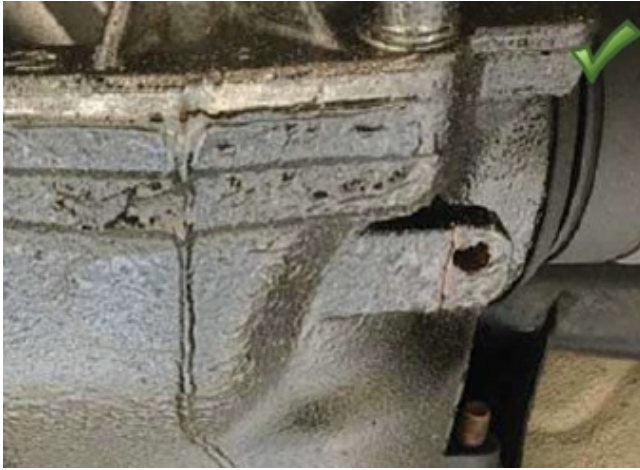
**Example B:**

Oil is actively leaking from the differential. Clean the differential, apply leak detection spray and test drive.

- **Repair the source of the leak.**

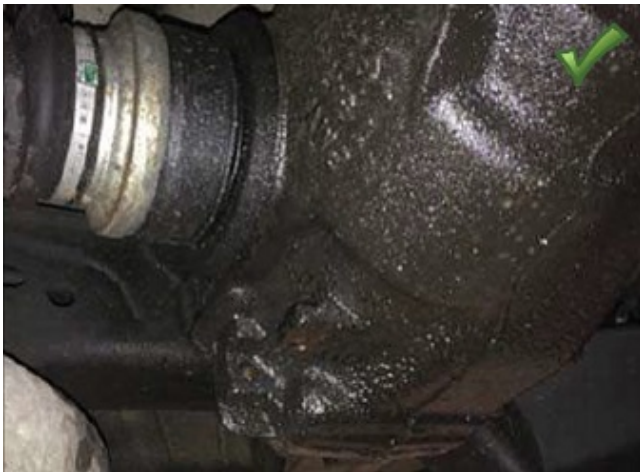
**Example B:**

Oil is actively leaking from the differential. Clean the differential, apply leak detection spray and test drive.

- **Repair the source of the leak.**

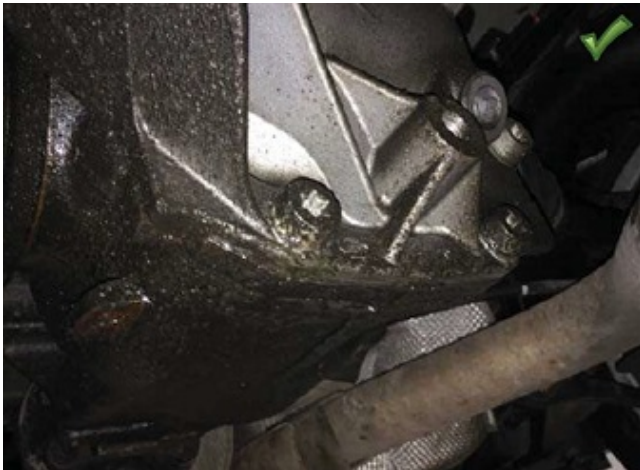
**Example B:**

Oil is actively leaking from the differential. Clean the differential, apply leak detection spray and test drive.

- **Repair the source of the leak.**
