SIB 64 08 21

AC Temperature Fluctuation or Loss of Cooling N63 S63 N74

Service Information Bulletin

Heating and Air Conditioning

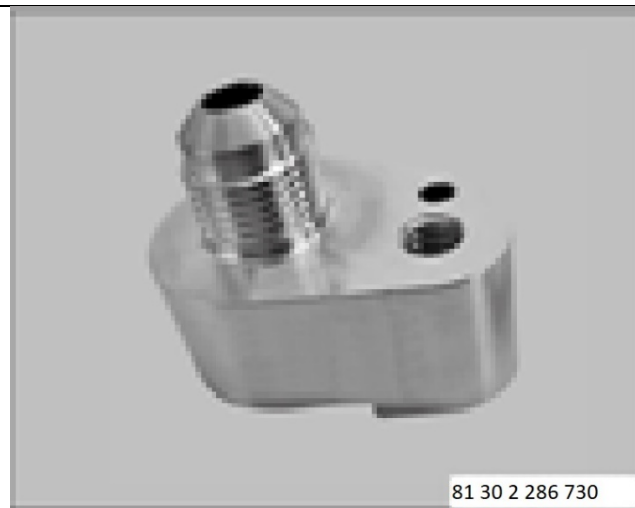
6. **Procedure if flushing equipment is available for the refrigerant circuit** Observe repair instructions
 - 64 50 770 "Flush refrigerant circuit".
 - Important: Follow Repair Instructions 64 50 775
 - Evacuate refrigerant circuit (if not done already)

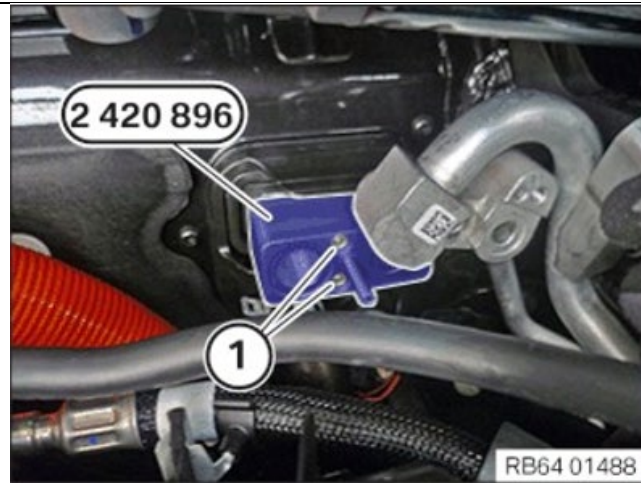
8. Remove and then bypass the expansion valve with flushing adapter **83 30 2 412 530**.
 - The flushing adapter will have a hole on both inlet and outlet as seen on the left.
 - There are identical shaped block off plates available for pressure testing which have no holes and will not allow for flushing. Do not use a solid adapter such as part number 3 420 896 if the evaporator is to be flushed!
 - Fasten with the M5 screws (1) of the expansion valve that has been previously removed.
 - **M5 Bolts Torque 5.5 Nm**
 - Attach the refrigerant lines to the special tool and secure with the M6 screw that has been previously removed.
 - **M6 Bolts Torque 13 Nm**
 - To reach the expansion valve by laying across the engine compartment you could use the padded board special i8 Tool **81**

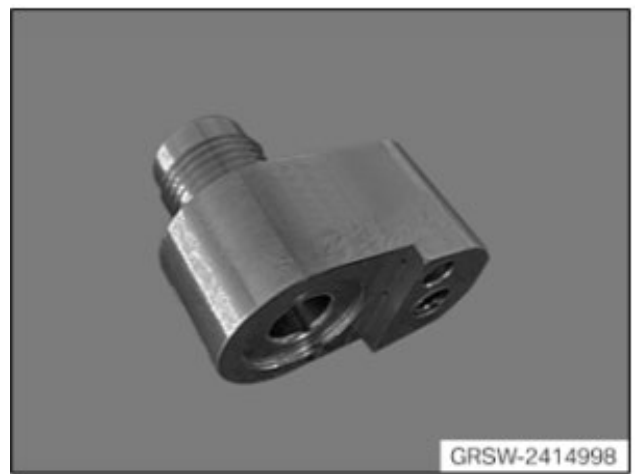
9. The condenser must be bypassed since it is a non-flushable component. Disconnect condenser hoses and bypass with flushing adapter **83 30 2 286 732** or **83 30 2 412 932** based on thread size and **83 30 2 414 998**. Connect the two adapters with connecting hose **83 30 2 285 575**.

This step may not yet be included in all ISTA repair instructions. This adds one additional vehicle AC hose to the flush circuit.

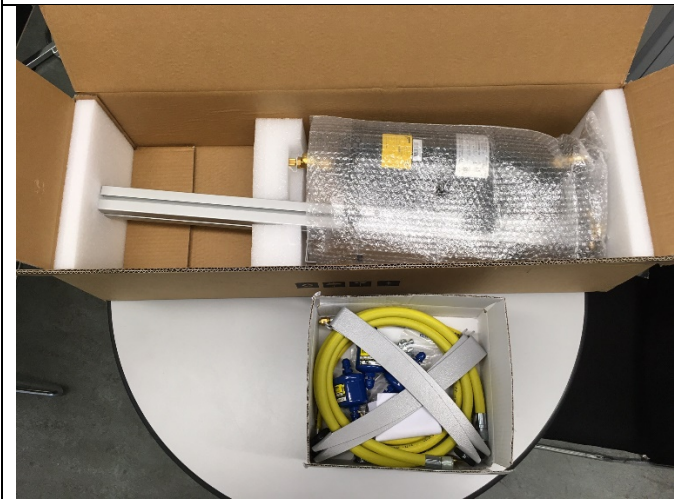
12. The flush machine (Robinair or Mahle manufactured) will come with hoses, filter, and hardware. Pictures are of the Mahle flush kit as received.

The adapters to connect to the AC machine come with the flushing machine.

There are adapters for both R134a and Y1234a.

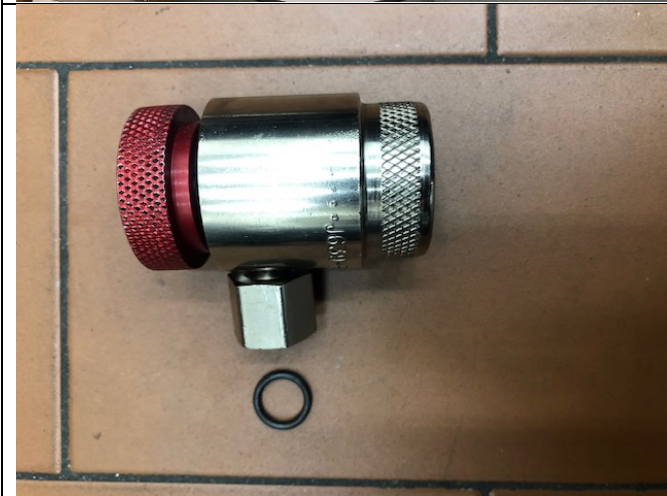
13. Only the R134a adapters fit the quick disconnects of the AC machine.

The **Y1234a** adapter fits the low side quick disconnect of the AC machine, however **the high side must have the quick disconnect fitting removed (left) in order to install the brass adapter** for connection. The O-ring seen in the picture, removed from the high side quick disconnect, must not be installed onto the brass adapter. This additional O-ring will not allow for full compression of the fittings when tightening resulting in a leak from the brass adapter.

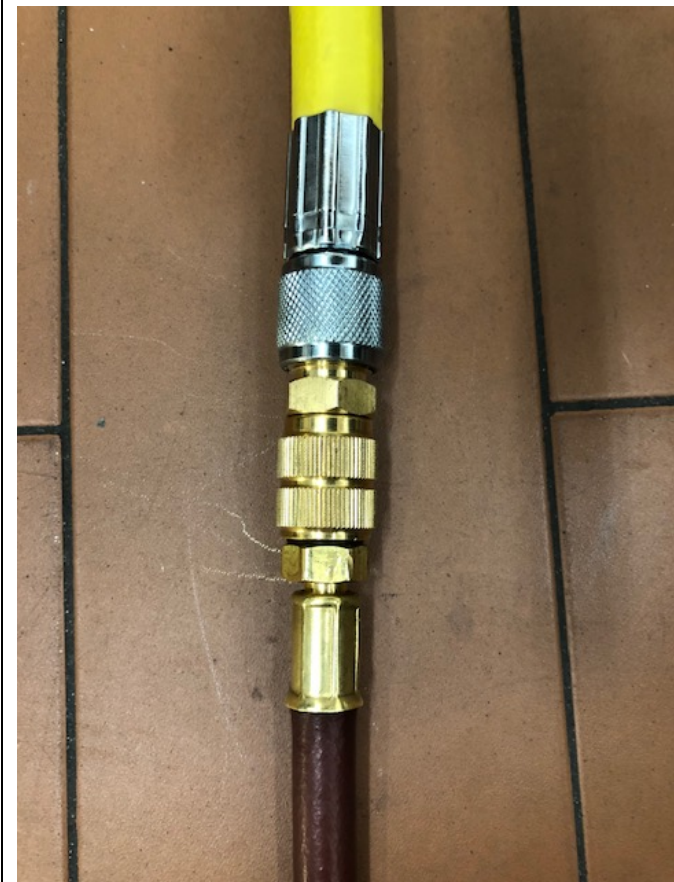
14. High side brass swivel fitting adapter for Y1234a high side connection.

15. **Y1234a high side adapter** installed in place of the quick disconnect

AC Flush circuit yellow hose (top), brass swivel adapter, and AC Flush machine high side red hose (bottom).

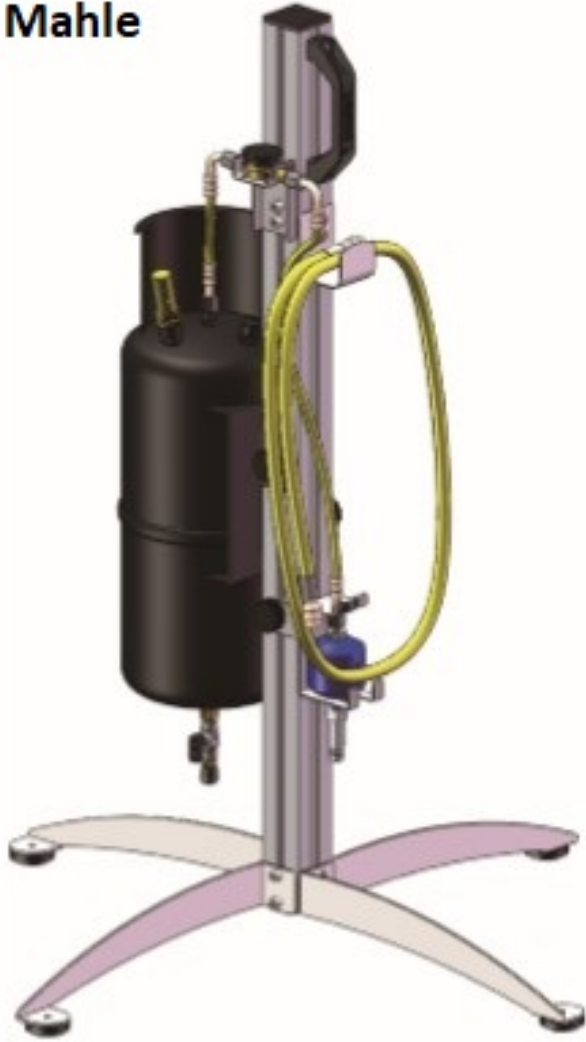
Mahle

16. Connect the air conditioning service device (AC Recycling machine and flushing adapter) to the cable connections. Follow instructions from the flushing adapter instruction manual on proper hose connections to the vehicle.

It is best to leave the yellow hose loose at the flush machine, make your connection to the vehicle, then tighten the hose at the flush machine.

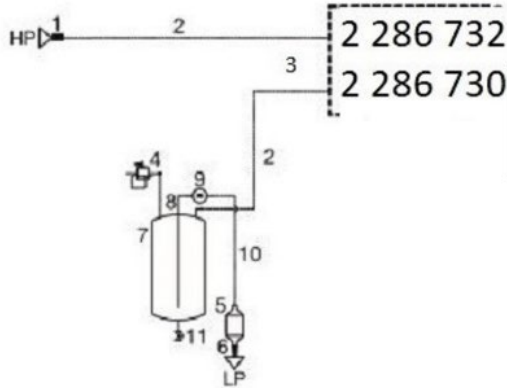
Pneumatic diagram

1	HP outlet adapter fitting
2	High-flow connection hoses
3	Item to be flushed
4	Safety valve 18 bar / 261 psi
5	Filter 15 µm
6	LP fitting
7	6 liter fluid vessel
8	Connection hose between vessel and sight glass
9	Fluid indicator sight glass with cap
10	Connection hose between sight glass and filter
11	Auxiliary valve with cap

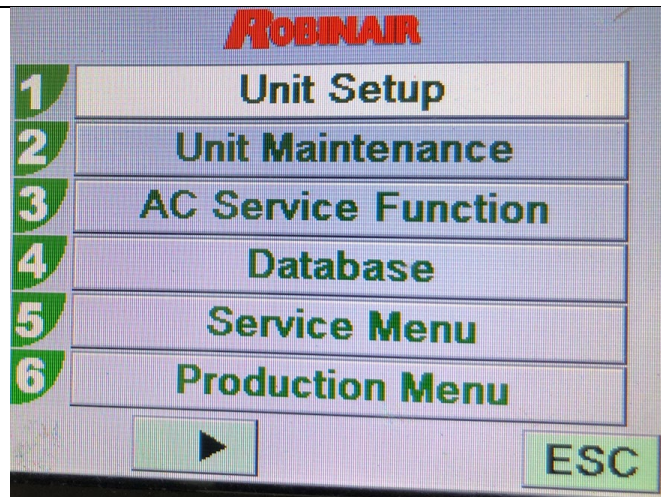
19. The flush procedure requires 4+ KG of refrigerant in the Internal Storage Vessel (ISV) tank within the AC flush machine. If there is an insufficient amount of refrigerant in the ISV the flush procedure will not start and will prompt an error message “Insufficient Refrigerant”. The amount of refrigerant allowed in the ISV when the AC flush machine transfers from the external tank is set in the machines settings menu. You may have to go into the menu of the AC machine to set the ISV amount. Follow instructions of the AC flush machine manufacturer.

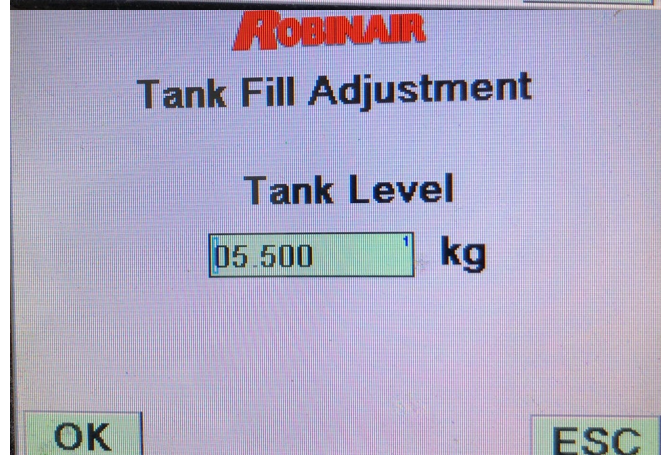
20. **For example** on the Robinair AC1234-6 machine to change the amount of stored refrigerant in the ISV go to UNIT SETUP

TANK FILL ADJUSTMENT
enter the amount required.

NOTE: On this Robinair AC machine there is .9 kg of refrigerant within the system that is not displayed in the ISV tank level. So to get an actual 4 KG of refrigerant you would need to set the tank level to at least 4.9 KG for the flush procedure to run.
