**SIB 11 03 14****SERVICE ACTION: Valve Clearance Sticker - Bulletin 11 003 14 (022)**

**Subject:** Valve Clearance Sticker

**Model:** S 1000 R (K47, 0D02 / 0D12)

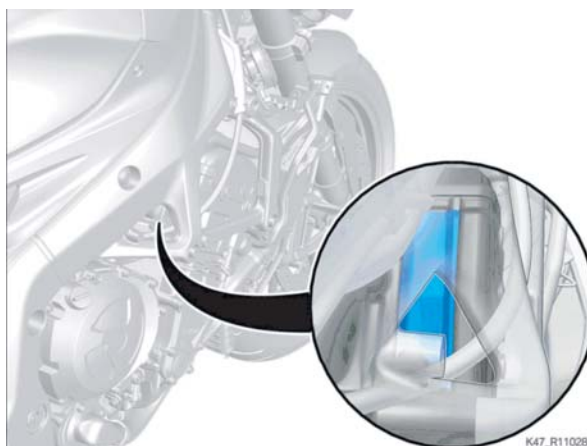
**Details:** Some motorcycles left the assembly line without being fitted with stickers affixed to the cylinder head stating the valve clearances. This information is essential for correct maintenance.

illustration: Surface for attaching the sticker

**Aftersales Solution:** Before handing over a new motorcycle to its owner or when motorcycles possibly affected by this issue are next brought to the workshop, attach a sticker (see attached work item 00 60 290 for details).

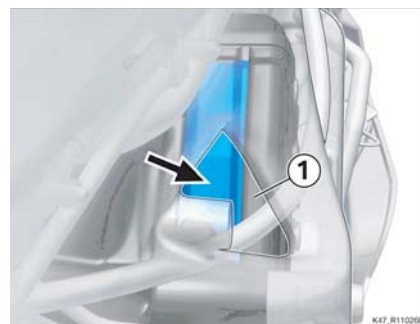
Use a degreasing agent to clean the surface indicated (**arrow**) on cylinder head (**1**). Allow the specified flash-off time to elapse.

The surface indicated (**arrow**) on cylinder head (**1**) is clean, dry and free of dust and grease.

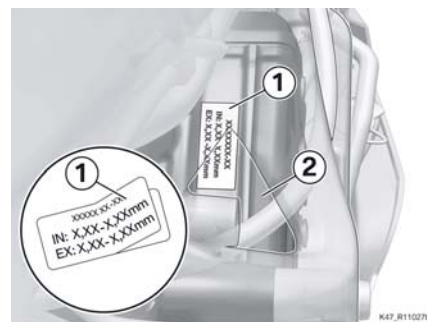
Peel sticker (**1**) off the backing paper.

With the aid of a suitable tool if necessary, affix sticker (**1**) to cylinder head (**2**) in such a way that the information on the sticker is clearly visible.
