Technical Service Bulletin

66 Water splashes into the cargo area when the rear lid is opened with standing water on it

66 21 81 2065342/1 December 13, 2021.

Model(s)	Year	VIN Range	Vehicle-Specific Equipment
RS 6 Avant	2021	All	Not Applicable
A6 allroad	2020 - 2021	All	Not Applicable

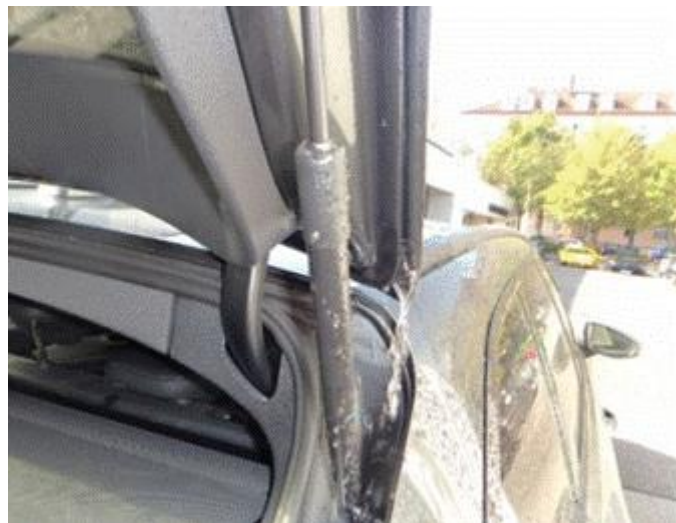
- The water is channeled through the side rear spoiler abruptly and is not channeled efficiently enough to avoid water entry into the cargo area.

1. The sealing surfaces between the center rear spoiler and the side rear spoilers are incorrectly sealed. As a result, pooled water runs out of this area when the rear lid is opened.

Figure 1. Water rushing from a poorly sealed rear spoiler connection.

Replace the side rear spoiler on both the right and left sides according to the Elsa Repair Manual.

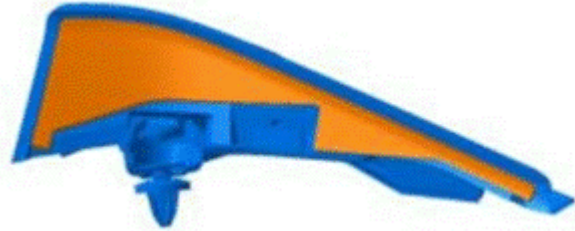
2. This symptom can occur on either the left or right sides. Figure 2 shows the improved seal on the end of the spoiler (in orange).

Figure 2. Improved seal at the end of the spoiler body.

The sealing on the spoiler components has been improved in production.

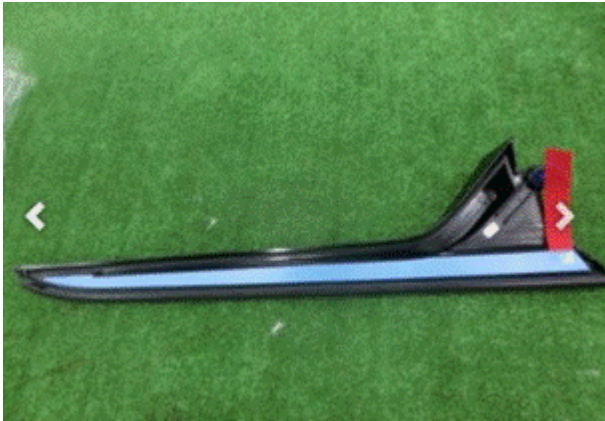
Spoiler, black-glossy, Left	01
4K9854872A 5FQ

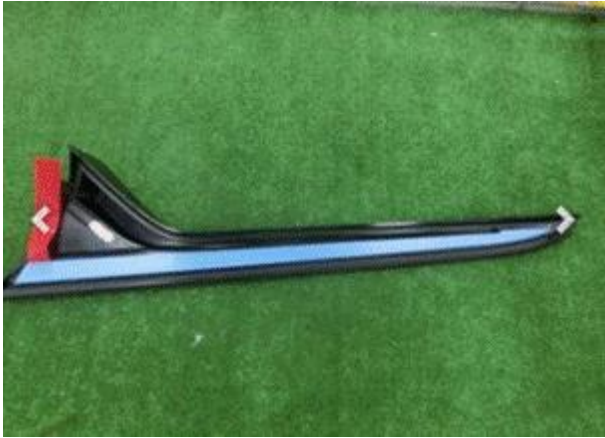
Spoiler, black-glossy, Right	01
