Technical Service Bulletin

66 Door cover trim is loose

66 21 82 2065566/1 December 15, 2021.

Model(s)	Year	VIN Range	Vehicle-Specific Equipment
Q7, SQ7	2019 - 2021	All	Not Applicable

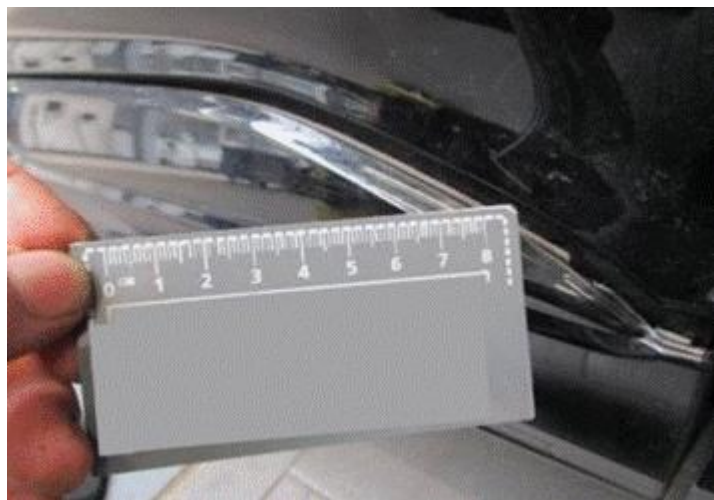
In production, the bonding of the door trim cover was insufficient. This compromised bond may cause the door trim cover to loosen creating a visible gap between the door trim cover and the door panel.

1. Figure 1 shows a debonded door trim cover.

Figure 1. Debonded door trim cover and extent of detachment.

Should the vehicle present with this condition do not make an attempt to reattach the trim. Inspect each of the four door trim covers for detachment. Replace the affected door trim cover in these cases.

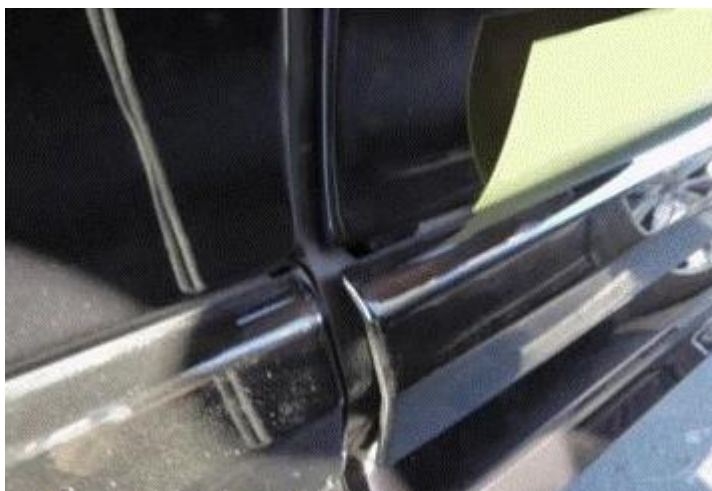
2. Figure 2 shows the door trim cover detachment.

Figure 2. Alternative view of debonded door trim cover.
