**SIB 46 02 07**

F 800 ST - Incorrect bolts to license plate bracket - Bulletin 46 002 07 (005)

**Subject:** Incorrect bolts fitted to license plate bracket

**Model:** F 800 ST (K71)

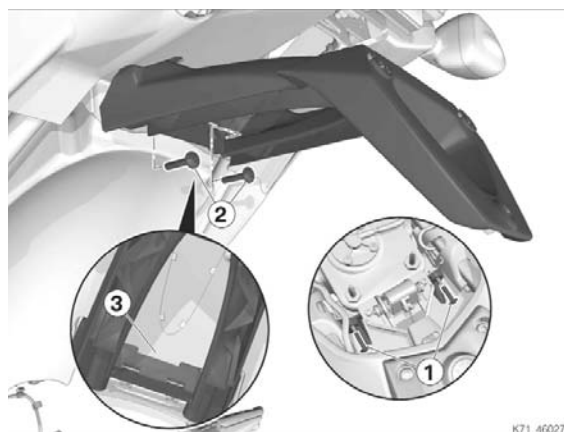
**Details:** By mistake, the incorrect bolts were fitted to secure the license plate bracket on a small group of motorcycles. The bolts used are 5 mm too long (35 mm in length). These longer bolts do not allow enough free play between the bracket and the fuel tank.

**Aftersales Solution:** Install the correct bolt, which is 30mm in length. The bolt in question is # 2 in the picture.

Part Number: 46 54 7 685 133 Qty. 2 M6x30 bolt
