Head Up Display Image is Blurry or Distorted

Supersedes 21-046, dated October 09, 2020, to revise the information highlighted in **yellow**.

Year	Model	Trim Level	VIN Range
2019–20	RDX	Advance	ALL

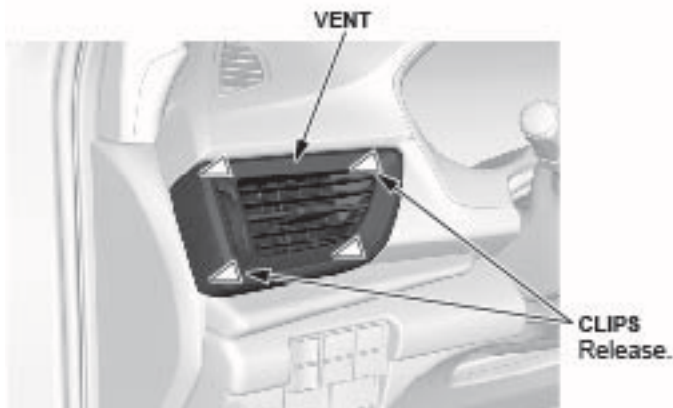
3. Remove the driver's and passenger's vents
