## Model Series 167: ARTICO Seat Covers On Front Seat Torn/Cracked

| Topic number | LI91.18-P-071629 |
| Validity | Model series 167 ARTICO man-made leather upholstery or ARTICO man-made leather upholstery/DINAMICA microfiber |

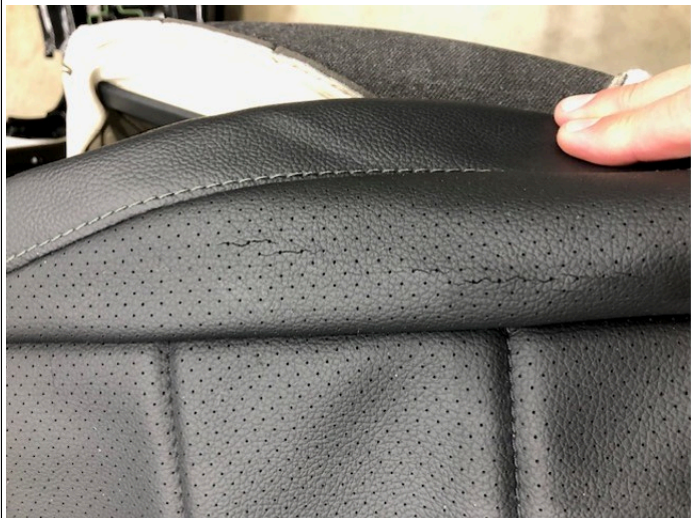
| Attachments | |
|---|---|
| <a href="#">example1.jpg</a> | Example 1 |

On vehicles with "ARTICO man-made leather upholstery" or "ARTICO man-made leather upholstery / DINAMICA microfiber - black (601A)" the material of the seat side bolster can tear. Both the seat cushion cover and the backrest cover on the front seat can be affected here.

The material may tear because the material in the side bolster is not suitable.

Optimized seat covers are expected to be available as from 10/2021. In the interest of the customer, please do not change any seat covers at the moment.
