TO: Mercedes-Benz Dealer Principals, General Managers, Sales Managers, Service Managers, Parts Managers	FROM: Gregory Gunther, Department Manager, Vehicle Compliance and Analysis, Engineering Services
RE: <b>Emission Service Campaign 2021050013 Launch Notification</b> <b>Replace Emission Control Information Label MY19 (E-Class, CLS-Class)</b>	DATE: August, 13 2021

Campaign No. 2021050013, August 2021

## **Replace Emission Control Information Label**

Model 213, 238, 257

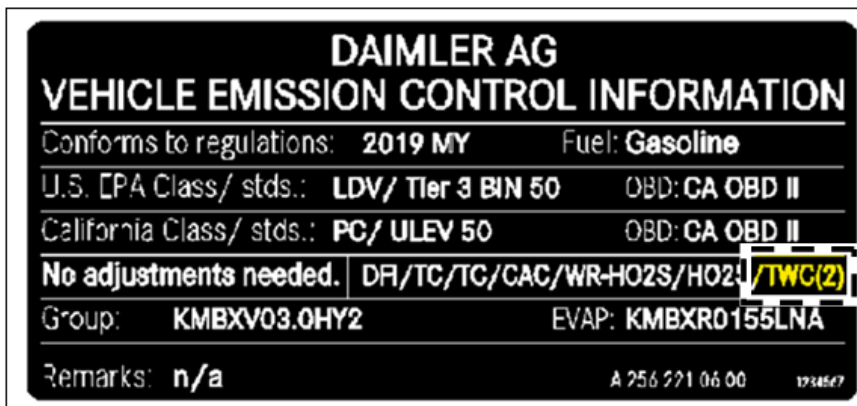
Figure 1

1. Open hood.
2. Replace the Emission Control Information label (**Figure 1**) on hood.
  - i** The new label must contain the text "**TWC(2)**" (**Figure 1**)!
  - i** For model 213 - bonding position 3.3, (**Figure 2**).
  - i** For model 238 - bonding position 3.3, (**Figure 3**).
  - i** For model 257 - bonding position 3.1, (**Figure 4**).
  - i** Remove old label by using a heat gun.
  - i** Contamination and adhesive residues from the old label must be removed via a thorough cleaning.
