SERVICE BULLETIN

APPLICABILITY: 2014-22MY Forester
 2013-21MY Crosstrek
 2015-21MY WRX

NUMBER: 05-88-21

SUBJECT: Front Stabilizer Bushing- Design Change
 Knocking / Squeaking Sound

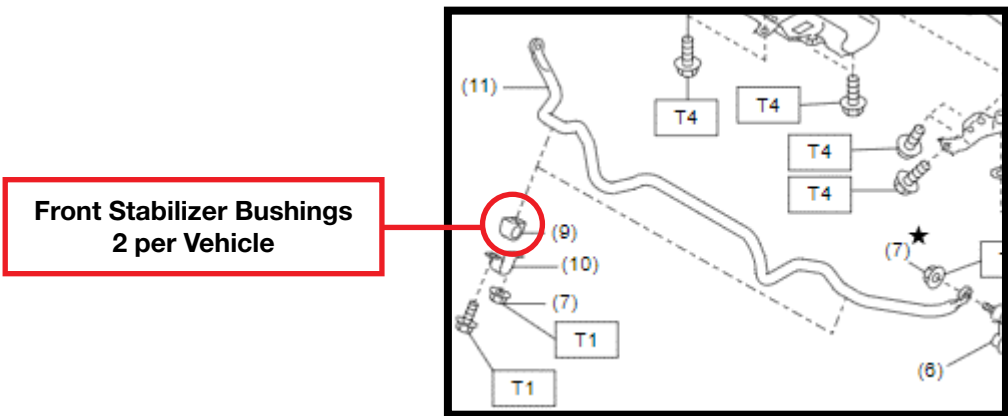
This bulletin announces a design change made to the front stabilizer bushings. The bushing material has been enhanced to address knocking / squeaking sounds when driving on rough roads during low ambient temperatures. If confirmed under the described driving conditions, the bushings shown in the illustration below should be replaced.

Part Description	Part Number
BUSHING-STABILIZER	20414SG001

The service procedures for front stabilizer bushing replacement remain unchanged. Always refer to the applicable Service Manual and review the full requirements of the repair being performed. The Service Manual procedures contain information critical to performing an effective repair the first time, every time. This includes but is not limited to important SAFETY precautions, proper inspection criteria, necessary special tools, required processes and related one-time-use parts needed for a complete and lasting repair.

Refer to the applicable Subaru Service Manual: Suspension > FRONT SUSPENSION > Stabilizer > STABILIZER BUSHING
