**Reversing Camera Misted Up and/or Droplets Forming in the Camera Lens: Rework Rear Lid Release (182/21)**

Model Line: **Panamera (971)**

Model Year: **As of 2017 up to 2021**

Concerns: **Reversing camera**

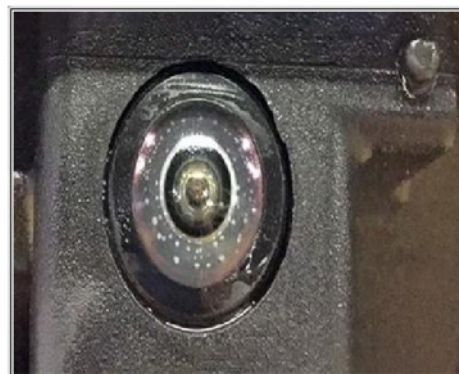
Information: The customer complains that the image on the reversing camera view on the PCM screen is cloudy. Drops and/or fogging are visible behind the reversing camera lens.

*Formation of drops*

Action required: In the event of a complaint, rework rear lid release and replace reversing camera.

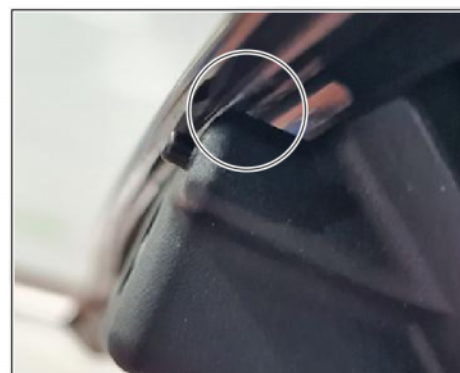
This may be caused by joint tolerances of the components in the reversing camera area as well as tolerances in the thickness of the body seam seal. They can cause the release for the rear lid in which the reversing camera is installed to touch the rear lid. If this happens, there is a gap between the release and the rear lid that can allow water to penetrate into the reversing camera.

*Contact between PVC seam and rear lid release*

Procedure: Affix a max. 5 mm/ 0.20 in wide chamfer to the actuator for the rear lid to prevent contact between the rear lid release and rear lid and to ensure that the seal is secure.

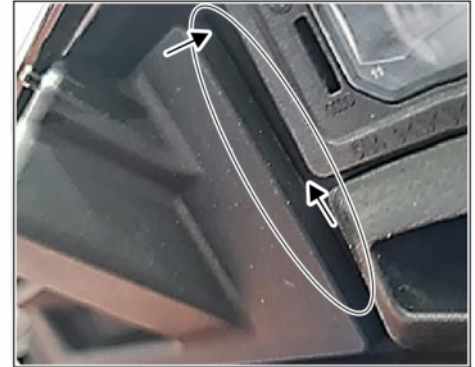
*Gap between release and rear lid*

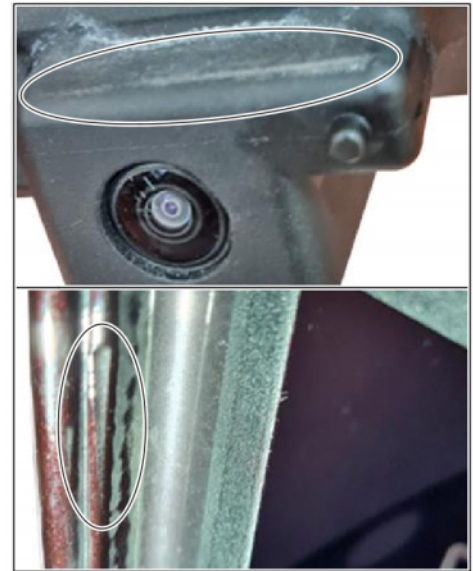
*Contact points*

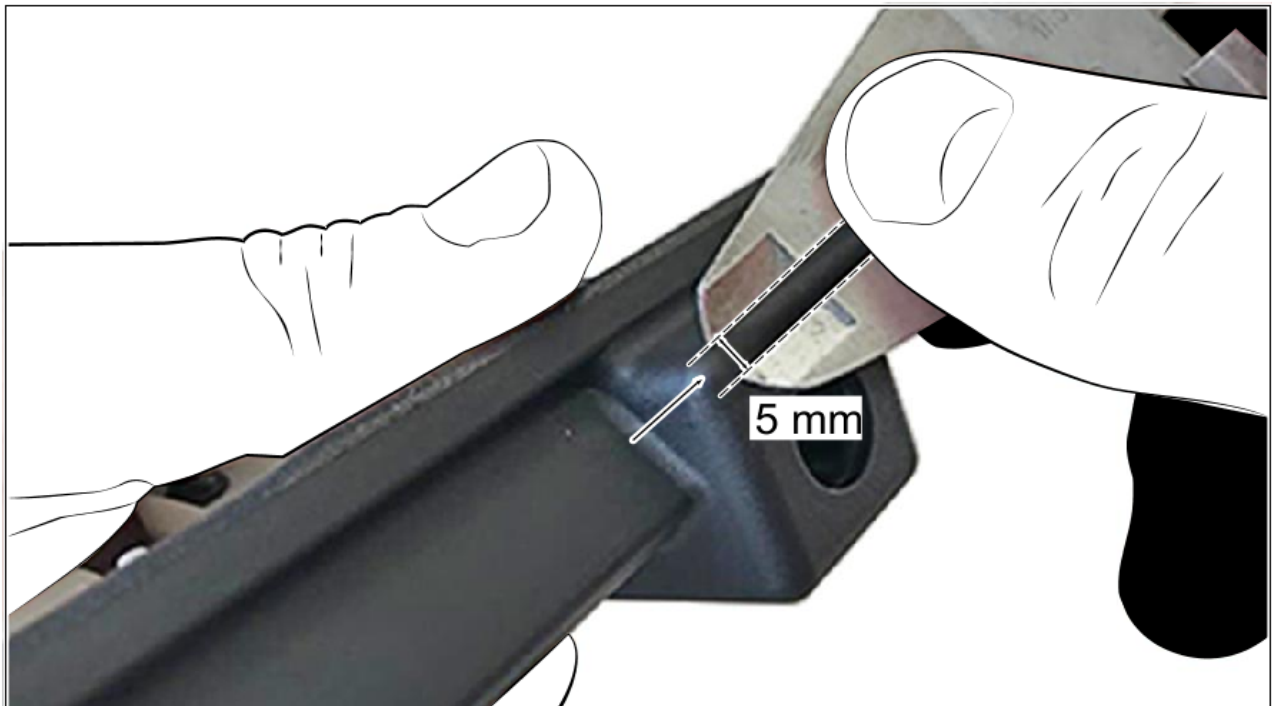
*Marking area to be removed*

- 1 Set calliper gauge to a width of 5 mm/ 0.20 in. Then scribe the surface to be removed as shown in  $\Rightarrow$  *Marking area to be removed* using the calliper gauge.

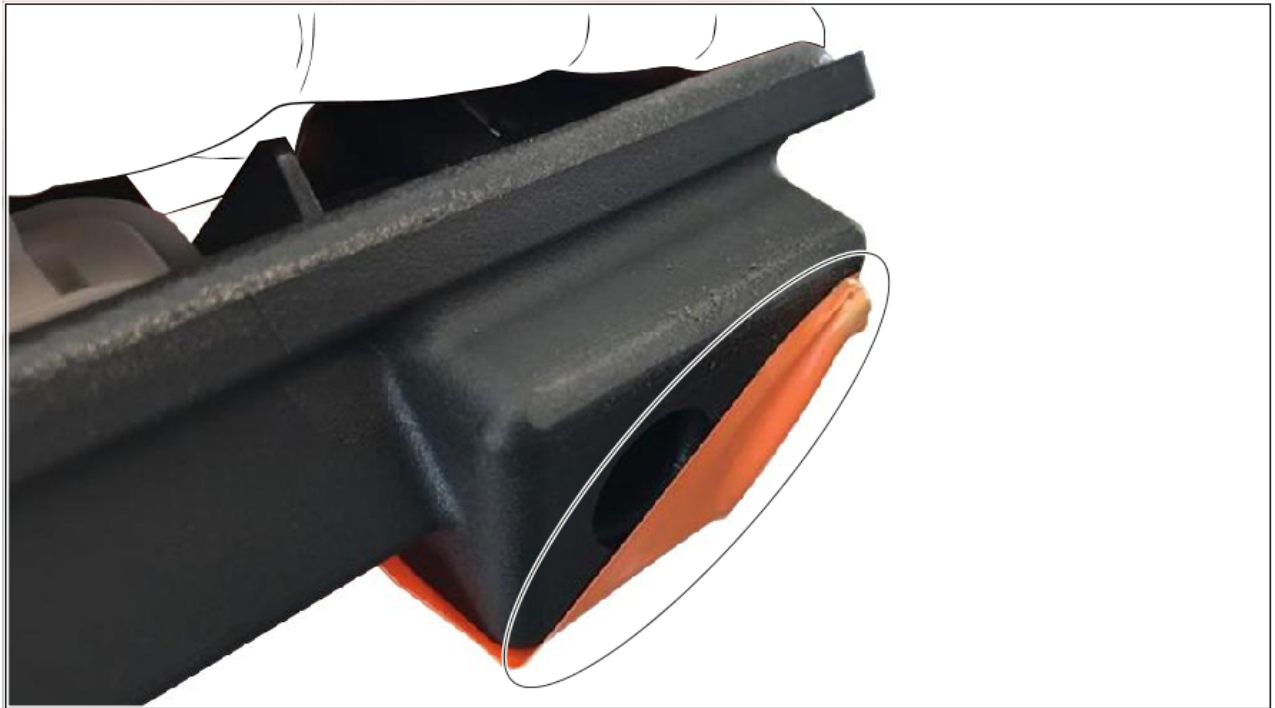
*Masking spray nozzle*

- 2 Mask the spray nozzle for the reversing camera at the actuator for the rear lid as shown in  
⇒ *Masking spray nozzle* using suitable adhesive or insulating tape.

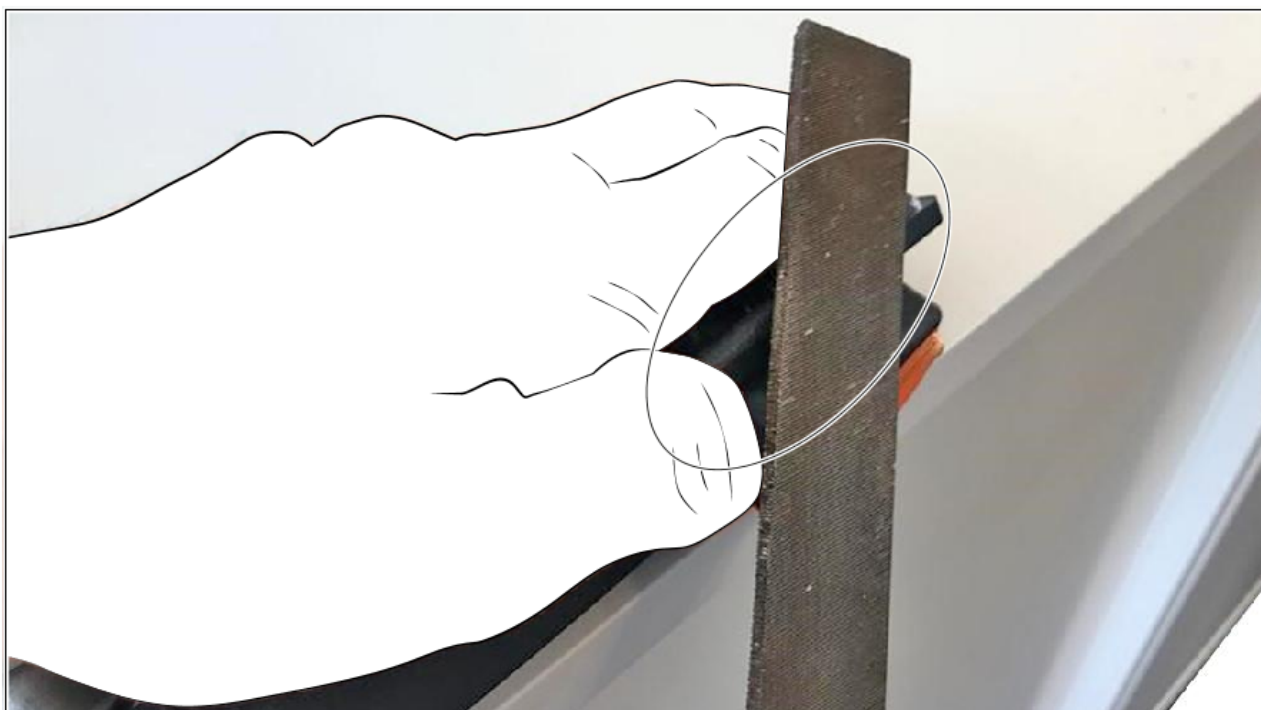
*Installing chamfer*

- 3 Remove the area you marked earlier using a fine-grained file over a width of max. 5 mm/ 0.20 in. ⇒ *Installing chamfer*

In most cases, it is sufficient to remove approx. 2-3 mm/ 0.08 — 0.12 in of material. Therefore, install the rear lid release in between and check the installation position after you have removed some material. Then, remove more material if necessary.

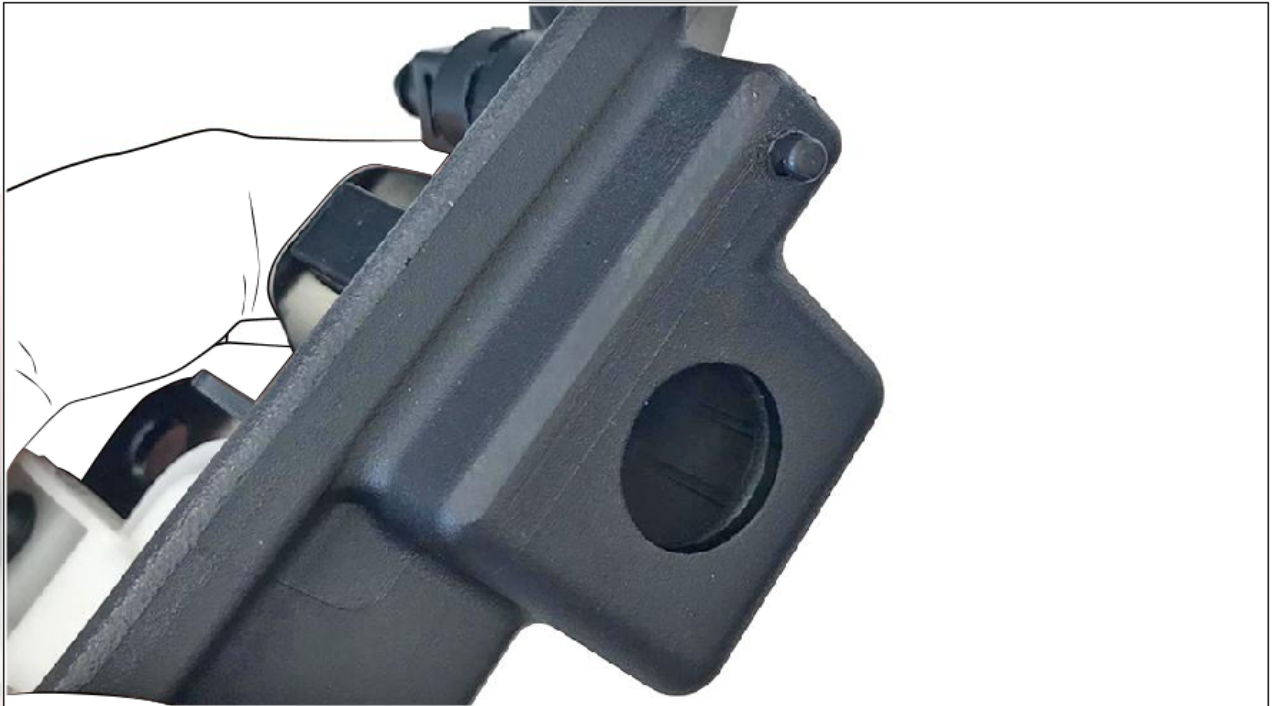
*Example of completed rework*

Work Procedure: 1 Install **new** reversing camera in the reworked release for the rear lid and install release for the rear lid together with the reversing camera. Then calibrate the reversing camera.
