December 23, 2021

Warranty Extension: B-612P Catalina Blue Pearl or Bright Kinetic Blue Pearl Paint

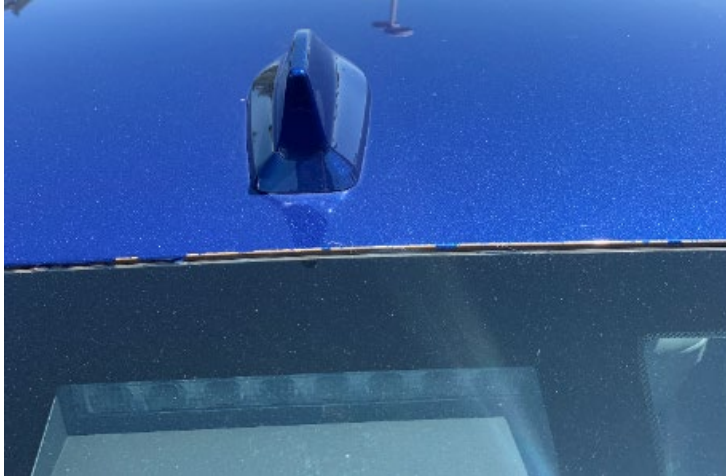
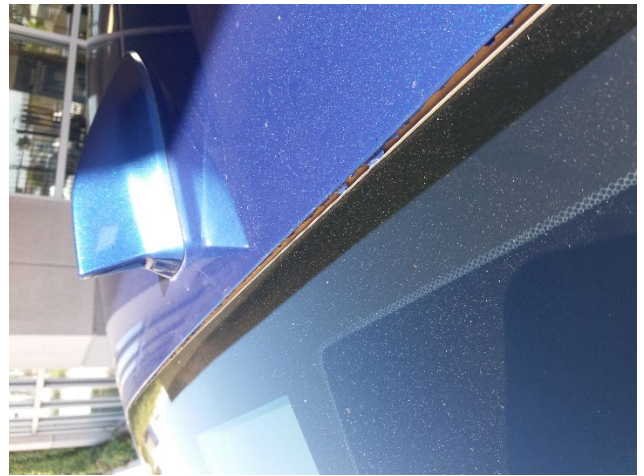
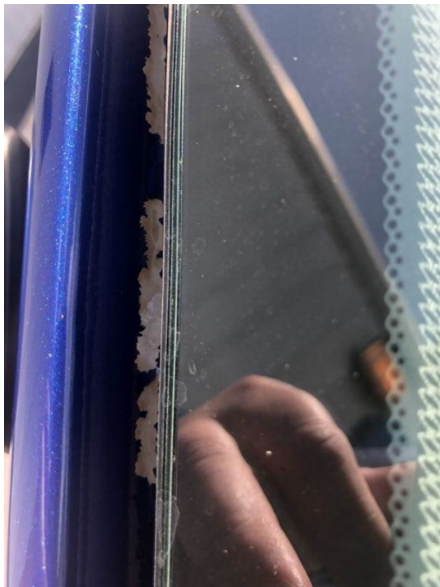
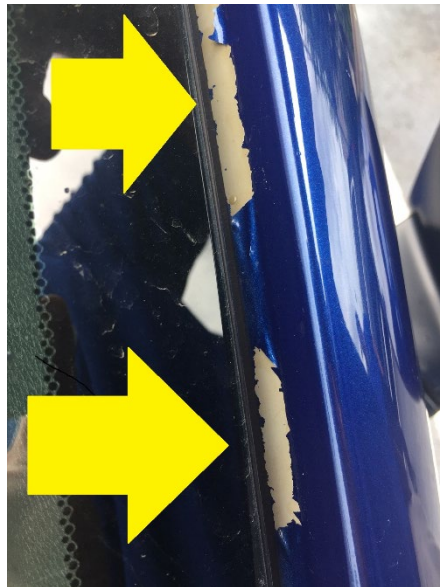
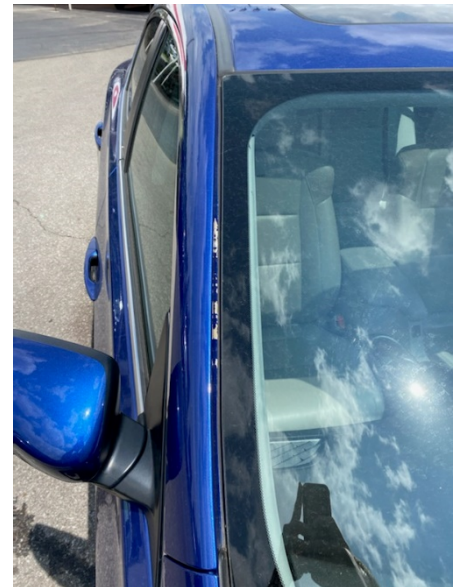
NOTE: If there are any questions about vehicle coverage under this warranty extension, contact your DPSM.
