## AMT-F With Crawler Gears - During Gearbox Removal From The AMT: Input Shaft Slips Out Of The Gearbox Or Becomes Loose In The Gearbox

During removal of an AMT gearbox equipped with Crawler gears, the input shaft may slip out of the gearbox or become loose in the gearbox.

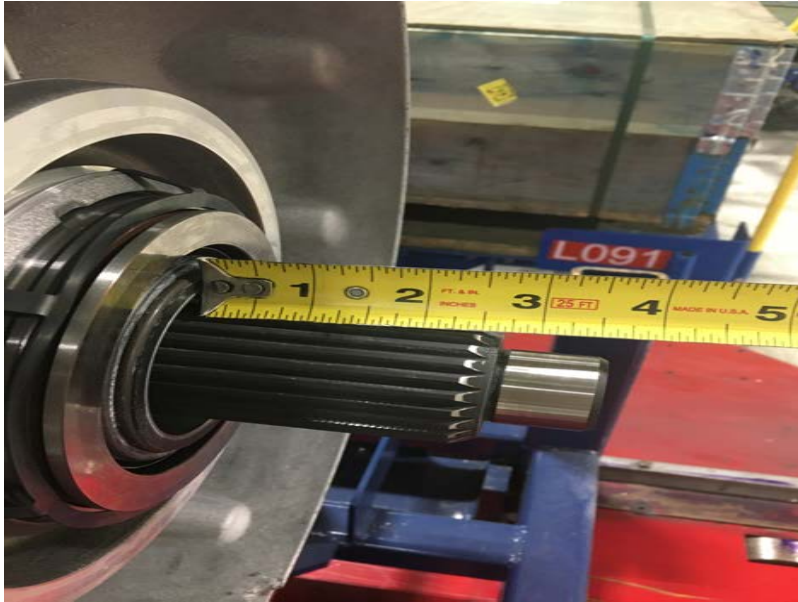
- Shaft protrusion from the front of the Clutch Control Actuator (CCA) on ALL gearboxes is approximately **3 5/8" (92 mm)** as shown below:

Always check the shaft after removing the gearbox.

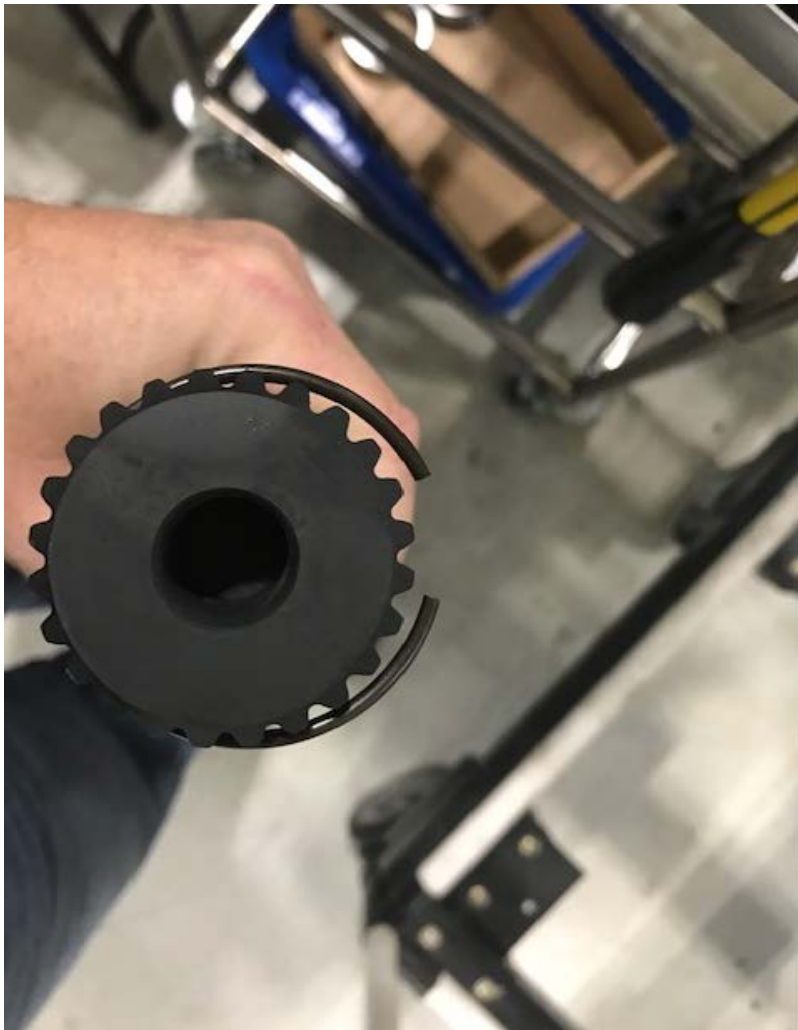
**NOTE:** The clip fits loosely.

1. **Clean and inspect the input shaft, clip and splines.**
2. **Reinstall the clip.**

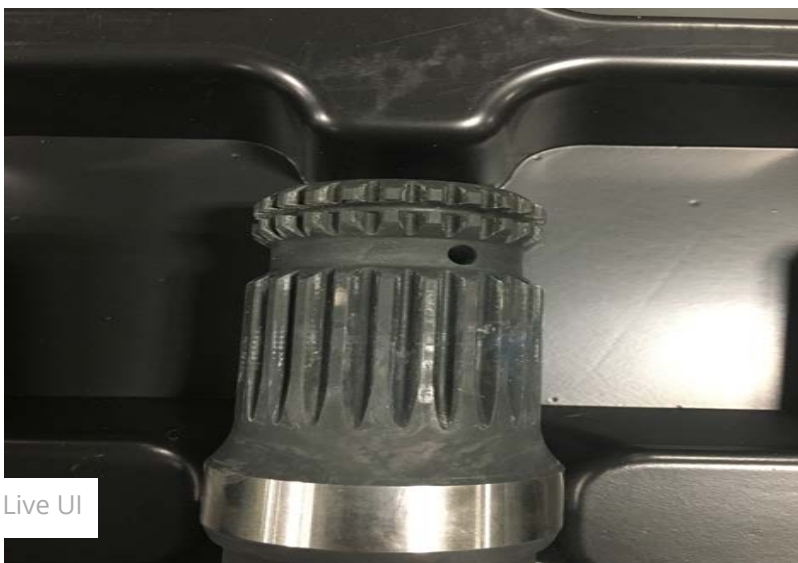
The ring fits in the small groove on the rear end of the shaft as shown below:

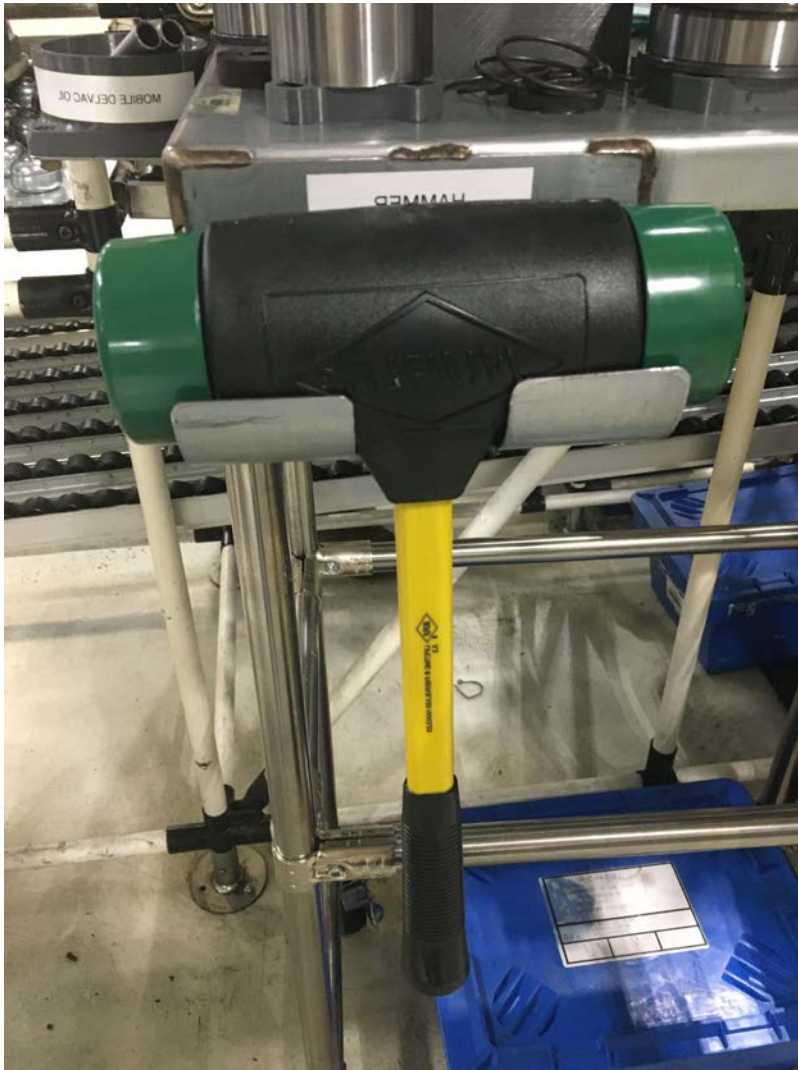
A rubberfaced deadblow hammer may be used to get the shaft started, as it can be difficult for the ring to start into the gears.

**3. Apply oil to the shaft and splines in the rear input shaft as needed and reinstall the front input shaft into the rear input shaft.**
