## Automated Manual Transmission ( AMT ) Fault Codes - P1075-38 ( PSID 27 FMI 8 ) Present After Working On The Air Supply System

## P1075-38 (PSID 27 FMI 8)

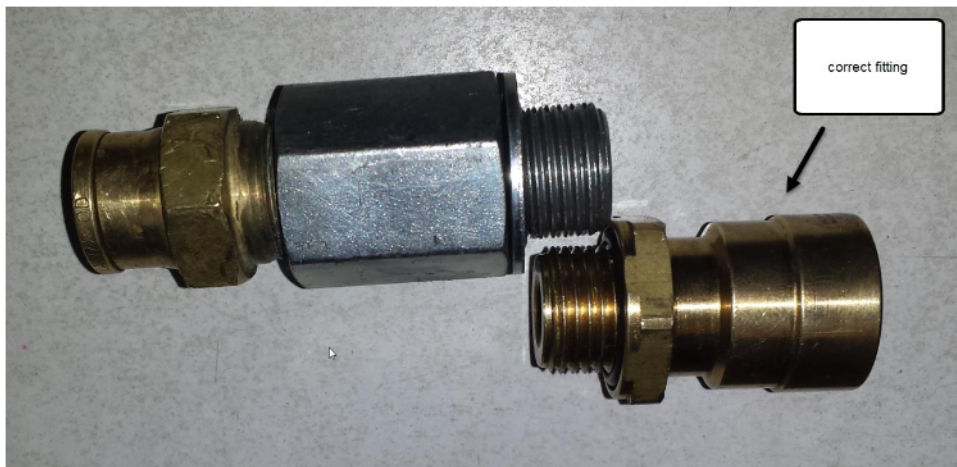
It has been found in several cases where the wrong airline fitting was used to repair an air leak on the CVU air inlet fitting. Too long thread length will crush the inlet check valve in the inlet to the CVU and cause the air to be restricted to the clutch system.

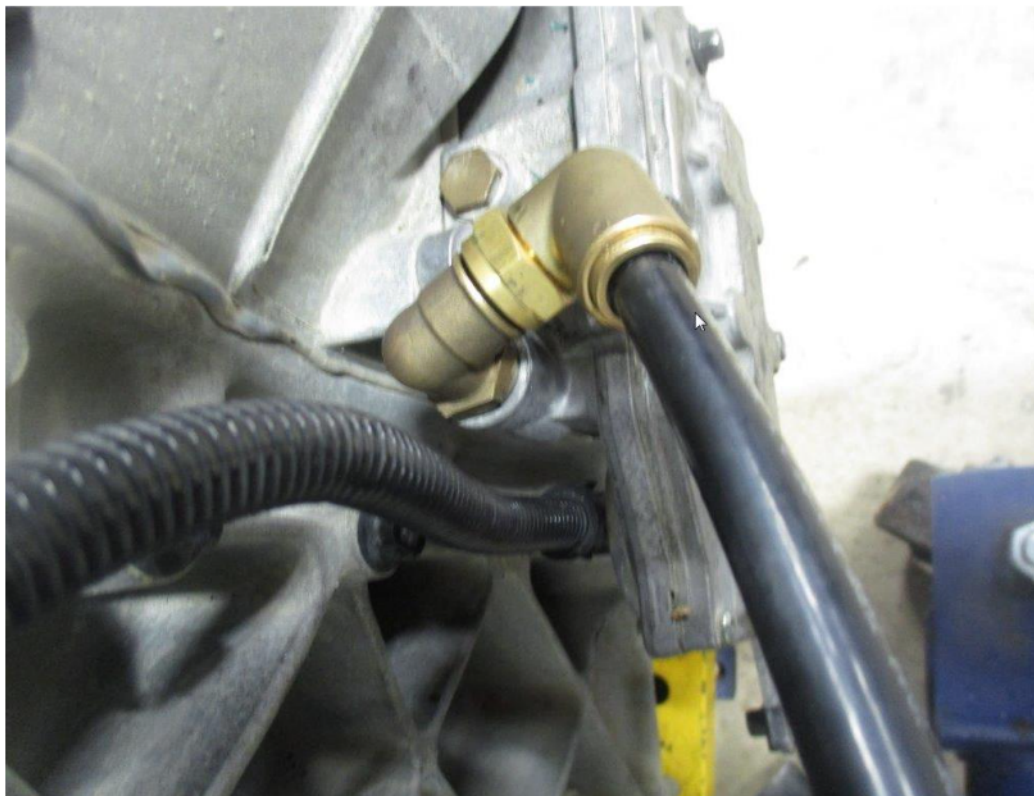
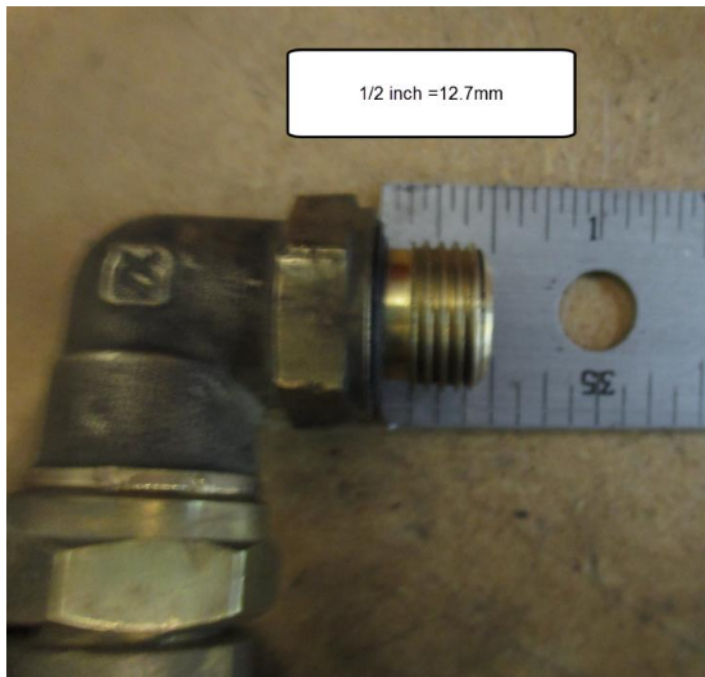
The fittings in the picture below are AMT gearbox air fittings but the thread length is 11 mm and will cause this issue.

The correct PN for the fitting is 991092. The correct thread length for the fitting is 9mm (L1 value in the drawing below). The thread size for the fitting is M16X1.5 and the tubing size is 12X1.5. It is always best to use the factory fitting for the application but if that fitting is not available then the thread length (L1) of the fitting is the most critical part of the fitting to be sure to not restrict the air flow into the CVU.
