## Volvo Chassis - Equipped With An (AMT) I-Shift Transmission Grinding While The Range Is Shifting From (6th To 7th) Or (7th To 6th) Gear

**Bulletin:** SNV15-003b  
**Date:** February 4, 2016  
**Valid to:** Until Further Notice  
**Replaces:** SNV15-003a  
**Action Required?** **Yes**

**Subject:** I-Shift Transmission Service Strategy (Revised failure mode descriptions)

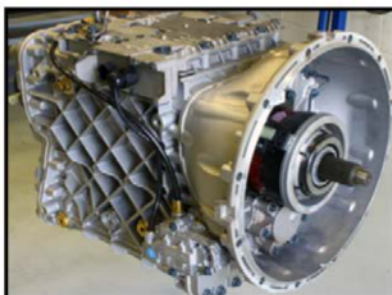
### Complete Transmission

Includes: Clutch Control Actuator, Transmission ECU, Top Shift Cover Assembly and solenoid.

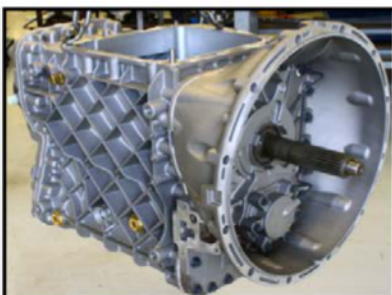
### Basic Transmission

Same as a Complete without the Clutch Control Actuator, Transmission ECU, Top Shift Cover Assembly and solenoid.
