# Service Campaign 72-06

**AFFECTED:** 2021 & 2022 Forza and Inspire models

**SUBJECT:** Missing Seal

### Missing Seal

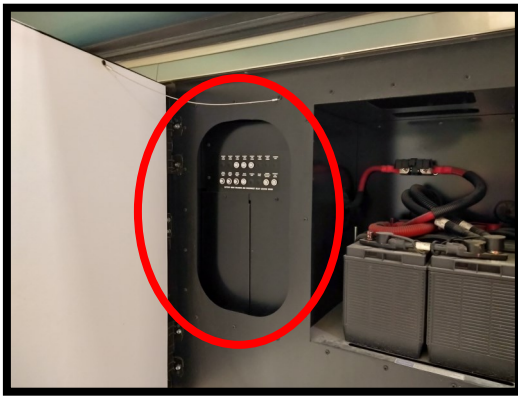
1. Inspect forward section of driver's side rear compartment to determine if seal is missing.

Figure 1 - Missing Seal

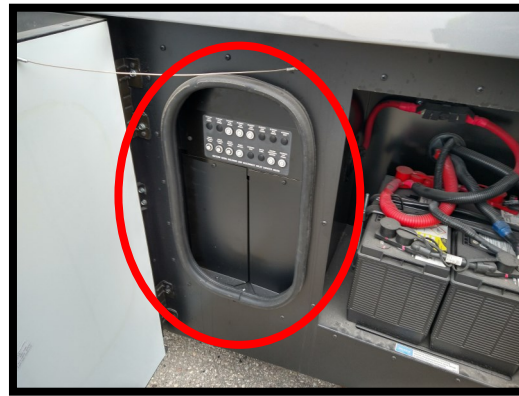
Figure 2 - Seal Installed

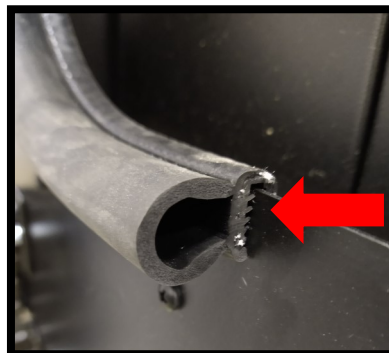
Figure 3

2. If seal is missing, order 5 feet of 316686-01-01A seal-bulb/single-black on a FastTrack Standard Parts order through WinPortal.
3. Beginning at bottom center of compartment opening, clip seal around the opening (Figure 3). Be careful not to leave any strands of metal wire exposed that could cause potential injury.

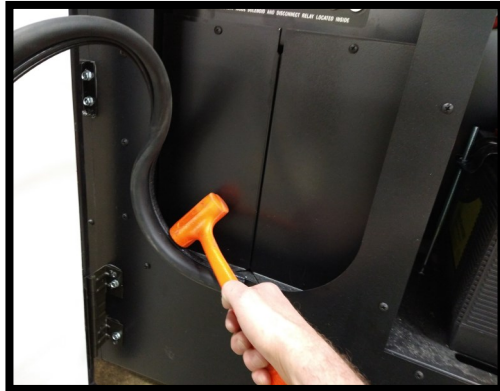
**Figure 4**

4. Working in a clockwise pattern, begin clipping on the seal all the way around the opening. It is recommended to use a hammer to gently tap the seal to make sure it is all the way clipped in at the corners.

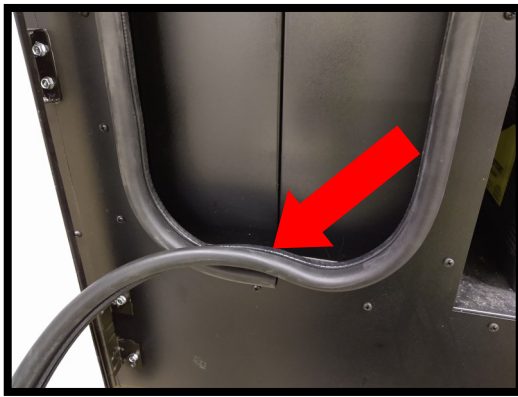
**Figure 5**

5. When seal is fully installed, cut the seal at the splice ensuring the cuts are flush with each other and there are no gaps or overlap.

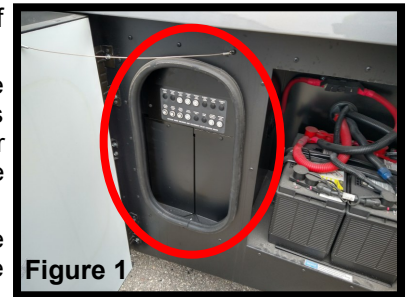
- If the compartment resembles Figure 1, the campaign does not need to be completed. You can notify us by completing the postcard included with this letter or contacting us at [customer care@wgo.net](mailto:customer care@wgo.net) or (800) 537-1885 with your Winnebago Body Serial Number and we will remove your coach from the campaign.
- If the compartment resembles Figure 2, the campaign will need to be performed. Contact your Winnebago dealer to arrange for a service appointment.
