STAR ONLINE PUBLICATION

Case Number: S1723000001 Rev D

Symptom/Vehicle Issue: Left Hand Drivers Side Mirror Takes Longer to Defrost Or Clear Than Right Side Passenger

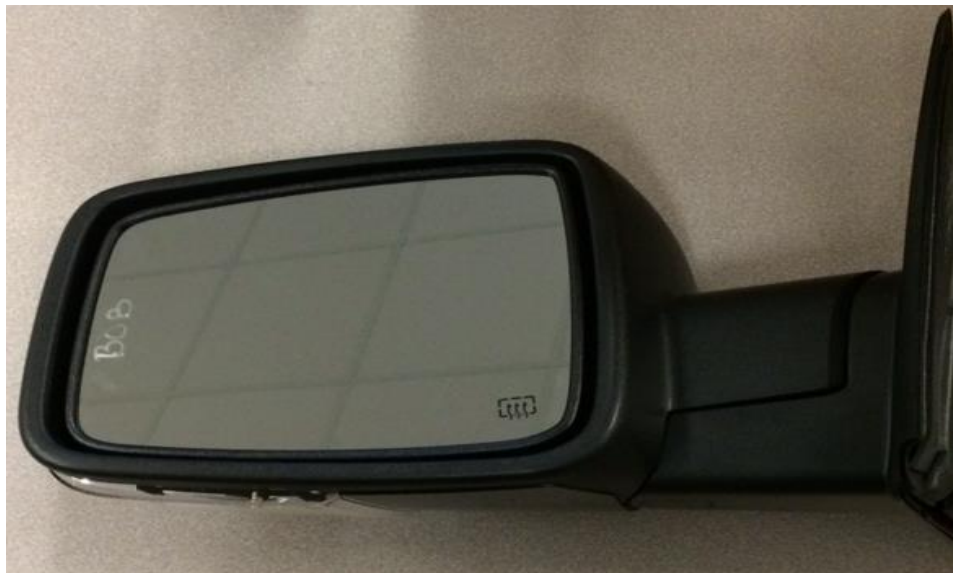
Discussion: The driver's side or left side door mirror is an ElectroChromic (EC) dimming mirror. The passenger side does not have the EC mirror unless the vehicle has the sales code "LEU". Due to the EC coating on the driver's side mirror, the time for the mirror to completely defrost may take up to 10 minutes. This is a normal condition and not a part failure. Replacing the mirror(s) will not correct this.

Image of a mirror assembly
