NUMBER: 23-020-21

Front Passenger Outer Seat Bolster Foam is Collapsed

2018 - 2021	(JL)	Jeep Wrangler
2020 - 2021	(JT)	Jeep Gladiator

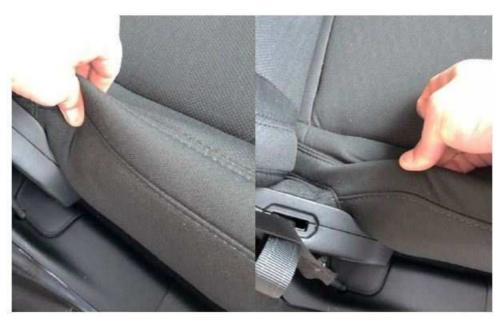
Fig. 1
Empty Seat Bolster

• The front passenger outer seat bolster cushion is missing (Fig. 1).

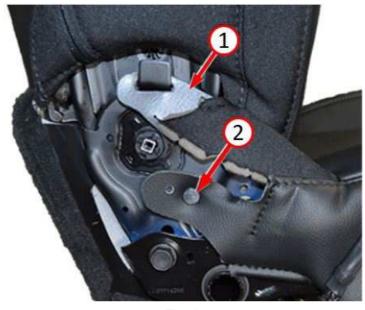
Fig. 2
Seat Cover Retainers

- 1 Seat Cover Tabs
- 2 Seat Cover Push Pin Retainer

- Remove the passenger seat from the vehicle. Refer to the detailed service procedures available in DealerCONNECT> Service Library under: Service Info> 23 - Body / Seats, First Row / Seat, Front / Removal.
- 2. Remove the seat side shield. Refer to the detailed service procedures available in DealerCONNECT> Service Library under: Service Info> 23 Body / Seats, First Row / Side Shield, Seat Cushion, Front / Removal.
- 3. Remove push pin retainer and release seat cover tab (Fig. 2) .

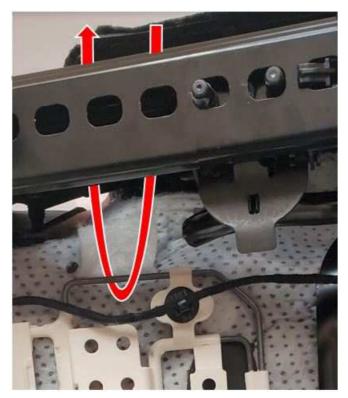
Fig. 5
Seat Strap Location

NOTE: The next steps are to install a strap between the seat suspension mat and seat frame. The strap will help prevent the seat bolster from being push back under the seat frame again (Fig. 5).

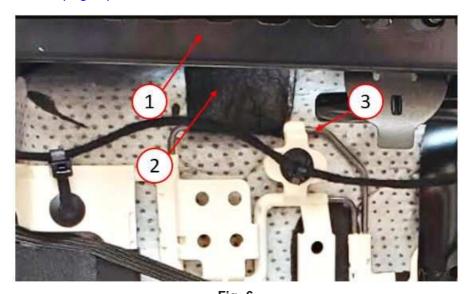
Fig. 6 Location of Seat Strap

- 1 Bottom of Seat Frame
- 2 New Seat Strap
- 3 Seat Suspension Mat

7. Lace the seat strap around the suspension mat frame pull it between the lower seat bolster foam and seat frame (Fig. 6).
