# Service Bulletin

Date: **5 november 2021**

Subject: **Lambda probe plug**

Product: **B4 1000 EURO 5 RR – RS – RUSH**  
**from VIN: ...NV000011 to VIN: ...NV000249 included, plus VIN ...NV000270**

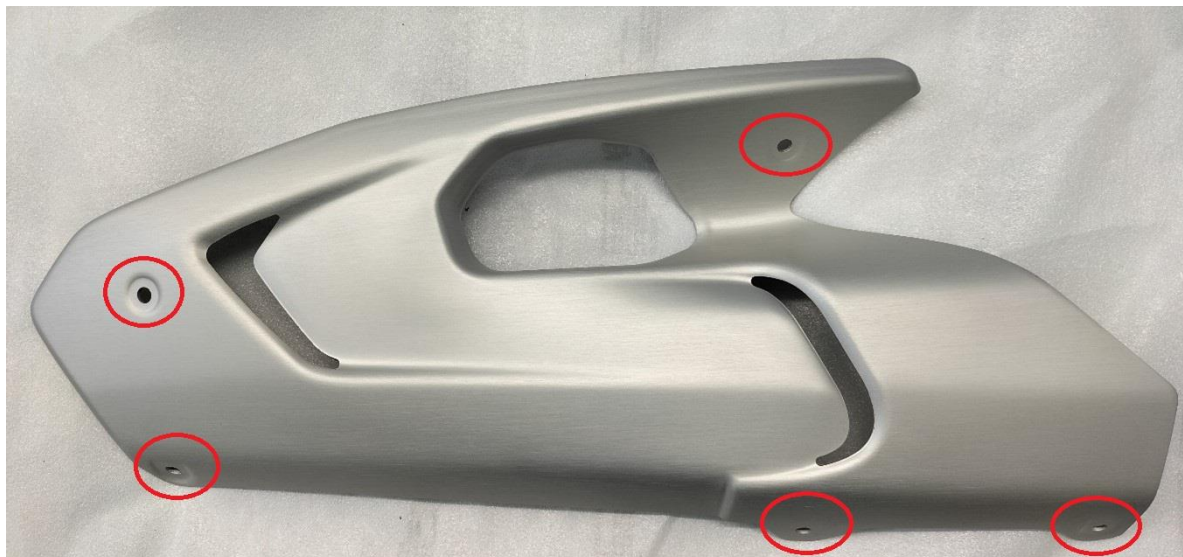
- Remove the protection of the exhaust manifold on the LEFT side by acting on the 5 fixing screws with a 4mm Allen key:

- Refit the protection of the LEFT exhaust manifold by acting on the 5 fixing screws with a 4mm Allen key and applying a tightening torque of **10Nm**.

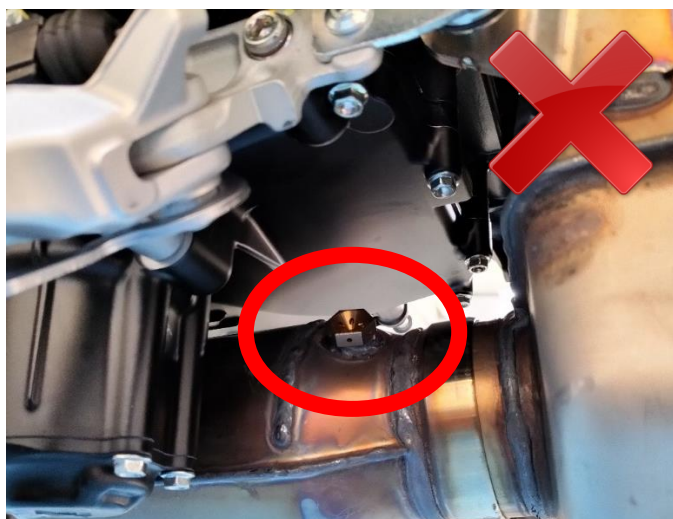
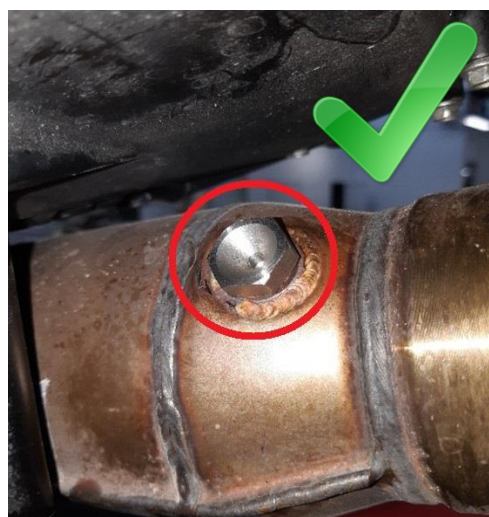
- Locate and remove the plug of the lambda sensor with a hexagonal key:
- **NOTE: The removed plug MUST NOT BE USED AGAIN.**

- Take the new plug cod. **8000D0759** and apply it to the Lambda probe socket using a 17 mm hexagon socket insert, tightening it to a torque of **40 Nm**.

**NOTE: The probe plug does not require a washer, lubricant or thread locker.**
