| S.A.T. | 283 MV |

# Service Bulletin

Subject: **Front brake hose connection washers**

Product: **Brutale 1000 RR EURO 5 - Brutale 1000 RS EURO 5 - RUSH 1000 EURO 5**  
from VIN: ...NV000011 to VIN: ...NV000249 included, with in addition VIN...  
NV000270

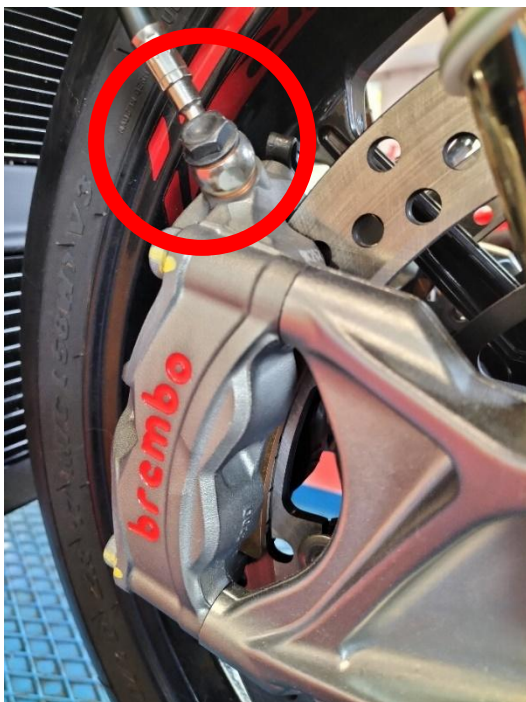
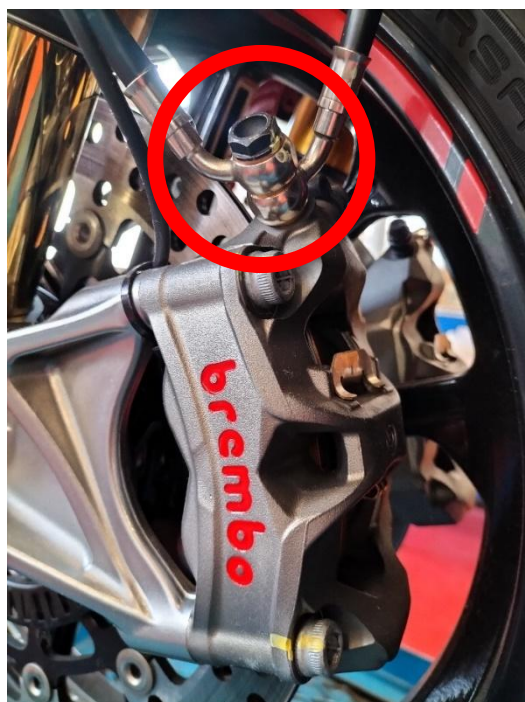
- Move the front brake lever slightly closer to the right handlebar grip and hold it in place with a cable tie in order to prevent brake fluid from draining during subsequent operations.
- Locate the brake hose connections on the front brake calipers:

- Protect the operating area adequately to prevent damage from contact with brake fluid.
- Loosen and remove the front brake hose connecting screws and remove the aluminium washers.

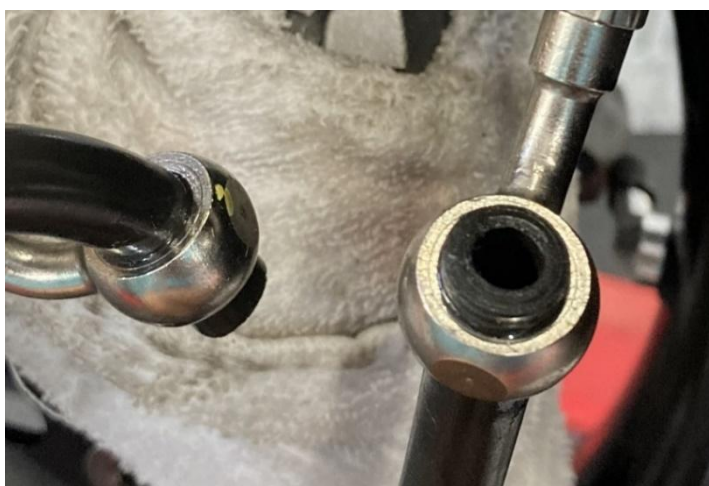
- Apply a piece of rubber hose with a diameter of approx. 11 mm to the inside of the brake hose opening to prevent the system from draining the fluid (inside diameter of brake hose opening: 10 mm):

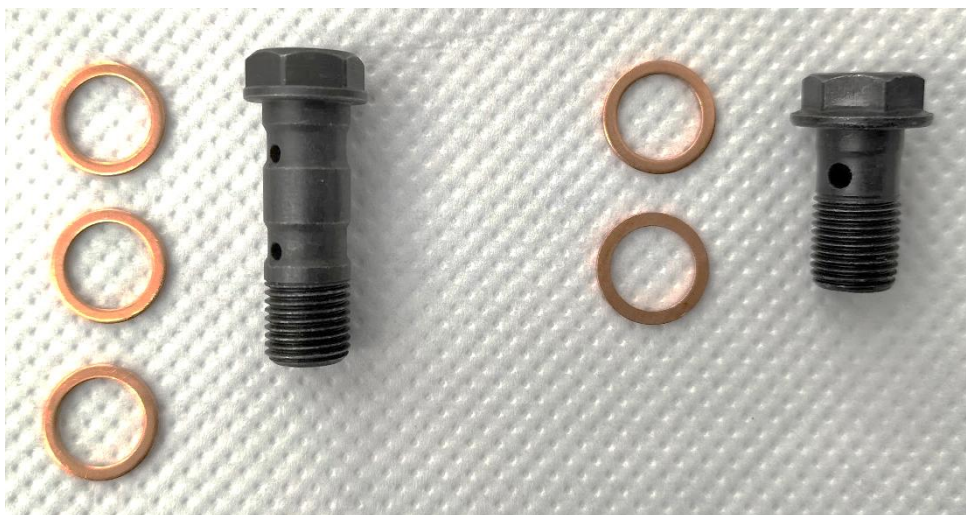
- Apply the 5 washers code **800021480** and tighten the brake hose connecting screws to a torque of **23 to 26 Nm**.

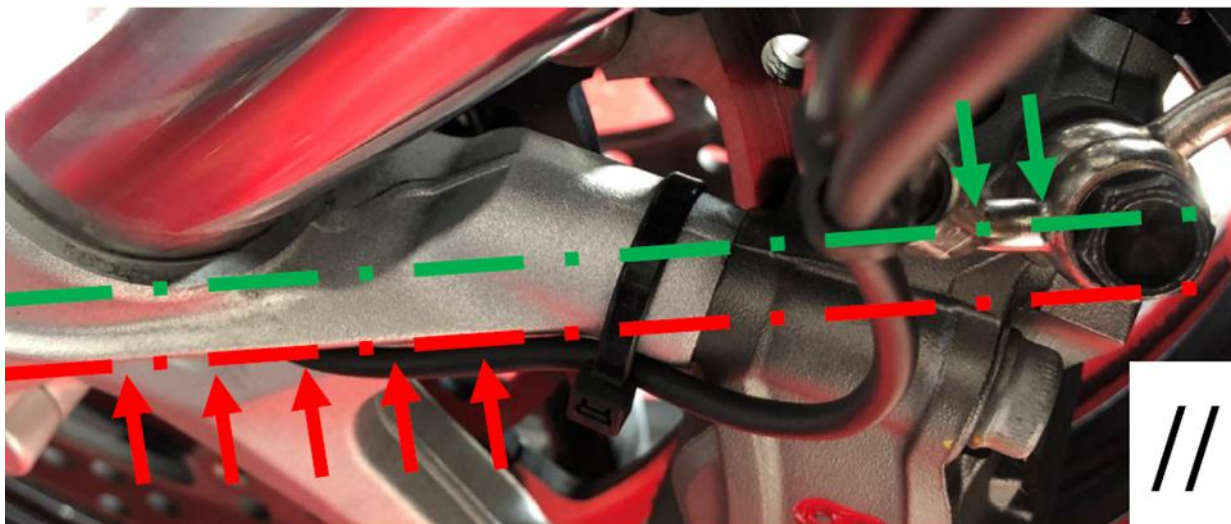
**LEFT SIDE:**

The left front brake calliper hose must have the axis of the connection (green line) parallel to the profile of the fork bottom left (red line), as shown in the photo below:

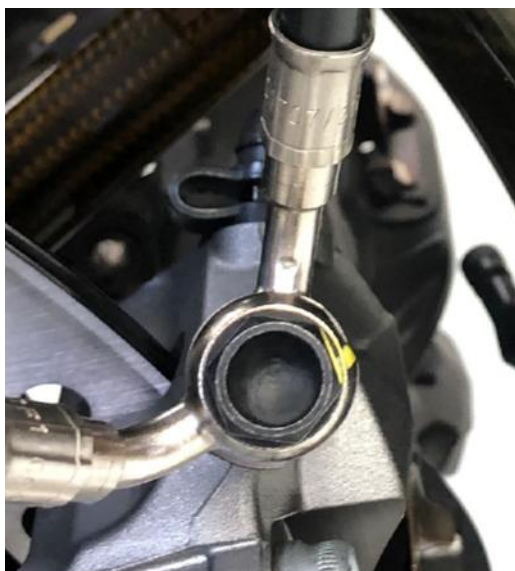
**BOTH SIDES:**

The front brake caliper hose must be tightened at both sides, as in the position shown in the photo below, taking the caliper bleed plug axis as a reference:

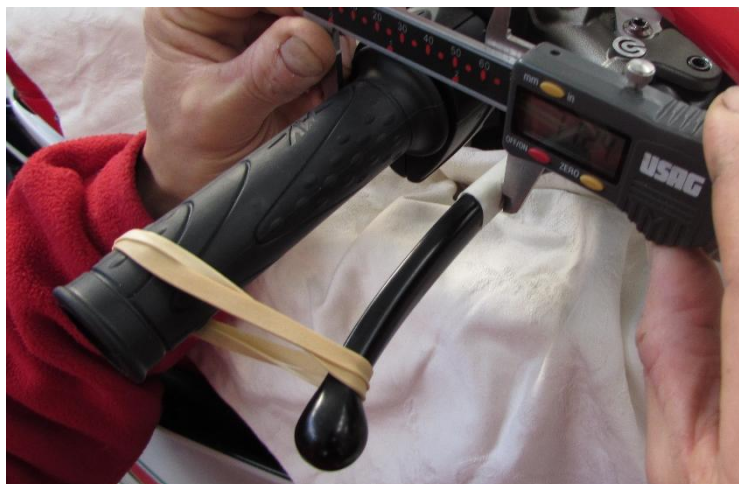
- Bleed the front brake system by topping up the system with Motul DOT 4 Brake Fluid from a sealed container (refer to the workshop manual for the bleeding procedure).
- Accurately clean the entire working area of any residues of brake oil.
- Check and, if necessary, restore the fluid level in the tank to the maximum reference mark.
- Apply a strip of adhesive tape to the front brake lever, mark it with a felt-tip pen and apply constant pressure to the brake lever with a rubber band
- Measure the distance of the lever from the knob in the previously marked area and **keep the elastic band applied for 10 min.**
- Check the distance of the lever from the handle again: **the maximum lever sag allowed is 3mm.**

- **IMPORTANT NOTE: If the distance between the lever and the handlebar is reduced by more than 3 mm, the brake circuit must be bled again.**
- Check that there is no oil leakage in the areas affected by the operation.
- Perform a dynamic test on the bike
