# Service Bulletin

Subject: **Starter relay cable**

Product: **Turismo Veloce Euro 5 (all versions)**  
from VIN:  
to VIN:

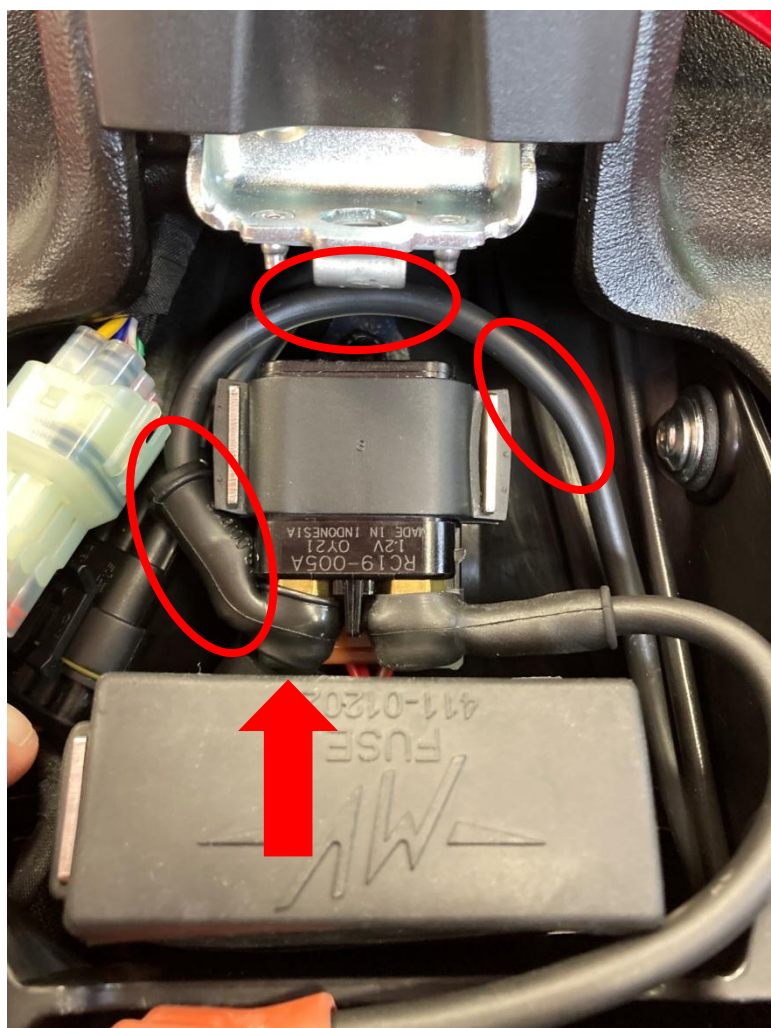
| Element to be modified/added | Type of operation to be performed | Reason for update |
|---|---|---|
| Path of the starter relay cable | The path of the cable must be corrected according to the instructions reported in the present Service Bulletin | The cable could be damaged by rubbing against the fixing plate of the rider seat |

- Remove the passenger seat
- Remove the rider seat (4 mm Allen key)
- Disconnect the battery (first the negative pole, then the positive one)
- Extract the relay, disconnect the connector, and loosen the end of the cable indicated in the figure with the arrow (8 mm hex key)
- Rotate the end of the cable as shown in the figure and tighten it again to the prescribed torque ( $3 \div 4$  Nm) making sure that the cable does not move during tightening.
- Reconnect the connector and put the relay back into place.
- Check that the cable does not have interferences in the highlighted areas. If necessary, gently bend the end of the cable until you obtain a path free from interference with the surrounding components.

- Reconnect the battery
- Refit the rider and passenger seats.
