Service Bulletin

Subject: **Gear selector connecting rod screw**

Product: **RUSH**

Service Bulletin n° 275 - Gear selector connecting rod screw RUSH

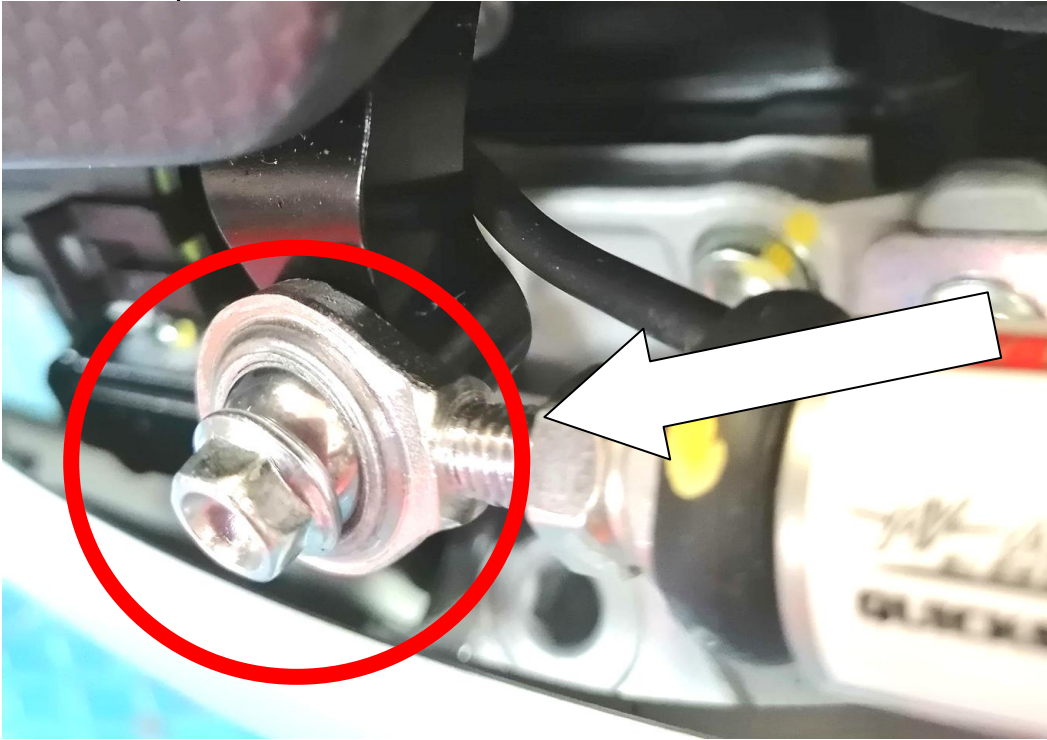
Identification of the part:

As part of the process of continuous improvement of the quality of our products, we would like to inform you about the new tightening of the gear selector fixing screw, having found that on some vehicles the fixing screw has an incorrect torque that could cause loosening and consequent malfunction or damage.

1. Locate the fixing screw of the gearbox connecting rod cod. 8A00C1214; the screw must be reused.
2. Tighten the M6X20 fixing screw cod. 8E00B2681 applying the torque of **10 Nm**
