Service Bulletin

Date: 05 February 2021

Subject: Fusebox holder

Product: Brutale 1000 Serie Oro - RR - Rush

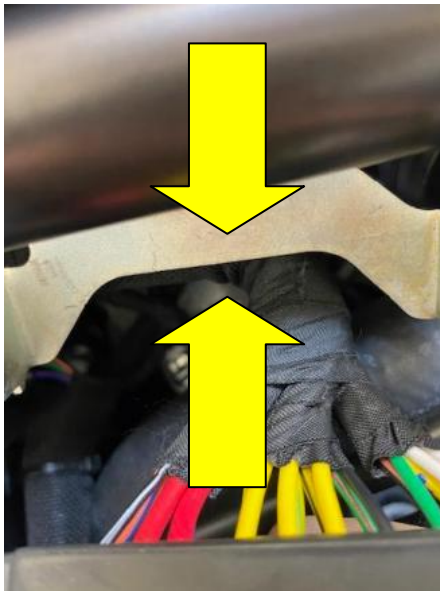
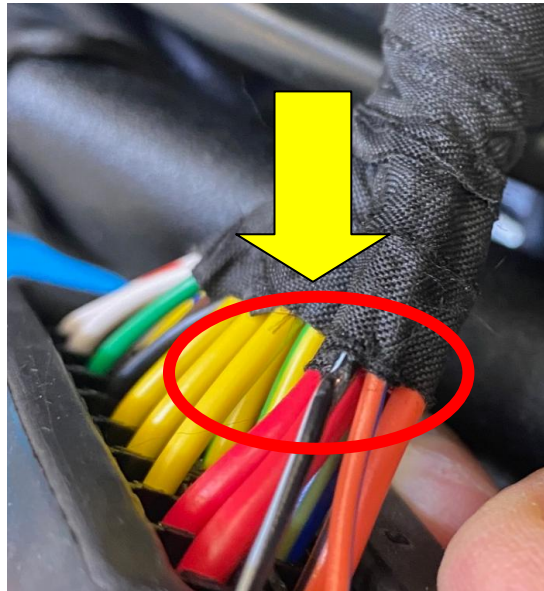
As a result of continuous monitoring of the quality of our product it has been found that for the Brutale 1000 Serie Oro - RR - Rush motorbike purchased by you, it is necessary to apply a rubber protection on the fuse-holder as an accidental contact with the wiring could damage the harness:

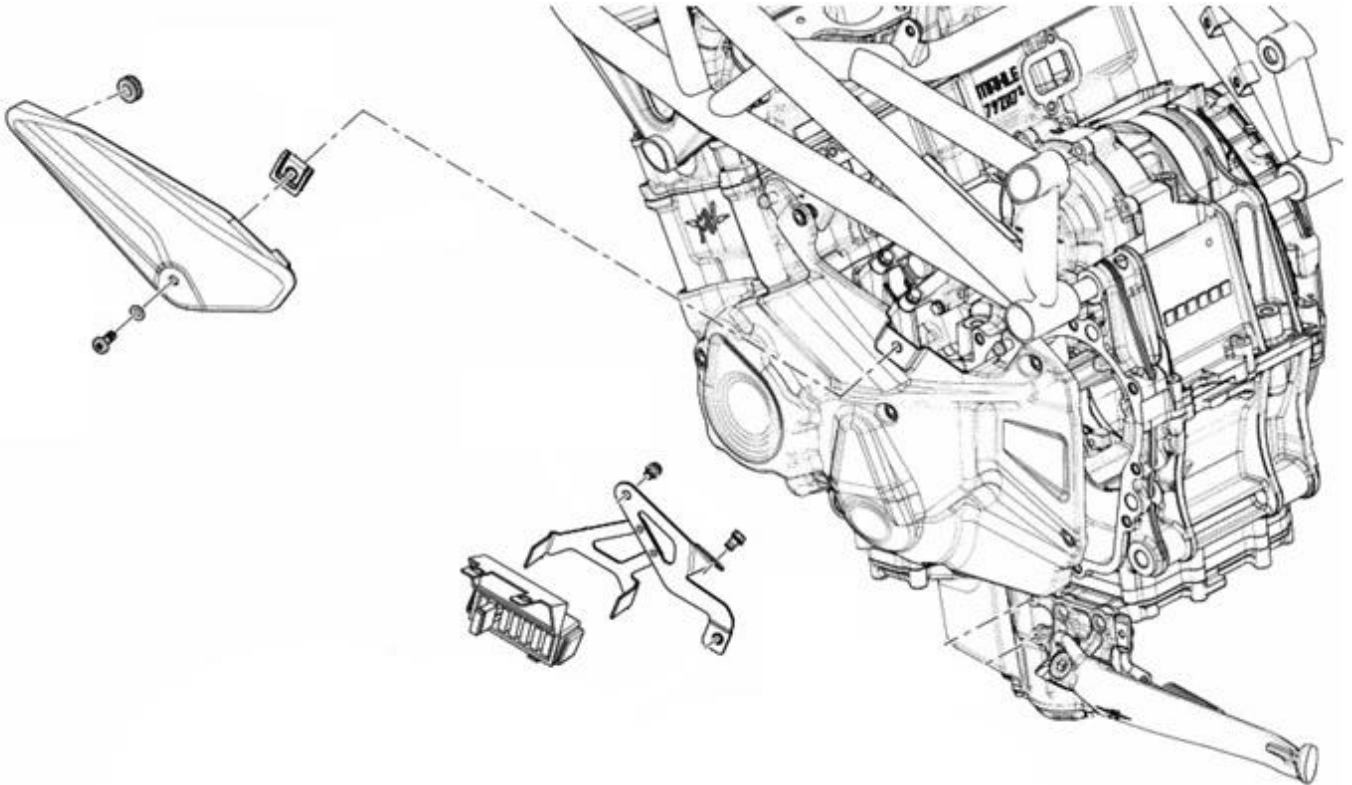
It will be possible to identify the motorcycles that needs to be updated by removing the aluminum cover on the left side of the bike, using a 4mm Allen key and acting on the quick release screw; Once the cover has been removed, remove the fuse box from its support and check the presence or absence of the rubber protection on the previously indicated area.

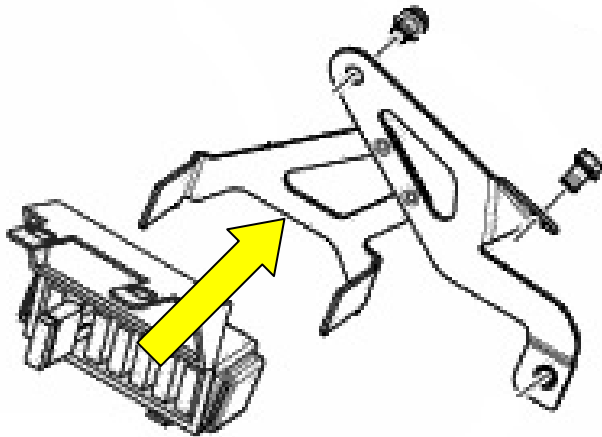
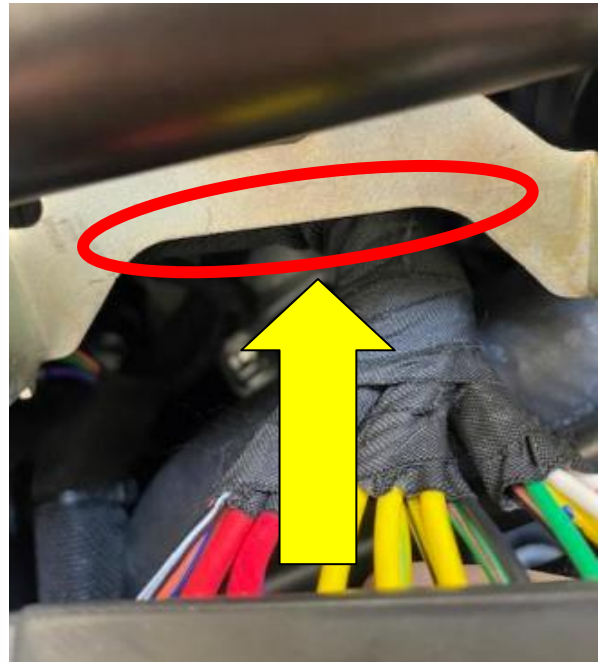
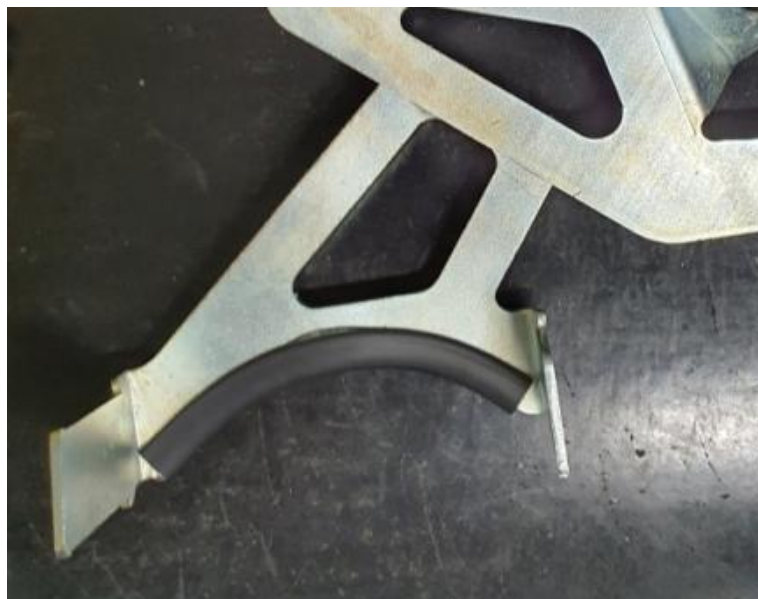
After removing the aluminium cover on the left side of the motorbike and removing the fuse box from its support, clean the surface indicated carefully and apply the rubber protection code **8D00B4458** (the protection is already supplied with adhesive):

Please place the fuse box back on its support, taking care to keep the wiring away from the edge of the support and reassemble the previously removed aluminium cover.
