NUMBER: 02-003-21

GROUP: 02 - Front Suspension

Noise in Front Over Bumps

2021 (DP) RAM 4500/5500 Cab Chassis

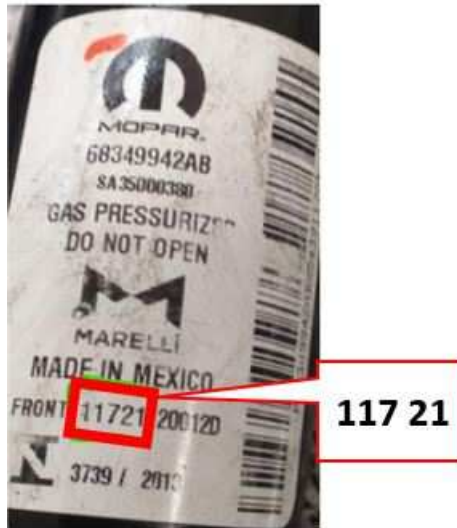
Fig. 1

Example Picture for the Location of Shock Julian Date

NOTE: This is an EXAMPLE: Julian date is broken down by days and year. First three digits of the Julian date is the days, 117 days with in the year and the last two numbers are the year 21.

1. Raise the vehicle in the air. Refer to the detailed service procedures available in DealerCONNECT>Service Library under: Service Info 04 - Vehicle Quick Reference / Hoisting / Standard Procedure.
2. Check both front shock absorbers Julian date (Fig. 1) .

3. Is the Julian date on one or both of the front shock absorber **07921**?
 - YES>>> **Only replace** the shock absorber with the Julian date of **07921**. Proceed to [Step 4](#).
 - NO>>> This bulletin has been completed. Use inspection LOP (02-15-10-9A) to close the active RRT.
4. Only replace the front shock absorbers with the Julian date of **07921**. Refer to the detailed service procedures available in DealerCONNECT>Service Library under: Service Info 02 - Front Suspension / Front / Shock Absorber, Suspension / Removal and Installation.
5. Lower and remove the vehicle form the hoist. This bulletin has been completed.
