NUMBER: 23-027-21

Third Row Headrest Fails To Fold Down

This bulletin involves inspecting both the left and right third row headrests and if necessary, re-seating the horseshoe cable clip(s).

2021 (WL) Jeep Grand Cherokee

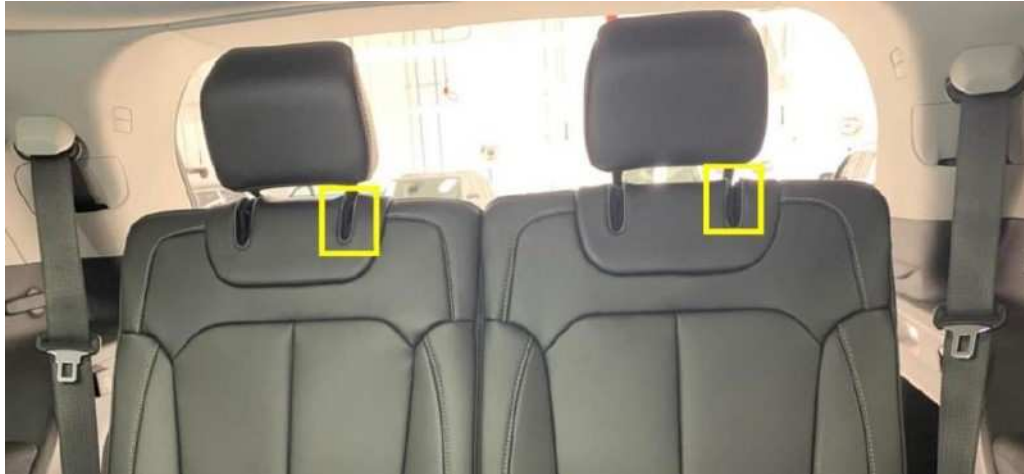
Fig. 1

1. Using a flashlight or equivalent light, visually inspect the horseshoe clips through both seat back trim cutouts (Fig. 1) .

Horseshoe Clip Seat Back Trim Cutouts

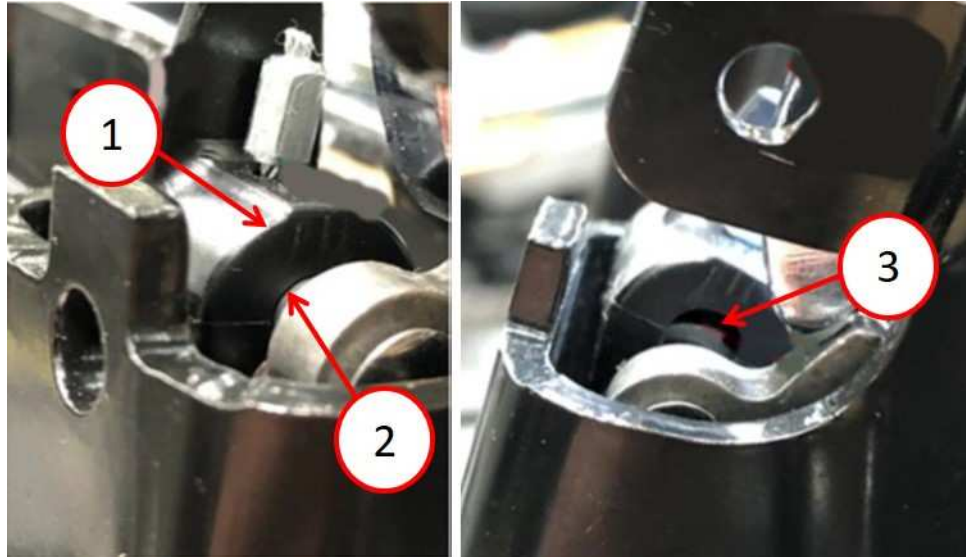
Fig. 2

2. Were either of the horseshoe clips partially seated (Fig. 2) ?
 - YES>>> Proceed to [Step 1](#) of the Repair Procedure.
 - NO>>> Proceed to [Step 3](#).

Correct And Incorrect Horseshoe Clip Positions

- 1 - Horseshoe Clip
 - 2 - Horseshoe Clip Fully Seated (**Correct**)
 - 3 - Horseshoe Clip Not Fully Seated (Incorrect)
-

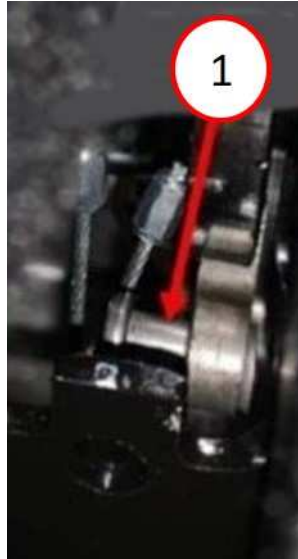
3. Was the horseshoe clip not visible at all (Fig. 3) ?

Fig. 3
Exposed Pin With No Horseshoe Clip

- YES >>> Proceed to [Step 4](#) of the Repair Procedure.
- NO >>> Further diagnosis should be performed, use inspect LOP (23-20-53-90) to close the active RRT.

11. Reach over the top and grasp the horseshoe clip with your other hand.
12. Position the horseshoe clip over the pin (Fig. 3) .
13. Using moderate force, pull the headrest forward to prevent the headrest from folding while seating the horseshoe clip (Fig. 4) .
14. Push the fin down on top of the horseshoe clip (Fig. 5) until the clip snaps into place on the pin.
15. Fasten the bottom J retainer and install the fir tree clip (if present) from the rear which holds the front face of the seat back cover. Zip both seat back trim cover zippers.
16. Cycle the folding seats using the radio soft button or manual handle, to ensure the headrest folds. Use LOP Left and or Right, Third Row Headrest(s) Inspect, Unfasten Seat Back and Seat Horseshoe Clip.

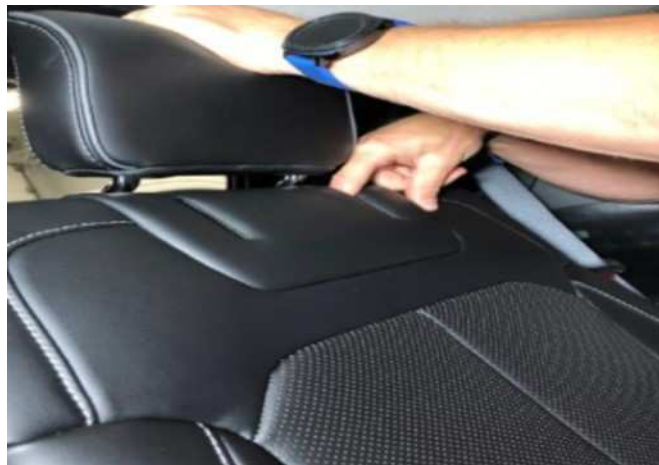
Fig. 4
Pulling Headrest Forward

1. **Using moderate force**, pull the headrest forward to prevent the headrest from folding while seating the horseshoe clip (Fig. 4) .

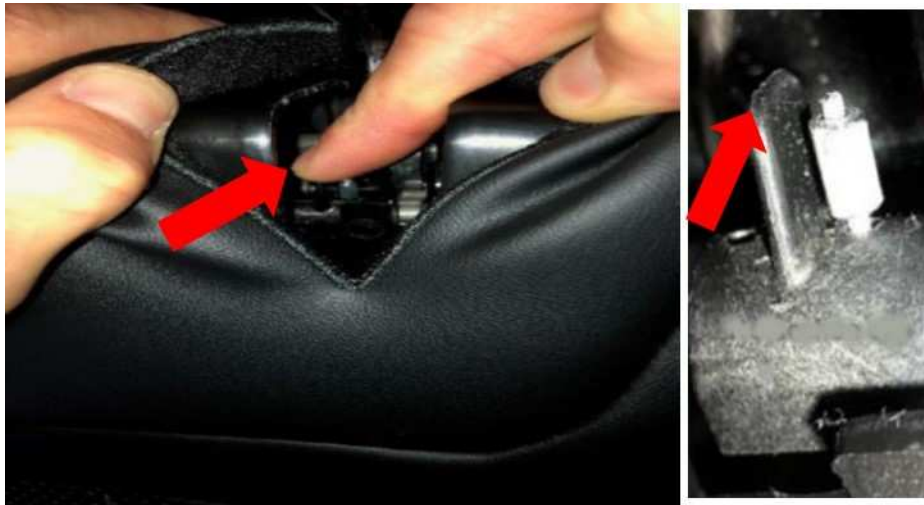
Fig. 5
Horseshoe Clip Fin

2. Push the fin down on top of the horseshoe clip (Fig. 5) until the clip snaps into place on the pin.

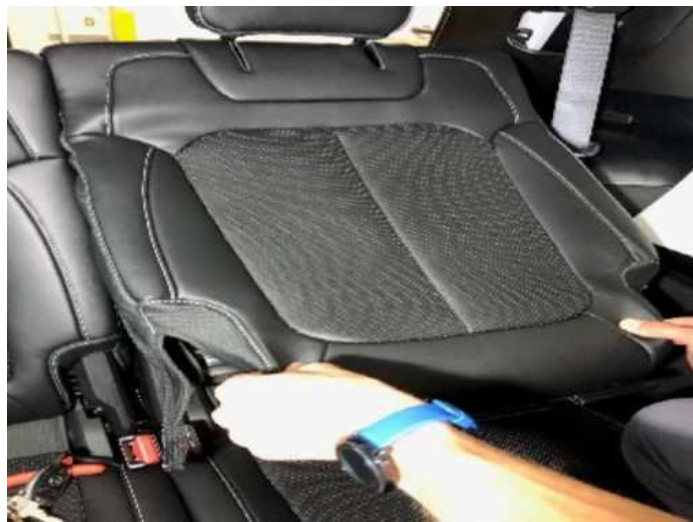
Fig. 6
Trim Cover

3. Cycle the folding seats using the radio soft button or manual handle, to ensure the headrest folds. **This bulletin has been completed.** Use LOP (23-20-53-90) Inspect and/or Engage Third Row Seat Headrest Release Cable to close the active RRT.
4. Fold the seat back to the downward position.
5. Lift the load floor close out panel to access to access the seat back trim cover zippers.
6. Unzip both the seat back trim cover zippers (using zipper tool or needle nose pliers) one on each side of the cover. Unfasten the bottom J retainer and remove the fir tree clip (if present) from the rear which holds the front face of the seat back cover.
7. Unfold the seat back to the upright position.
8. Pull the seat back cover and foam pad assembly forward (Fig. 6) until seat structure is accessible.

9. From the front of the seat, reach under front cover foam and locate horseshoe clip by following the cable conduit upward.
10. Push the horseshoe clip upward inside the headrest bracket, next to the headrest release pin.

NOTE: The horseshoe clip opening must face toward the pin, the fin facing inboard, and the cables must not be twisted (two cables for manual seats and one cable for power seats).
