NUMBER: 23-029-21

Loose Rear Spoiler Scat Pack Badge

This bulletin involves inspecting and if necessary, replacing a separating or not adhering chrome Scat Pack badge on the rear spoiler.

2021 (LA) Dodge Challenger

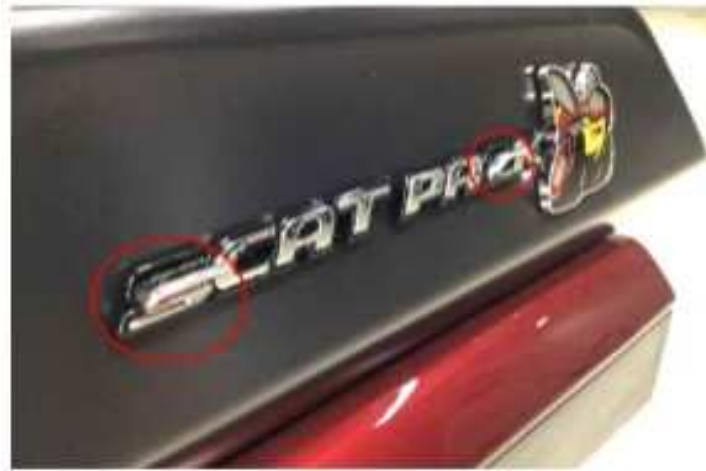
- The chrome letter Scat Pack badge is separating or loose, has gaps or is not adhering to the rear spoiler on the passenger side of the vehicle.

1. Visually inspect the chrome Scat Pack badge letters for any separation or looseness from the rear spoiler (Fig. 1) .

Fig. 1
Loose Badge Or Separation

2. Was the badge loose or any separation noticed?
 - YES>>> Proceed to [Step 1](#) of the Repair Procedure.
 - NO>>> No visual looseness or separation was found. Proceed to [Step 3](#).
3. Cut a piece of 3M 898 tape at a length long enough to cover the entire face of the Scat Pack badge chrome letters.
4. Apply the 898 tape to the badge chrome letters, ensuring that the entire surface of the badge chrome letters are covered (Fig. 2) .

1. Replace the chrome Scat Pack badge.
2. Apply a length of masking tape on the rear spoiler parallel to the top and bottom edges of the badge as a guide if necessary.

3. Using a plastic trim stick tool, remove the chrome Scat Pack badge carefully from the rear spoiler.
4. Thoroughly clean all residue from the rear spoiler badge attachment surface area.
5. Wipe the rear spoiler badge attachment surface area with a clean, lint-free cloth, moistened with a 50% solution of water and alcohol. Wipe dry the area immediately with a dry, lint-free cloth.

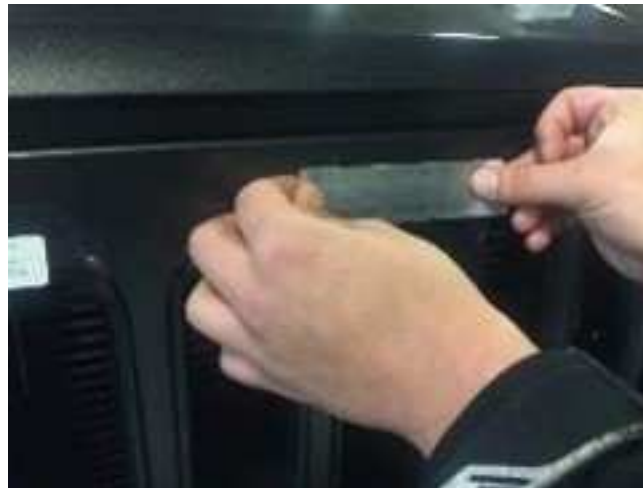
Fig. 2
Applying 898 Tape To Badge Letters (Example)

5. Pull the 3M 898 tape off quickly and perpendicular, from right to left and inspect the chrome badge letters for any lifting or separation.
6. Did any of the chrome Scat Pack badge letters lift, or separate from the badge?
 - YES>>> Proceed to [Step 1](#) of the Repair Procedure.
 - NO>>> This bulletin has been completed, use inspect LOP (23-03-08-9R) to close the active RRT.
