**NUMBER:** 23-008-21

Missing (Power Wagon) Decals on Tailgate and Both Front Doors

2021 (DJ) RAM 2500 Pickup

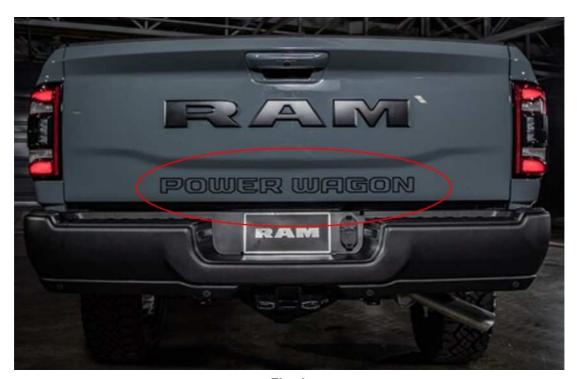
Fig. 1 Power Wagon Tailgate Decal

Verify the vehicle does not have the "Power Wagon" decals already installed per the picture (Fig. 1) & (Fig. 2).

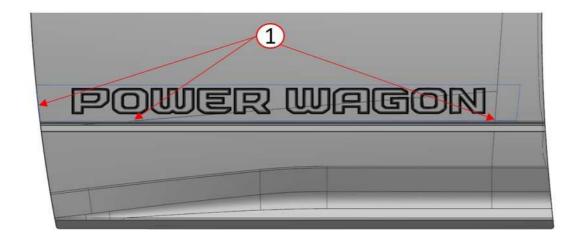
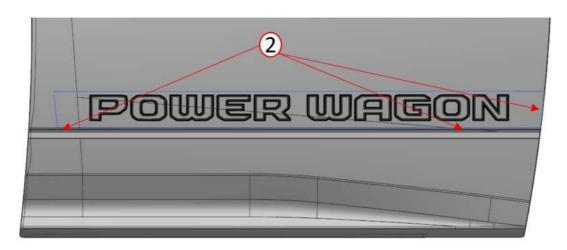
Fig. 4
Front Side Doors Decal Proper Placement

1. Locate decal premask to front edge of door and to character line as shown (Fig. 4).

- 1 Front Door Driver Side Decal Locate Decal Premask to Front Edge of Door and to Character Line.
- 2 Front Door Passenger Side Decal Locate Decal Premask to Front Edge of Door and to Character Line.

- 2. Lay decal paper liner side up (face down) on flat, clean surface. Slowly remove paper liner at a 180° direction, keeping as flat as possible. Avoid finger contact with decal adhesive surface. Spray exposed adhesive and the body surface with the wetting solution.

- 3. Hold the premask area of the part and position to body using premask locators. Do not preadhere decal to vehicle with hands. Do not allow the adhesive surface to become contaminated by touching clothing, or floor etc. If the decal does not float into position, add one to two more drops of liquid dish soap to the wetting solution.

- 4. Squeegee entire premask surface with a plastic squeegee. Start at the center and fan out to the edges using firm, overlapping strokes.
- 5. Slowly remove premask at a 180° direction, (flat to surface). Do not snap it off or remove in a 90° direction, (perpendicular to the surface). If the decal comes up while removing the premask, there may be too much soap in the wetting solution or the temperature may be below 21°C (70°F). Resqueegee the entire decal. Then wait a few minutes to allow the adhesive of the decal to increase before removing premask.
