STAR ONLINE PUBLICATION

Case Number: S2124000004

Symptom/Vehicle Issue: A/C does not cool and vehicle is low on Freon charge but no leak is found with sniffer or black light anywhere in the system

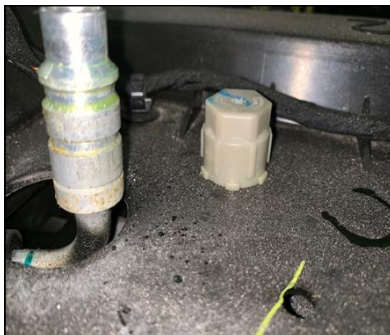
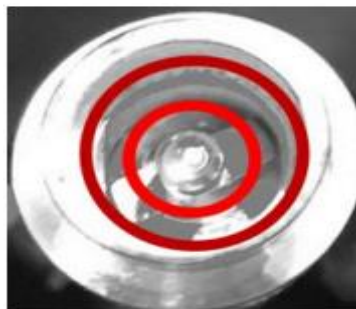
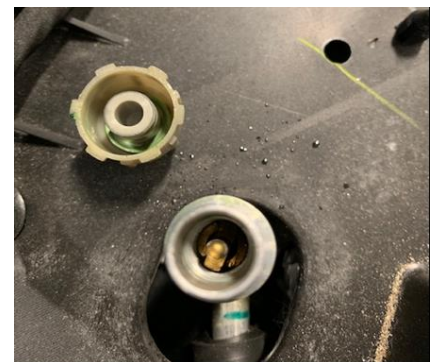
Use Leak Detector Sniffer in
This Area as Shown Below.

Discussion: Fill the high side and low side charge ports with POE oil. Turn the vehicle on, set A/C to the "A/C Max" setting and let the car run for 5 min, Inspect the charge ports for bubbles coming from the valves.

Check to see if bubbles come out of the valve. Please note whether the bubbles are coming from around the valve or through the valve.

- If bubbles detected, reclaim the system through the low side ONLY, replace the entire line and send part back to FCA.
