## STAR ONLINE PUBLICATION

Case Number: S2008000126 REV. D

**Symptom/Vehicle Issue:** RKE Has Reduced Range, Remote Start Inoperative, Multiple Keyless Go Push Attempts To Start, Key Not Detected Message, Tire Pressure Warning Lamp On

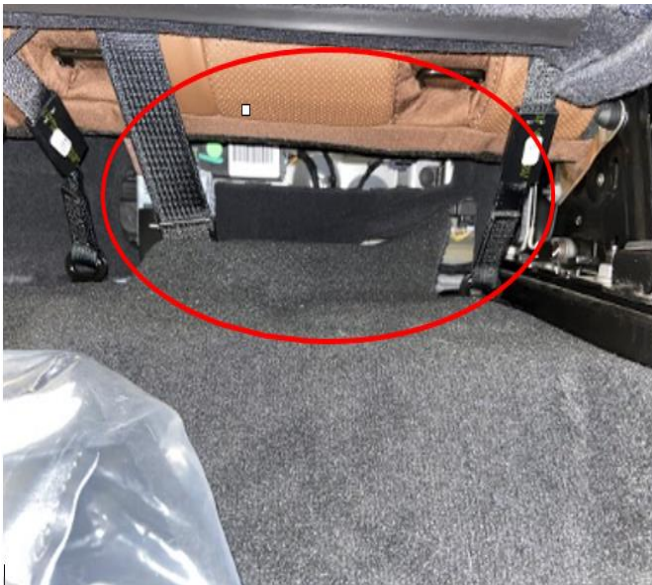
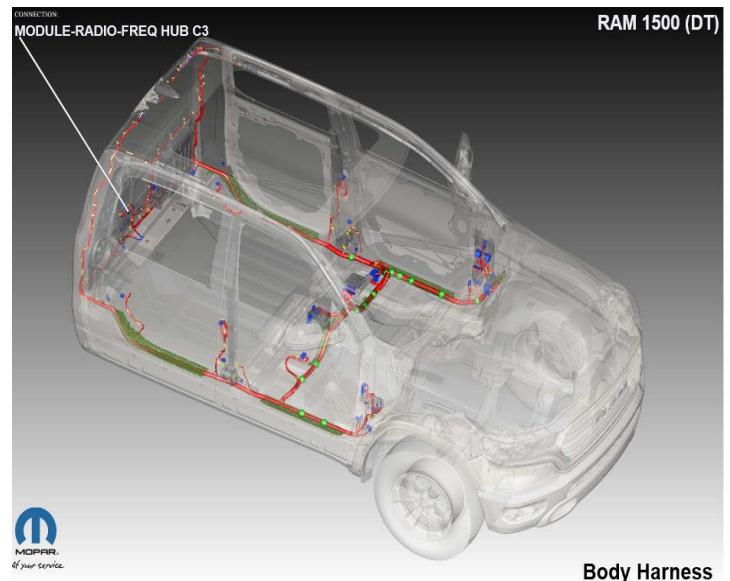
Fig 1

**Discussion:** Inspect the remote start antenna connection to the RFHUB located under the rear seat. Connections at the module may have been affected after owner usage of the storage area under the seats or at the remote start antenna headliner location. Secure connections and test and or **swap** out the RSA (remote start test antenna or jumper RFHUB to RSA) with a known good antenna to confirm operation. Do not replace RFHUBS or multiple sensors until checking for the following Fig 1, 2.

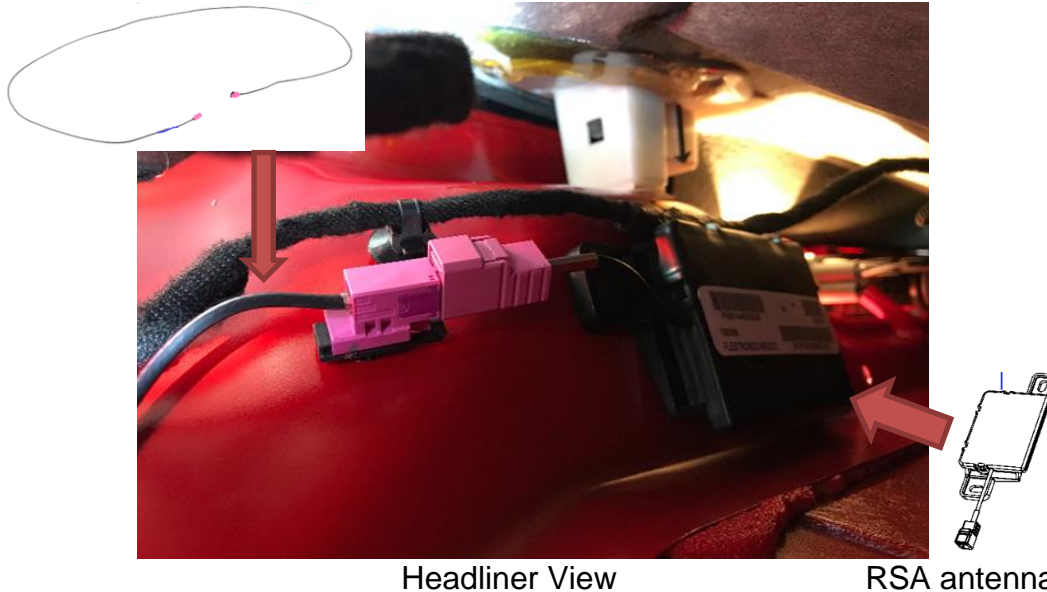
**Fig 2**

Coaxial jumper - RFHUB to RSA 68463501AA

Headliner View

RSA antenna

Disconnect Coax and inspect  
Check for Damage at the RFHUB and/or RSA locations.  
Secure reconnect Coax – test or check operation with test lead or known good part.  
Reset ECU  
Verify DTC or concerns not returning

After market equipment inspection  
Validate 3<sup>rd</sup> brake lamp has not been replaced to an LED lamp assembly  
Check Key FOB Range to validate operational strength.
